## SERVICE PROBLEMS OF AN AXIAL COMPRESSORS OF A LAND BASED, HIGH POWER, REACTION GAS TURBINES

*A compressor blade failure was experienced at the 69 MW gas turbine of a combined cycle (C.C.) unit after four years operation since the last overhaul. Three unit failure events occurred at small periods, which caused forced outage. Visual examination carried out after the failure events indicated that the compressor vanes (diaphragms) had cracks in their airfoils initiating at blade tenons welded to the diaphragm outer shroud at some stages. Also, many stationary vanes and moving blades showed foreign object damage (FOD), rubbing and bending. A compressor failure evaluation was completed including cracked vane metallographic analysis, unit operation parameter analysis, history-of-events analysis, and crack initiation and propagation analysis. This paper provides an overview of the compressor failure investigation, which led to identification of the vane high cycle fatigue (HCF) failure mechanism generated by rotating stall during unit start-ups, highly accelerated by corrosion generated by the fogging system and influenced by high stationary vane and moving blade brittleness as the pri

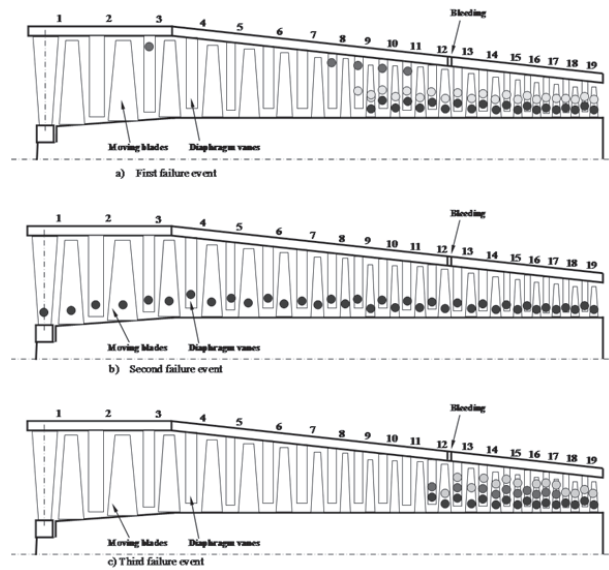
a third event in May 2009. The compressor damage distribution during the three failure events is shown in fig. 2.

Fig. 2. Compressor damage distribution during the three failure events

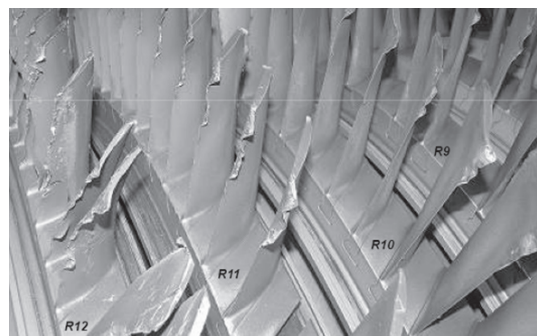
During the first failure event in December 2008, there was FOD and rubbing of compressor moving blades (see fig. 3) and FOD, rubbing, bending and fracture of compressor stationary vanes (diaphragms) as shown in fig. 4. There were also vane fractures at the vane union diaphragm shrouds, stages 8 to 10 as shown in fig. 5.

Fig. 3. Compressor moving blade damage

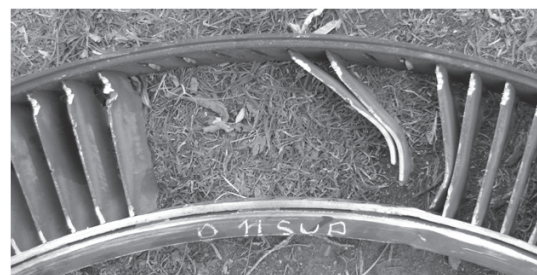
Fig. 4. Compressor stationary vane (diaphragms) damage stage 11

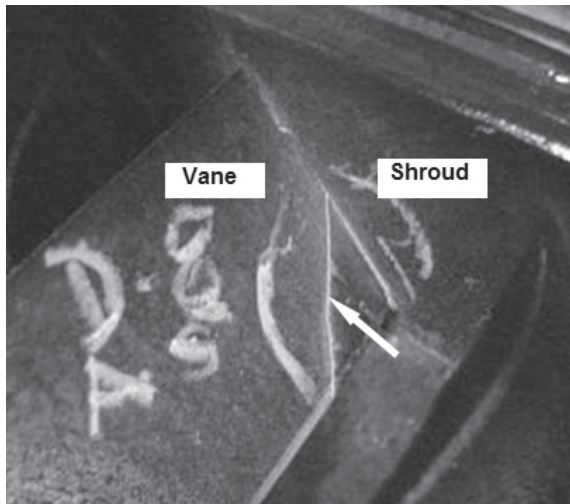
Fig. 5. Vane fractures at the union of vanes with diaphragm shrouds stages 8 to 10.

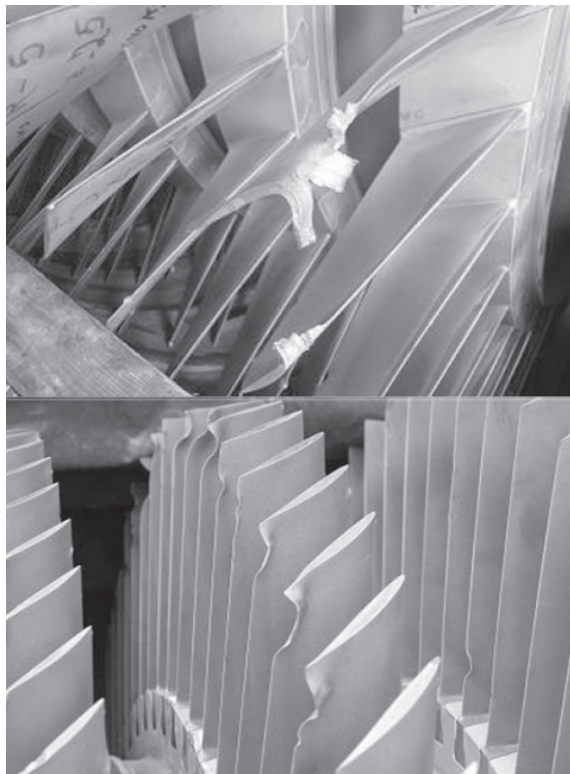
During the second failure event in March 2009, there occurred FOD of compressor moving blades and stationary vanes (diaphragms) stages 1 to 19 as shown in figs. 6 and 7. The failure was attributed to the fogging system water spray nozzle, which broke and was separated from the nozzle support structure and then introduced in the compressor flow path channel at high velocity causing FOD in the compressor. During the third failure event in May 2009, there occurred FOD of compressor moving blades and stationary vanes (diaphragms) stages 12 to 19 as shown in figs. 8 and 9.

Fig. 6. FOD damage of compressor moving blades

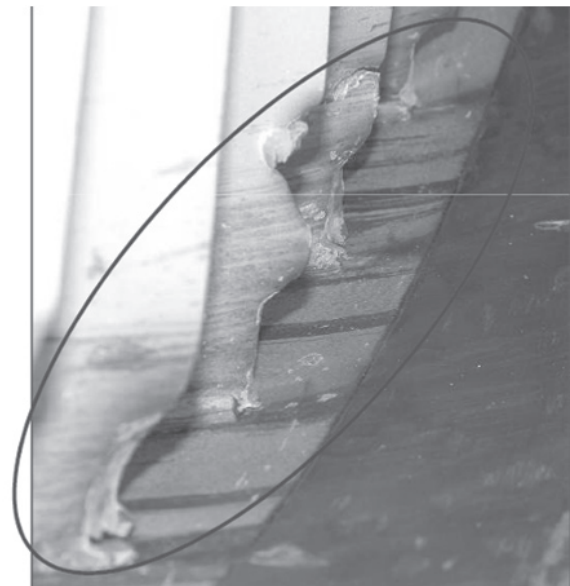
Fig. 7. FOD damage of compressor vanes (diaphragms)

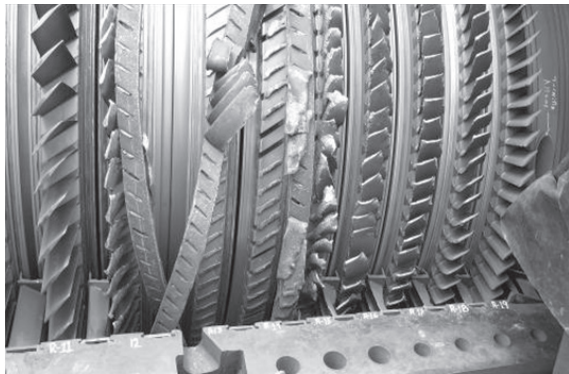
Many blades/vanes were heavily impacted and deformed; some moving blades and stationary vanes were fractured. An apparently fatigued type fracture surface was found in the union of vane tenons with diaphragm outer shrouds, stage 13, as shown in fig. 10. It can be seen from fig. 10 that fracture was initiated at the vane tenon weld heat affected zone and the presence of fatigue beach marks can be observed. Also, there were corrosion deposits on the compressor vanes and casing as shown in fig. 9. Among the three compressor failure events presented, the third one is the root cause analysis in this paper.

Fig. 10. Fracture surface of compressor diaphragm vane tenons, stage 13 with appearance of HCF

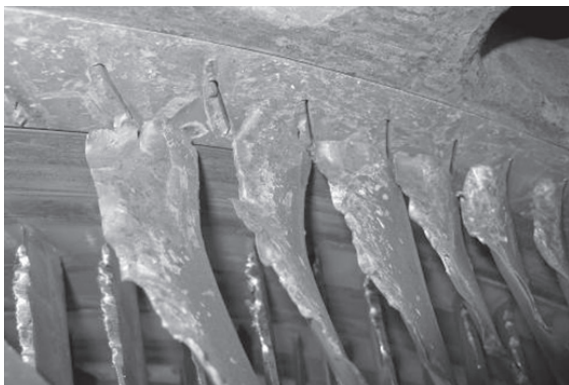
Vane cracks were developed in the vane tenons at the outer shroud of the diaphragm (fig. 11). As mentioned before, these cracks were of the high cycle fatigue type (fig. 10) and initiated in the heat affected zone adjacent to the tenon weld. They were caused by vibratory stresses which occurred during start-up acceleration as a result of diaphragm resonance in one of its first three natural frequencies [7] with local air flow disruptions associated with the presence of rotating stall cells, as explained before, and upstream rotating blade wakes. The first three diaphragms vibratory mode shapes corresponding to mentioned previously diaphragms natural frequencies are shown in fig. 12 [7]. The manufacturer reported that the stress concentration factor due to the weld heat affected zone of diaphragm tenons is 3.5 approximately [7]. Due to this fact and the presence of corrosion pits on the vane/tenon, local stresses rise significantly in this zone, leading to fatigue failure initiation and propagation.

Fig. 11. Fracture localization at compressor vanes of diaphragms

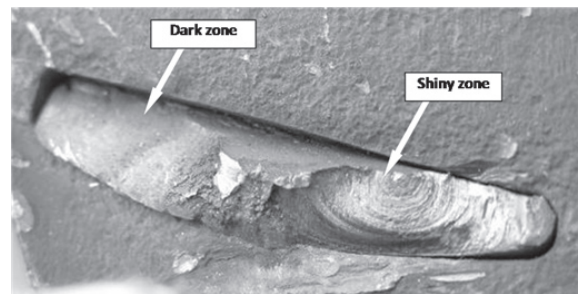
falls within the range 40–56 HRC. This value is very high (brittle material) and means that, after vane-to-shroud welding, no stress relieving process of the diaphragms was executed. Fractography evaluation was achieved on the exposed vane/tenon crack surface using scanning electronic microscopy (SEM) to determine the origin of the fracture. Fig. 16 shows a general view of the vane/tenon fracture surface. Two different zones were found: a dark zone with appearance of sudden fracture and a shiny zone with beach marks typical of a HCF failure mechanism.

Fig. 16. General view of the vane/tenon fracture surface, stage 13

Severe FOD impacts on the vanes close to the diaphragm outer shroud during the first failure event (December 2008) could generate sudden partial fractures of the vanes/tenons due to their high hardness and related brittleness, as appears in the dark zone in fig. 16. Diaphragm stages 13 and 14 in which vanes/tenons fatigue fractures occurred during the third failure event (fig. 10, May 2009) operated continuously since the overhaul in 2005 and were present during all unit failure events. These vanes were probably fractured partially during the first failure event by FOD and not detected by non destructive examination. As can be seen in fig. 11, if tenon fracture is localized within the diaphragm outer shroud width (not propagated to the vane airfoil), this fracture is covered by the weld and outer diaphragm shroud, making it impossible to detect by the magnetic particle examination commonly used for diaphragm non-destructive testing. It supports the conclusion mentioned above that tenon partial fractures (dark zone in fig. 16) were developed during the first failure event. This conclusion is supported also by the chemical analysis of the vane/tenon fracture surface presented in fig. 19, which indicates that the fracture dark zone (fig. 16, sudden fracture) is more oxidized than the shiny zone (fatigue fracture), meaning that sudden fracture was developed some time before fatigue fracture. A pre-existence of initial sudden fractures at the vanes/tenons before the unit third failure event is also supported by the fact that vane fatigue failure soon developed during the third failure event after only two unit start-up attempts. Diaphragm vanes are joined to the shrouds by one

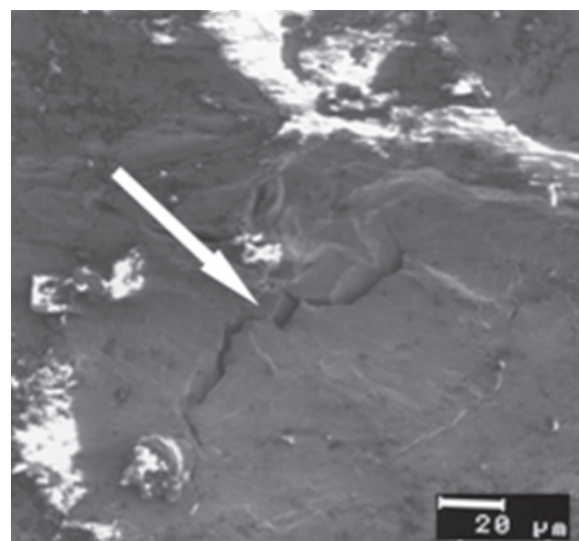
Fig. 17. Detail of the vane/tenon fracture initiation zone, stage 13

Fig. 17 shows a detail of the fracture initiation zone of the vane/tenon stage 13. It can be appreciated that fracture initiation was trans-granular which is typical for an HCF mechanism and the presence of micro cracks on the fracture surface close to the fracture initiation zone. Blade fracture initiated in corrosion pits (Fig. 18 b). The presence of beach marks on the fracture surface is noticeable (fig. 18a) as well as a high quantity and density of corrosion pits, which indicates severe corrosion attack (fig. 18b). Twelve (12) beach marks were counted on the fracture surface, and no visible striation lines were detected. The shiny appearance of this fracture surface zone suggests that it is a recent fracture. Fig. 19 shows an Energy Dispersion Spectrum (EDS) of deposits found on the vane fracture surface in two zones: the dark zone and the shiny zone shown in fig. 16. It may be concluded from fig. 19, that the dark zone/surface has more oxygen concentration than the shiny one has, which means it was exposed more time to a corrosive ambient than the latter. Deposits of Na, Al, S and Zn were also found on the fracture surface, among which Na and S are principal corrosive agents in reaction with water.

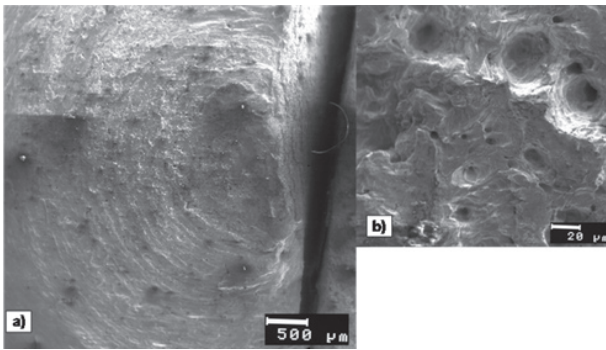
Fig. 18. Details of the fracture surface shiny zone from figure 16. Beach marks a) and corrosion pits b) on the fracture surface of vane/tenon stage 13

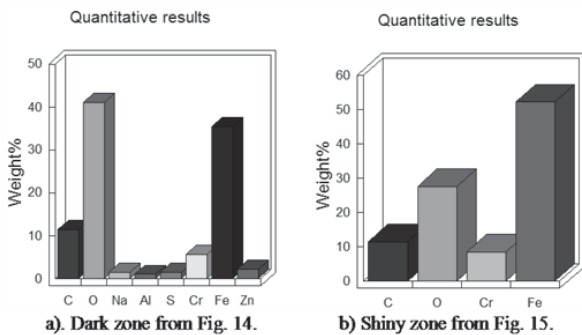
Fig. 19. Deposits found on the vane/tenon fracture surface, diaphragm stage 13: a) Dark zone from fig. 16, b) Shiny zone from figure 16

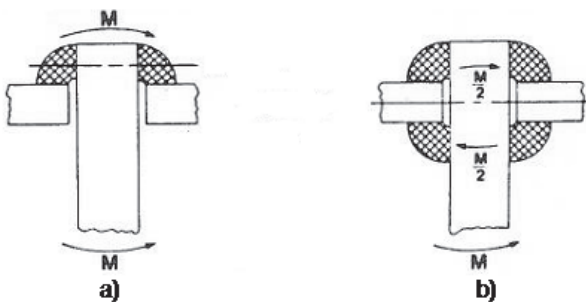
weld in the case of stages 12 to 19 (fig. 21a) and by two welds in the case of stages 1 to 11 (fig. 21b). It may be seen from fig. 21 that the joint with two welds (fig. 21b) provides a better distribution of flexural moments ( $M$ ) because each weld is loaded by half of the moment ( $M/2$ ). In the case of joints with only one weld (fig. 21a) the load is twice as high, and the probable failure of this joint is much greater. During the first and third failure events, vane fatigue fracture is related to rotating stall initiated at vanes of the front stages, before air bleeding, see fig. 2a) and fig. 2c) which is consistent with the rotating stall mechanism described in previous sections. Fatigue fracture of the rear stage vanes, after air bleeding during the third failure event (fig. 2c) is related to upstream rotating blade wakes associated with rotating stall. Also, the weaker vane-to-shroud weld joint design of the rear stages (fig. 21a) accelerated the fatigue fracture of these vanes. Other possible causes of vane failure were verified including IGV angles and IGV schedule control logic, excessive water injection by fogging (water overspray), possible off-design operating conditions and compressor blades/vanes degradation, but no related irregularities were found.

Fig. 21. Design of the diaphragm vane-to-shroud weld joint: a) Stages 12-19; b) Stages 1-11.
