Csilla VANYA

DAMAGE PROBLEMS IN GLUED LAMINATED TIMBER

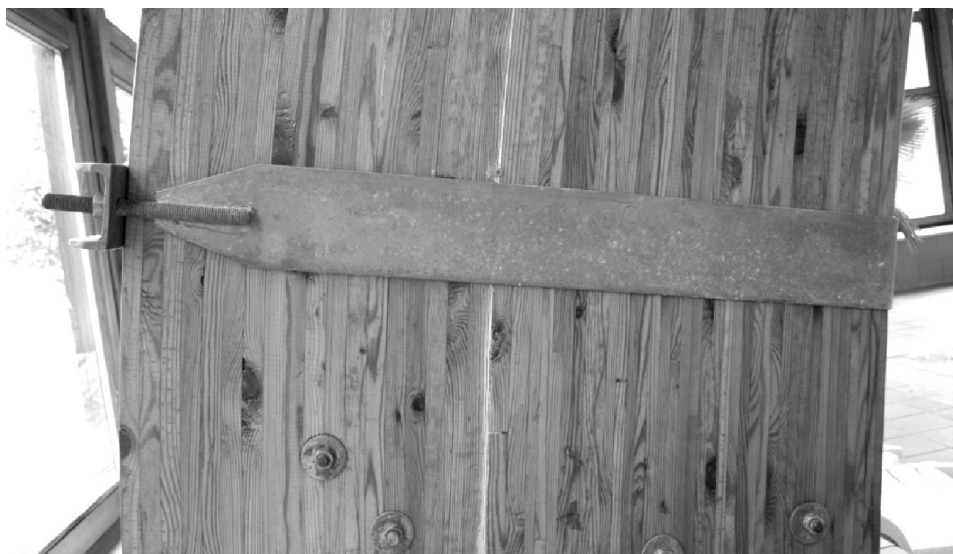
Fig. 1. Steel bandage element on the frame column in the pool at Hajdúszoboszló
Rys. 1. Stalowa opaska na kolumnie szkieletu konstrukcji – basen w Hajdúszoboszló

Typical problems were cracks on the ends of the beams, and delamination at the metal connectors. The bolted connections were hindering the shrinking and bulking, and the beam showed splits between the bolts. The effect of the hindered deformation was also examined at the University of West Hungary Testlab.
