FRACTOGRAPHY AND DAMAGE ANALYSIS OF CARBON/EPOXY COMPOSITES UNDER STATIC AND DYNAMIC LOADS AT ELEVATED TEMPERATURES

Abstract: This paper presents the microstructural and fractographic analysis of damage in carbon/epoxy composites after static and fatigue strength (shear) tests at elevated temperature. The microstructural tests and fractographic analysis confirmed the complexity of degradation process and degradation mechanisms in composite structure. Multiple cracks, delaminations and interface degradation between fibre and matrix have been observed. The fracture analysis indicate the occurrence of characteristic failure area: matrix river lines, matrix rollers, fractures and reinforcing fibres imprints. The interface, except of the type of components and their features, is the principal factor determining the properties of composite material. The quality of the bonding between the reinforcing phase and matrix, mechanism of composite cracking as a whole as well as cracks of individual components are directly affected by the interface.

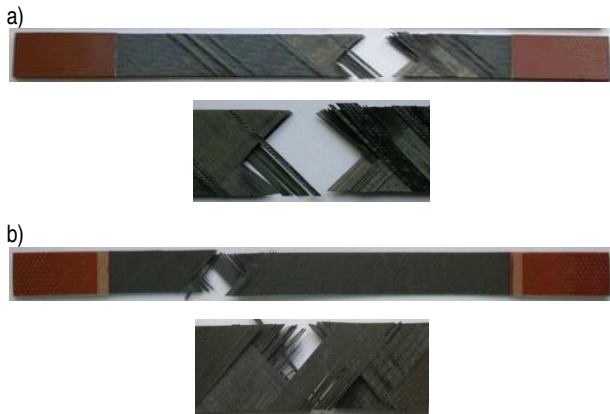
Fig. 1 illustrates the macroscopic image of carbon/epoxy composites after (static and fatigue) shear test. In both cases, the damage occurred in the central part of the material in the form of complete damage of reinforcing fibres and matrix as well as delamination in interlayer planes.

Fig. 1. Specimens of carbon/ epoxy composites after shear test: a) static test; b) fatigue test

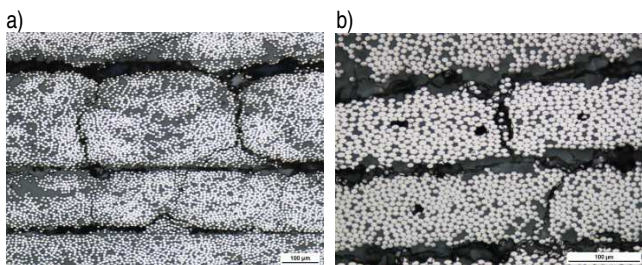
The microstructure of carbon/ epoxy composite after the static shear test is illustrated in Fig. 2a.

The delaminations between successive layers and lateral cracks connected to each other are visible along fibre/matrix boundaries.

Fig. 2. The microstructure of carbon/epoxy composite after the shear tests: a) static test; b) fatigue test (cross- section)

In case of carbon/epoxy composite after the fatigue shear test (Fig. 2b), the presence of delaminations is found between layers and lateral cracks across the composite layers. Multiple porosities have been observed, particularly within interlayer spaces. Individual cracks combine with porosities forming the grid of cracks.

The process of porosities forming in carbon/epoxy laminate occurred probably in course of manufacturing i.e. polymerization process (loss of vacuum bag tightness). Occurred porosities may affect not only the quality of composite structure but also may lead to the reduction of strength and fatigue properties of the material.

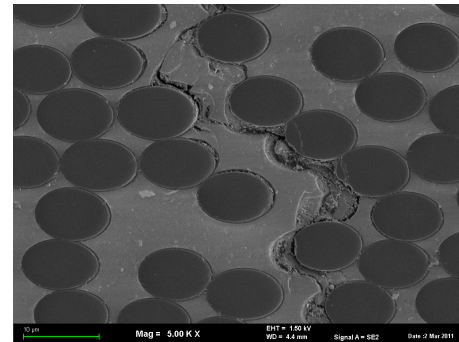
The mechanism of crack propagation process along the fibre/matrix boundaries with visible degradation of interface has been illustrated in Fig. 3. Multiple areas of initiation and cracks are visible (loss of adhesion) and may combine together easily leading to the damage of composite.

Fig. 3. Cracks and degradation of fibre/matrix interface (cross- section); SEM

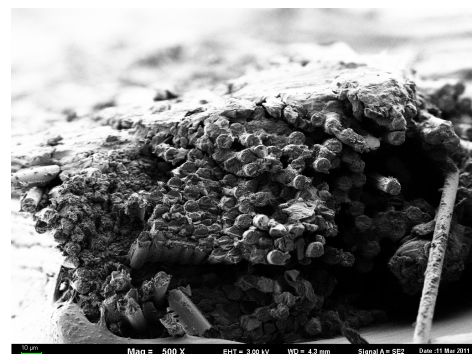
Fig. 4. Fracture surface in examined composites after static and fatigue tests. Damage region is typical for high energies; SEM

In case of low energies, the surface on fibres fracture is smooth and the fibres are arranged in an uniform manner. Their location on the same level is the symptom of low energy level occurring at the time of structure damage. However in case of the damage characterized by the high energy level and observed also in materials under analysis, the surface of fracture is non-uniform and the reinforcing fibres are located on various levels (Greenhalgh, 2009).

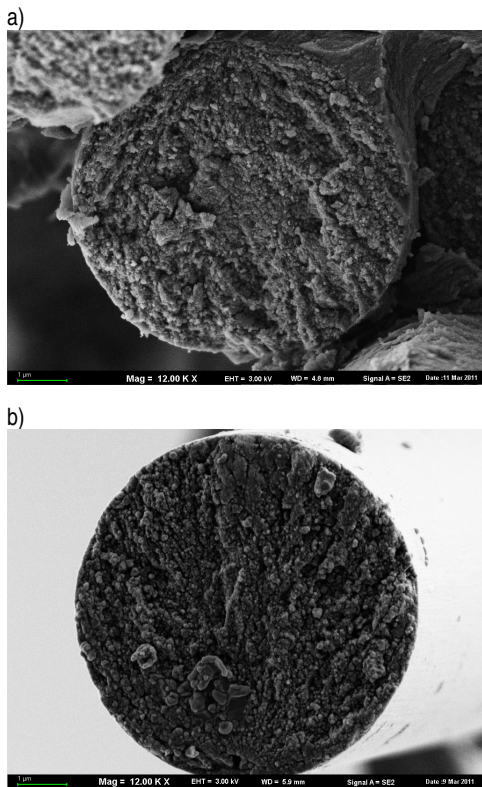
No significant differences appeared from the analysis of damage fractures after static and dynamic tests. Fig. 5 illustrates the fractures of reinforcing fibres.

Fig. 5. Fractures of carbon fibres after shear strength tests: a) static test; b) fatigue test

A characteristic crack initiation zone (source) has been observed in both cases. Radially propagating crack growth direction lines are the symptoms of brittle cracking phenomenon occurred in fibres in course of structure damage. This phenomenon has been confirmed by observations of Greenhalgh (2009).

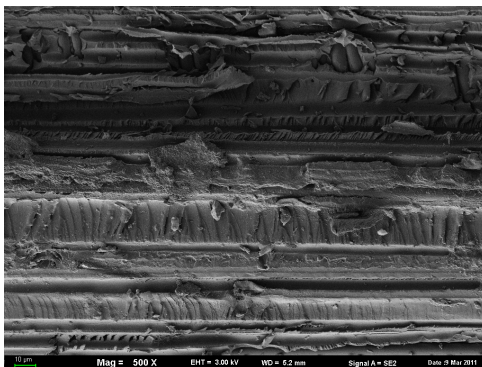
The surface of matrix after performed static shear tests has been illustrated in Fig. 6.

Fig. 6. Surface of matrix fracture after performed static shear tests; SEM

The figure illustrates visible characteristic matrix flow lateral lines indicating the structure damage growth direction lines which are situated between adjacent fibres or their imprints.

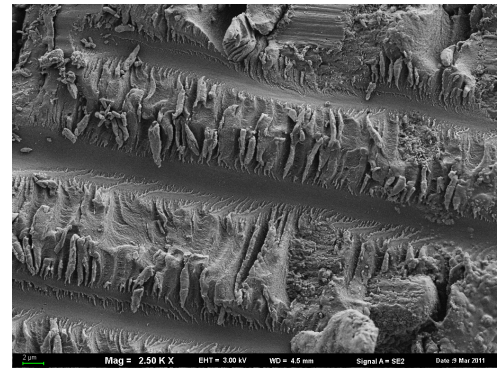
Fig. 7 illustrates a characteristic morphology of matrix rolling and the creation of resin “flakes” inclined to surface. This effect

is characteristic for damage as a result of fatigue processes with high number of cycles and under the impact of shear forces. The dimension and distribution depends on the space between the matrix and fibre. The number of cycles and the strength of fibre/matrix bonding are the factors affecting such behaviour of the matrix material. Under fatigue loads, the matrix plasticity is increased and its deformation takes place (Fig. 7). The damages are initiated locally in the matrix. There the micro-damages propagate along fibre/matrix boundary in the initial phase and grow until the interface degradation is achieved and the fibre – matrix bonding is lost (Greenhalgh, 2009).

Fig. 7. Morphology of matrix fracture surface in carbon/ epoxy composite after fatigue shear strength test; SEM

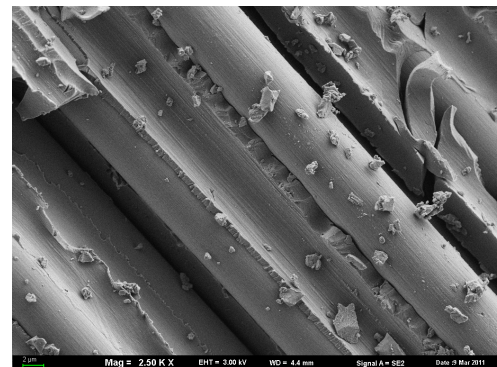
In both cases, characteristic imprints of reinforcing fibres have been observed on damage surface (Fig. 8); the fibres have been completely separated from the matrix (Greenhalgh, 2009).

Fig. 8. Characteristic imprints of reinforcing fibres on damage surface; SEM

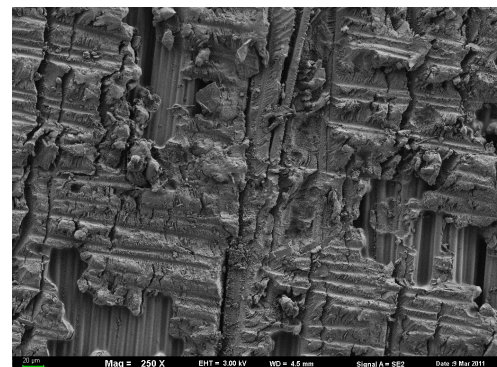
Fig. 9. Surface of carbon/ epoxy composite fracture with visible fracture layer and fibres after performed fatigue shear tests

Fig. 9 illustrates the surface of matrix material after fatigue shear strength tests with visible traces of arrangement of individual fibres. There are multiple cracks and deep furrows in matrix, parallel to each other, oriented in the direction perpendicular to the previous direction of fibres (Greenhalgh, 2009).
