## SUSTAINABLE RESTORATION OF THE ROOF OF A LARGE INDOOR POOL

**Abstract:** During an inspection of the roof of an indoor pool from 1971 in Potsdam (Germany) it was observed, that the roof and the column structures of the building are partially damaged by corrosion. The roof construction is a suspended simple-bent pre-stressed shell between two stiff edge beams. The span of the roof is 39.5 m. The edge beams are supported by A-frames. After further investigation on the damaged areas (including tension tests, tension tests on notched tendons with different load cycles, tests of the bearing capacity of sleeve splices and screw nuts) the conclusion was that the joint of the tension rod and the concrete column had to be restored. This was accomplished through the attaching of a new supporting construction to the existing parts, which took over the load from the old connection. At both sides of the columns pre-stressed DYWIDAG-single-tendons (St1080/1230, diameter of 36 mm) were used. They have to bear a maximal tension force of 835 kN. With this unusual restoration technique, a fast and relative inexpensive retrofitting of the construction could be carried out. The existing constructi

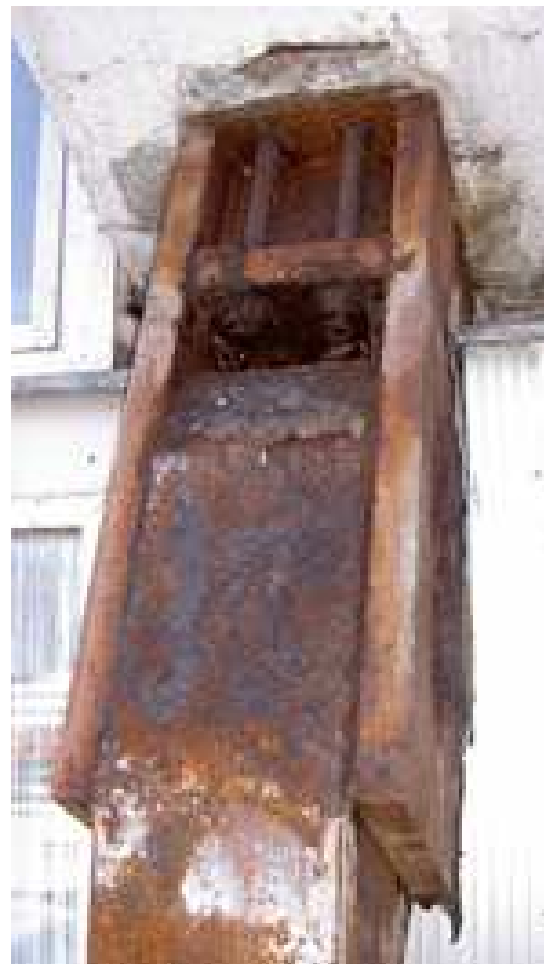
During an inspection of the indoor pool in February 2006 was observed, that at the connection between the tension rod and the concrete column heavy corrosion damage occurred on the screwings (Fig. 4). The damages were especially heavy on the northern facade of the building. Here were the joints, which lie outside the façade are covered by a sheet-metal lagging. Behind this lagging moisture could congregate, which was leading to increased corrosion. The bad accessibility of this part was a reason why the damage could only be discovered at a close inspection. Besides this it was assessed that the roof is leaky which meant that water could get to the tendons of the roof construction. The indoor pool had to be closed temporary in the spring, until the faults of the structure would be resolved, since the structural safety of the construction was not ensured anymore.

Fig. 4. The corroded joint of the tension rod.

After the analysis of the test results and the comparison of the load bearing capacity it was obvious that the roof construction had a sufficient bearing capacity, but the connection of the tendons in the columns did not.

actions. After the assay of the building it was decided to restore the columns whose tension members are outside the facade. The penetration point of the tension members through the concrete column, the points of force transmission (inside) and the joints of the tension members had to be retrofitted.

The strengthening was carried out through the installation of additional parts. A new construction would bypass and unload the original connection. This way there was no critical intermediate state like in case of a replacement. (Fig. 9-11).

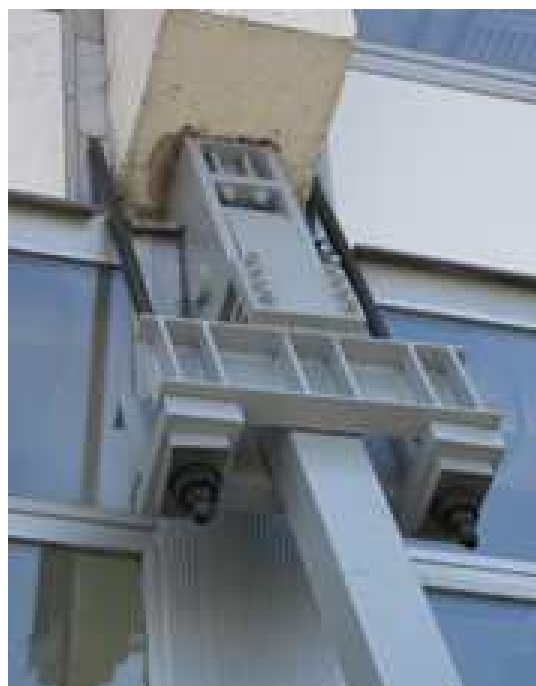
Fig. 9. The lower joint of the by-pass construction.

Using four bolted wedges a plane bearing surface was created on the chamfered part of the tension rods. The wedges were connected with 50 mm thick steel plates with eight M27 10.9 screws to the tension rod. Like at the inner construction a pair of 350 mm high U-profiles were placed under the bearing surfaces. Between these profiles the single tendons were placed. At the lower connection the U-profiles and the force transmitting plates were made identical. (Fig. 9 and 12).

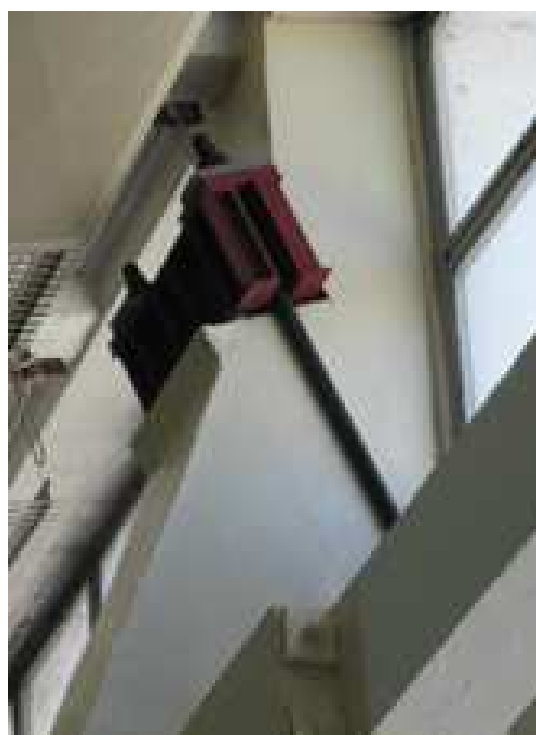
Fig. 10. The upper joint of the by-pass construction.

The area of the anchor plates on the concrete columns were laid open, in doing so the grouting was removed carefully. The cheeks on the concrete columns were cut off. The overhang of the existing threaded rods was cut off to ca. 1 cm over the counter nut. The anchor plates were derusted and cleaned. 350 mm high U-profiles were laid pairwise on the created supporting areas and their bedding were sealed. The forces from the tendons were transferred by a 80 mm thick steel plate to the 350 mm high U-profiles. On each U-profile 3×2 stiffeners were applied because of the high local loads. The profiles bear directly on the concrete construction. (Fig. 10 and 12).

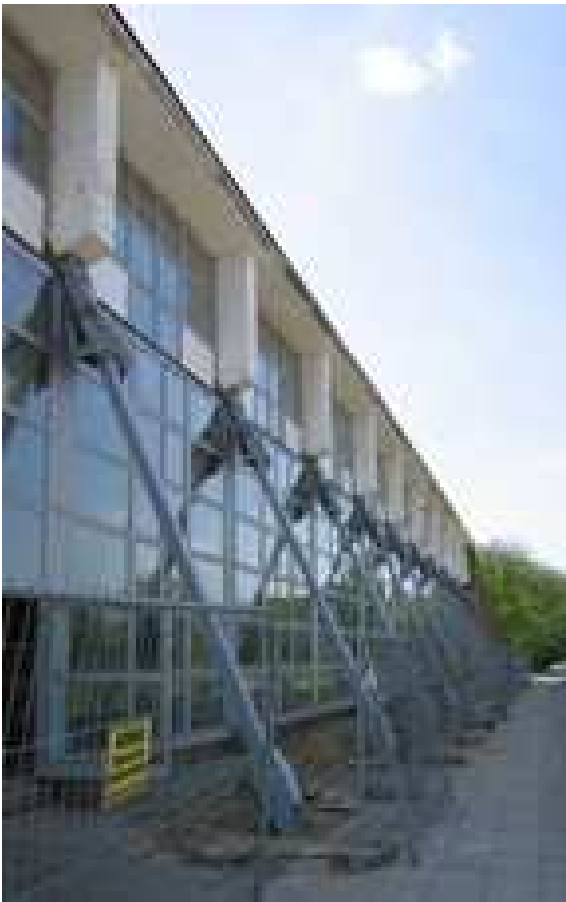
Fig. 11. The restored column line.

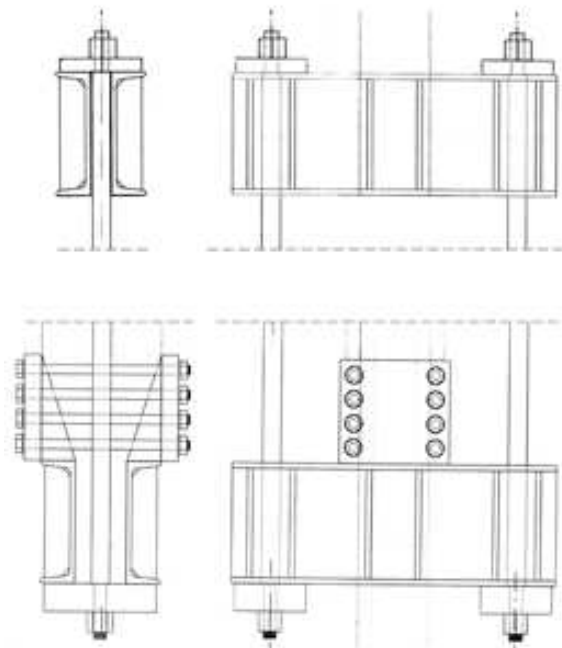
Fig. 12. The new connection.

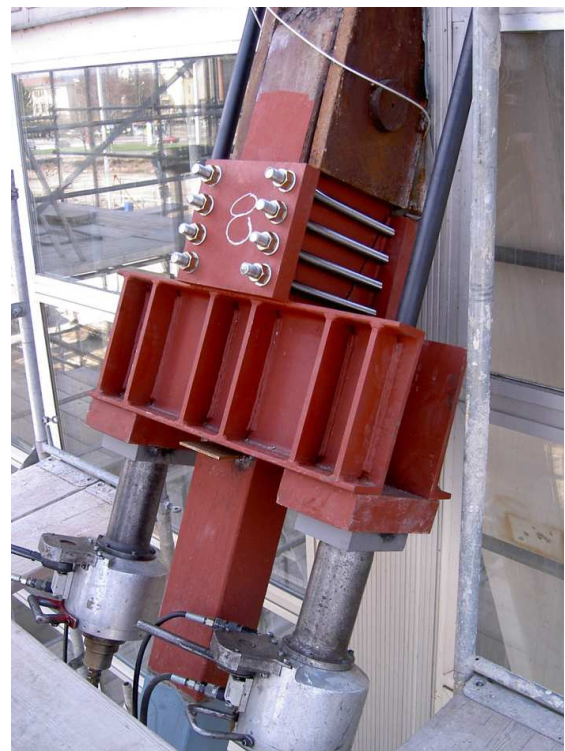
Fig. 13. The pretension of the tendons.

At both sides of the columns in each case a single tendon was placed between the U-profiles. They were guided directly beside the columns through the facade. The tendons are DYWIDAG-single-tendons without bracing, with quality class St1080/1230 and a diameter of 36 mm (DIBt 2006). They have to bear a maximal tension force of 835 kN. The tendons were to prestress with 50 % of the calculated service loading. The pretension was alternating (Fig. 13).
