ENDOSKOPIC EXAMINATIONS OF MARINE DIESEL ENGINES' TURBOCHARGING SYSTEMS

Zbigniew Korczewski

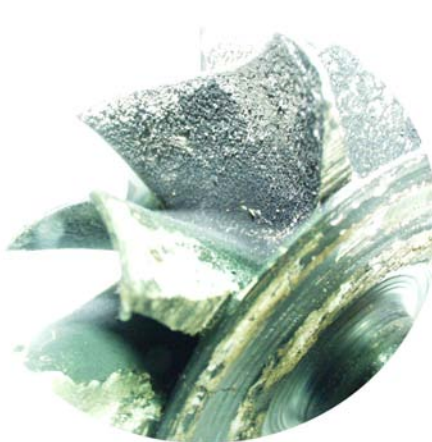
Fig. 1. Failures of turbochargers; a) surface deposits on a turbine rotor of the turbocharger

From the operational experiences results, that the thickness of deposits layer on the compressor's blades can reach tens micrometers, meanwhile on the turbines blades - even a few hundred micrometers [2]. It makes the significant influence on the turbocharger's performance and efficiency (and obviously a performance and efficiency of the engine) taking into consideration small mass and size of the turbocharger's rotor working at very large rotational speeds (up to $100\,000\text{ min}^{-1}$).

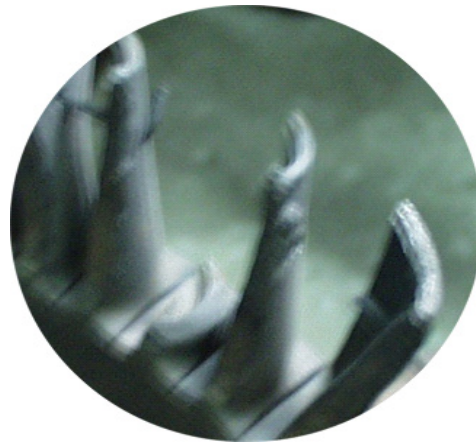
Fig. 2. Fatigue crack of the turbine rotor blade of the turbocharger

As an effect, the process of carbon deposit formation on passages' surfaces of the turbine part intensifies. This concerns especially stator blades and rotor blades of the turbine as well as labyrinth seals. It deepens the unfavourable phenomena that concurrent a dirt process of the sucking air channel. Additionally, as a consequence of deposits creation on the turbocharger's rotor the loss of stability of turbocharger mechanical system may occur. It also leads to the vibration resonance phenomenon causing in turn the accelerated waste of shaft bearings, and also fatigue cracks of the rotor blades - fig. 2.

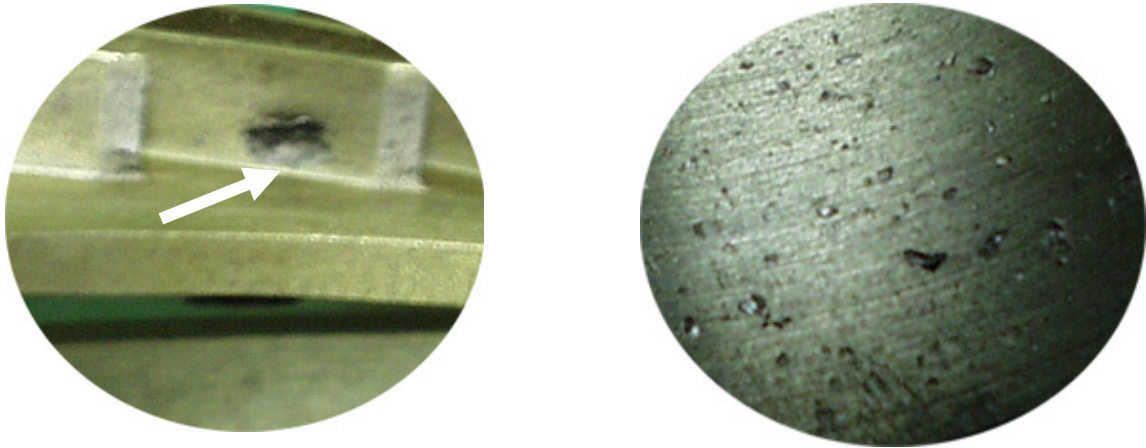
Fig. 3. Erosion pits on guide vanes of the compressor's diffuser

turbocharger is the phenomenon of erosion caused by the presence of hard particles of mineral origin in flowed working medium - in case of air, and the carbon deposit and the pitch substances in exhaust gases, as products of incomplete and improper fuel burning in cylinders as well as the remainders of lubricating oil - fig. 3.

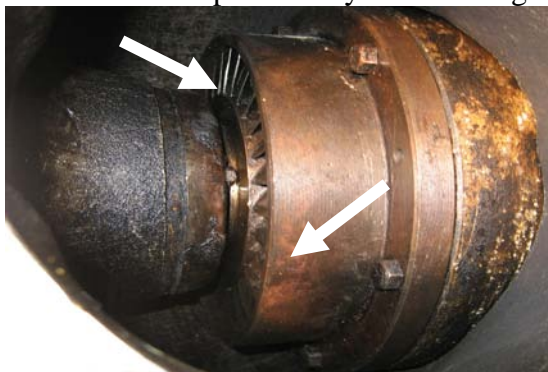
a) Zvezda M401A-2 type 4-stroke engine – exhaust (discharge) passages of the turbocompressor's turbine after cleaning

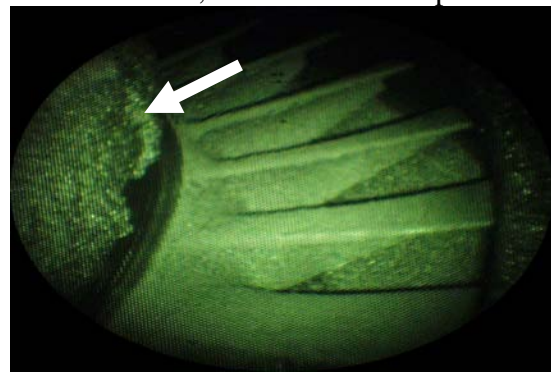
b) Zvezda M401A-2 type 4-stroke engine – intensive carbon deposits on exhaust (discharge) passages of the turbocompressor's turbine

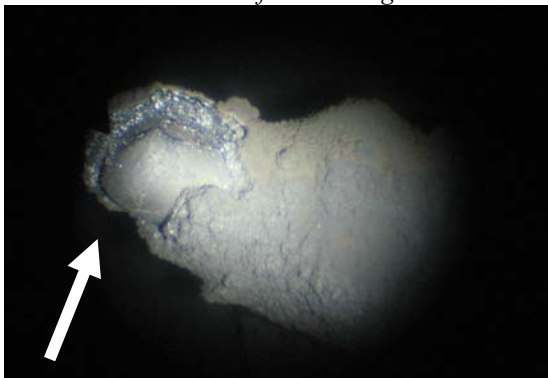
c) Zvezda M401A-1 type 4-stroke engine – intensive carbon deposits on the thermocouple measuring turbine discharge temperature

It is worth pointing out that there is another, very important aspect resulting from the endoscopic examinations of turbocharging systems. Namely, in exhaust channels thermocouples for temperature measurements of exhaust leaving individual cylinders. The measurement likelihood (authenticity) of such parameters decides about the correctness of exploational decisions undertaken during an engine operation. Whether it is possible to confirm an authenticity of the exhaust temperature's measurement worked out by means of the thermocouple in such a technical state as shown in fig. 7c - or not?

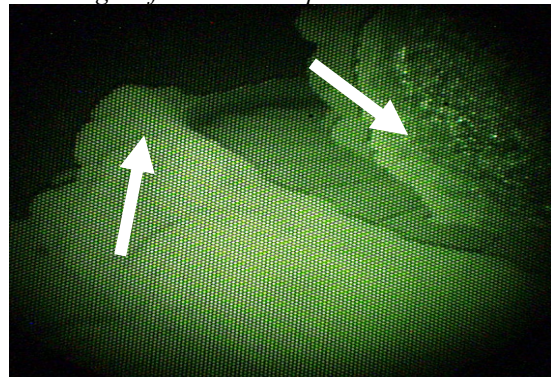
d) Zvezda M401A-1 type 4-stroke engine – intensive carbon deposits on exhaust (discharge) passages of the turbocompressor's turbine

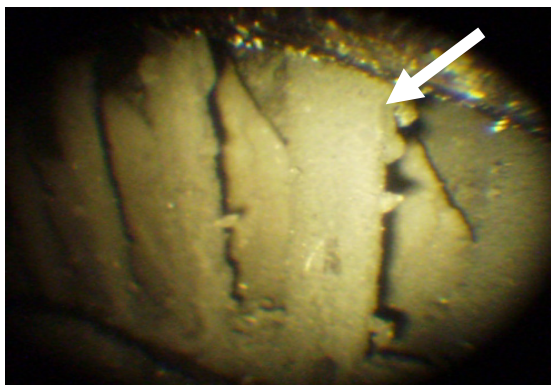
e) Zvezda M401A-1 type 4-stroke engine – carbon deposits in interblade channels of the turbine

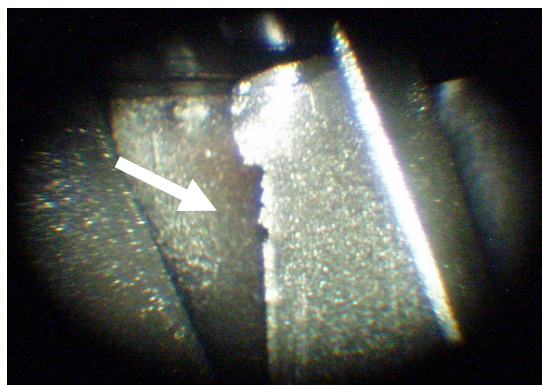
f) Zvezda M503A type 4-stroke engine – material decrements of the turbine's rotor blade

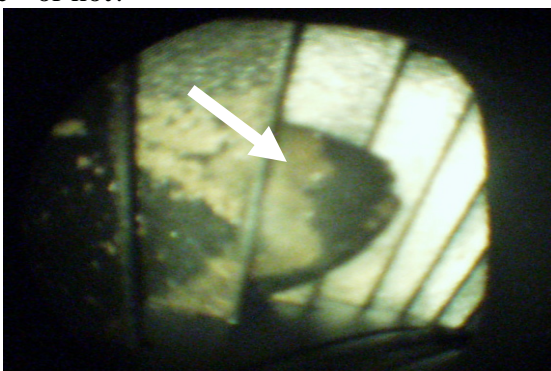
the observed control parameters of the engine. For example, metallic fragment, introduced in fig. 8a, imprisoned in an interblade channel of the turbine's guide vanes was detected during routine diagnostic investigations of the engine in current operation. As a result of optical inspection of the whole system of exhaust gases (the engine at the configuration of a star - 7 blocks of 6 cylinder liners), the extensive damages of the channel off taking gases from cylinder block number 6 were confirmed. The character of detected cracks and decrements of the constructional material showed, that a low-cycle fatigue of the welded joint, which had been working in the chemical active (aggressive) corrosive environment, represented the primary reason of their appearances.

a) Zvezda M503A type 4-stroke engine – metallic fragment imprisoned in an interblade channel of the turbine's guide vanes

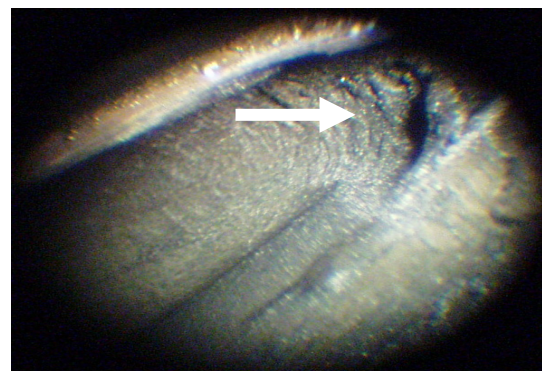
b) Zvezda M401A-1 type 4-stroke engine – an erosion pit in an interblade channel of the compressor (at the bottom)

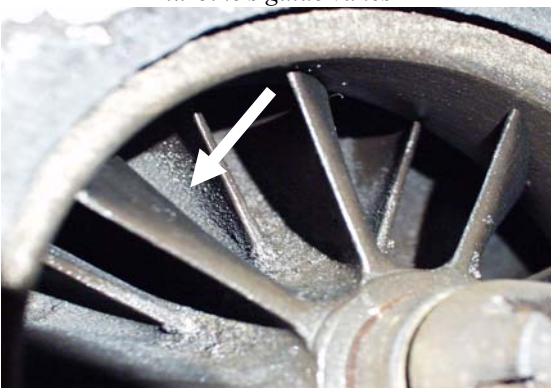
c) Zvezda M401A-1 type 4-stroke engine – dirt deposits in interblade channels of the compressor

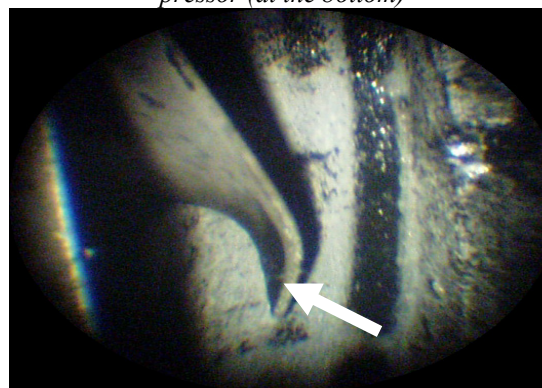
d) Detroit Diesel 16V149TI type 2-stroke engine – a curved rotor blade of the compressor on the edge

of attack

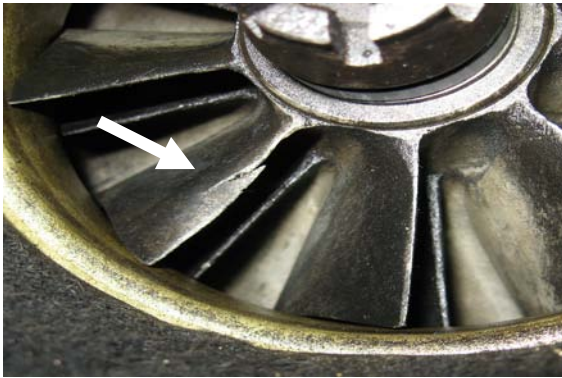
e) Zvezda M401A-2 type 4-stroke engine – an edge crack of the rotor blade of the compressor

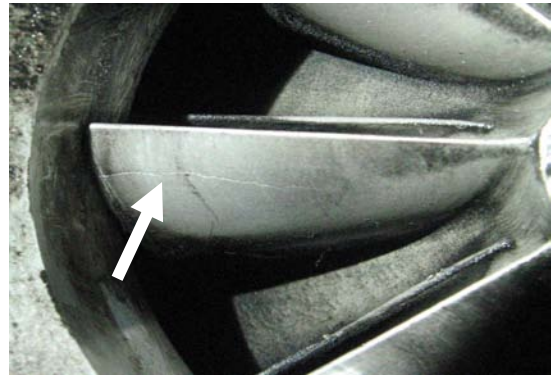
turbocompressor's rotor unit of a medium- or high- speed marine diesel engine achieve tens thousand of rev/min, it is quite clear that the cracks of the compressor's constructional material not detected in time may cause the extensive secondary damages of cylindrical systems, excluding the possibility of the repair execution in shipping conditions.

f) Detroit Diesel 16V149TI type 2-stroke engine – a crack of the compressor rotor blade

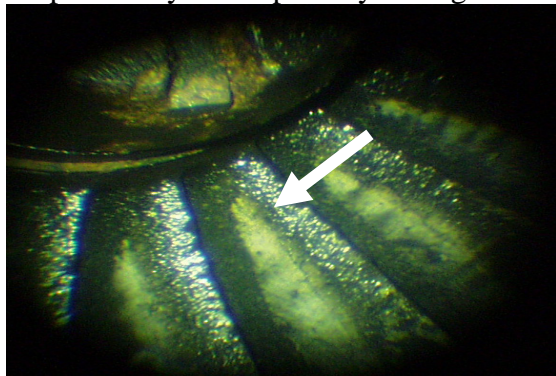
a) Zvezda M401A-1 type 4-stroke engine – oiling up of surfaces of rotor blades of the compressor

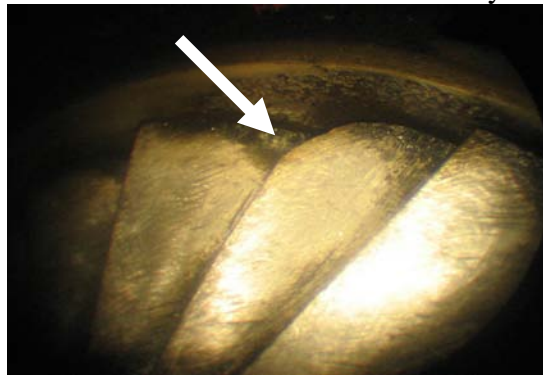
b) Zvezda M401A-1 type 4-stroke engine – curvature of the failed edge of attack of the channel's profile on the external diameter of the compressor's rotor

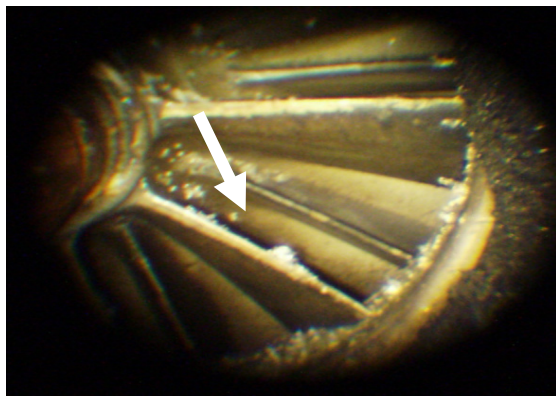
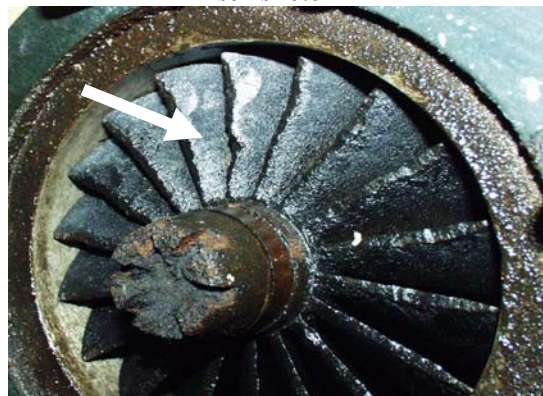
c) Zvezda M401A-2 type 4-stroke engine - dirt deposits in interblade channels of the compressor

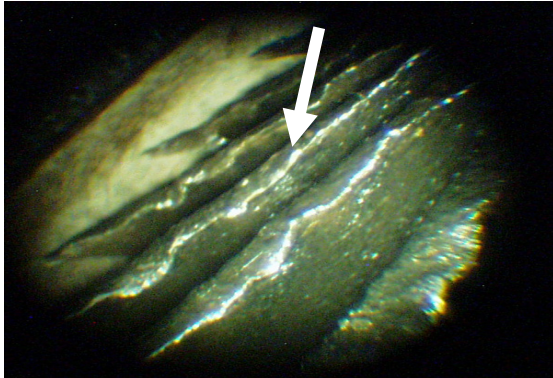
d) Zvezda M401A-1 type 4-stroke engine – deformations and mechanical failures of the compressor's rotor

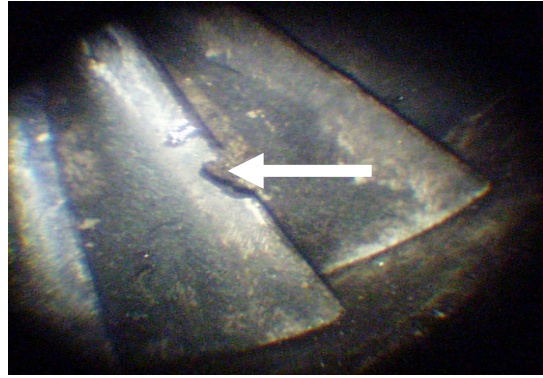
e) Zvezda M401A-1 type 4-stroke engine – deformed profiles of the compressor rotor's blades
