THE CONDITION ASSESSMENT OF IN-SERVICE VANES OF GAS TURBINE NOZZLE UNIT WITH HELP OF DIGITAL ANALYSIS OF VANE SURFACE

Mariusz BOGDAN, Józef BŁACHNIO

Białystok Technical University

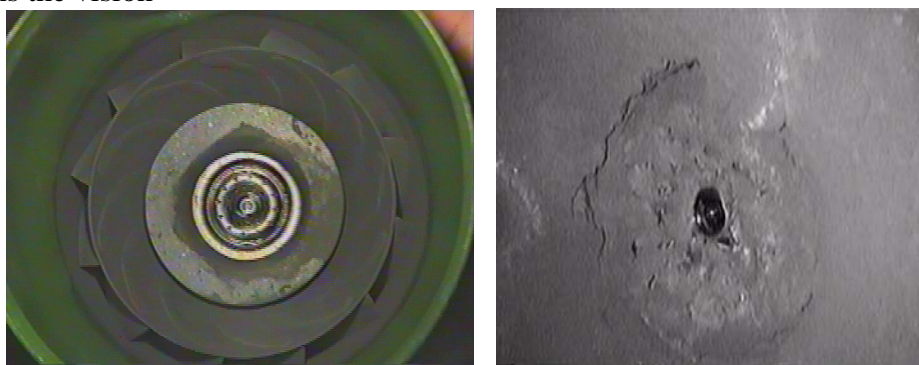
circumference: e.g. as a result of improper fuel atomisation due to carbon deposit on injectors (fig. 1).

Fig. 1. General view of a combustion chamber injector: a – clean, b – covered with carbon deposit [1]

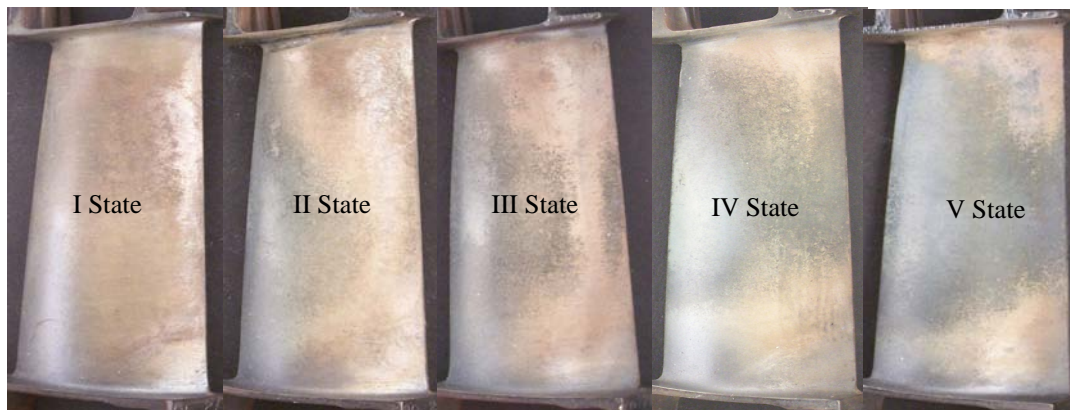
Fig. 3 shows an exemplary set of vane surface images of various overheating degree (according to hitherto applied classification of their technical condition). After long-standing operation the vanes made of ŻS-6K alloy are in various technical condition.

Fig. 3. Surface images made with digital camera Kodak Easy Share DX7590

The process of destruction of a gas turbine vane starts with destruction of aluminium coating (shown on images of surface in the form of colour change – fig. 3). Digital images of surface of in-service stator vanes of a turbojet turbine were analysed for the purpose of determination of size of local overheating areas. Altogether were made five expositions for each state in guaranteed repeatable recording conditions for each appliance [7]. The stages of realisation of diagnostic method developed for the purpose of assessment of technical condition of examined turbine element (size of local overheating areas) are shown on fig. 7. As a criterion of degree of overheating was used the colour of vane surface in state V (overheated structure – metallographic examinations). Basing on prepared histograms (for each channel of digital image, i.e. red, green and blue – the RGB model) determined was the criterion threshold, which value was calculated on the base of saturation (position of maximum amplitude) for each individual component of RGB colour ($R+G+B/3=162$) – fig. 8.

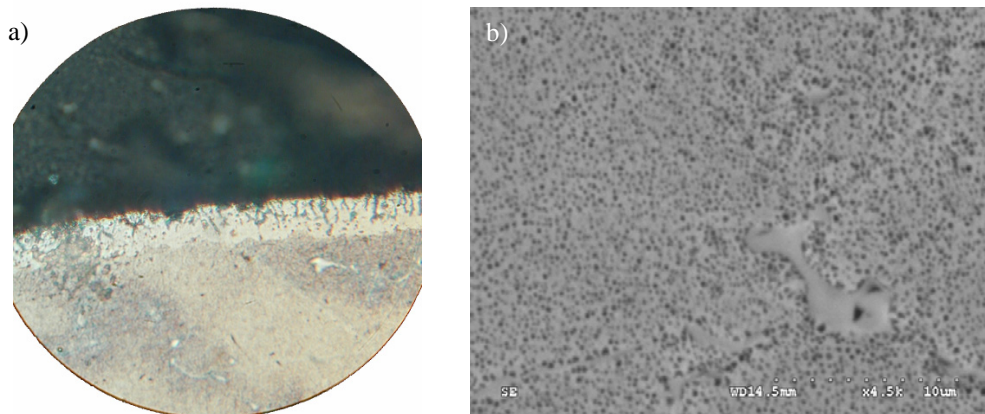
*Fig. 4. Correct microstructure of turbine vane (state I): a) coating (magn. x450);
b) alloy ŽS-6K (magn. x4500)*

Initially, after certain period of operation, the vane coating (fig. 4a) was not subject of degradation and its thickness differs only slightly from the thickness of the brand new coating. In the course of further operation the coating swells, and cracks appear due to thermal fatigue (fig. 5a).

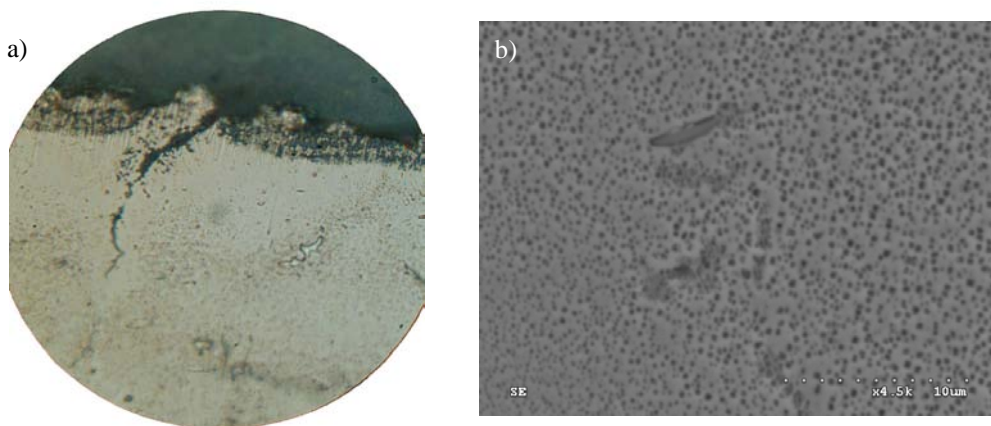
*Fig. 5. Overheated microstructure of turbine vane (state V): a) coating (magn. x450);
b) alloy ŽS-6K (magn. x4500)*

On the image of microstructure of ŽS-6K alloy were detected secondary precipitations of fine dispersion phase γ' (fig. 5b) formed after action of high-temperature exhaust gas. The morphology of γ' proves that if the critical temperature is exceeded, the alloy becomes overheated and in such case the vane cannot be considered as a serviceable one [6].

The examinations of coating microstructure (protective layer) and Ž6-SK alloy proved that influence of high-temperature exhaust gas caused decohesion of coating (fig. 5a, fig. 6) and modification of reinforcing phase γ' (fig. 5b). Results of examinations of vane microstructure proved that the vane No. 1 has correct structure and the vane No. 5 has overheated structure.

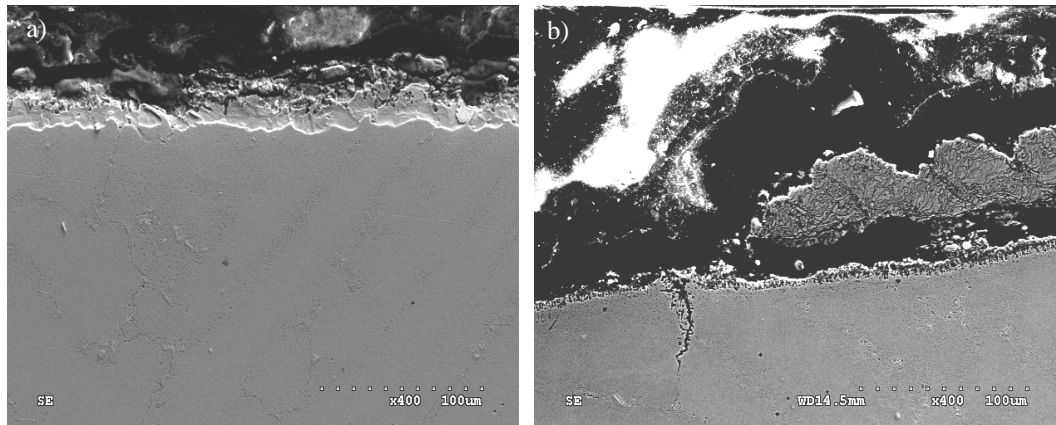
The coating thickness gradually changes as a result of influence of working medium (exhaust gas) of high kinetic energy on vane material. The coating becomes thinner (fig. 6a), what results in loss of protective properties. As a result the temperature of vane material grows and the vane losses protection against chemical influence of exhaust gas. The vane becomes very sensitive to influence of exhaust gas. This leads to degradation of coating as well as of native material (fig. 6b).

*Fig. 6. Metallographic structure of surface layer of an in-service vane (state V):
a) reduction of coating thickness (magn. x450); b) thermal crack in coating, penetrating inside the vane material (magn. x4500)*

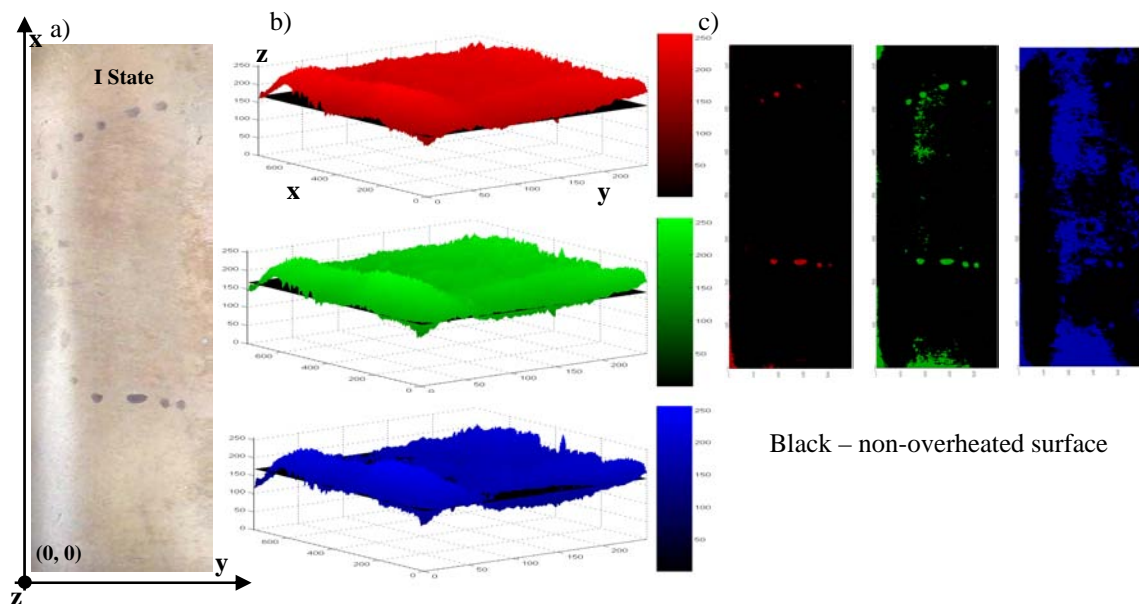
Fig. 9. Vane in state I: a) surface image; b) 3D distribution of basic RGB components; c) vane surface viewed from below – the result of introduction of criterion plane

As the technical condition of vanes deteriorates, the overheated area increases (the set of image pixels) – figs. 9c, 10c. The introduction of the plane (criterion of overheating of vane material) to 3D graphs of distribution of RGB colours for images of surface of examined turbine element allows determination of overheated area/total area ratio (fig. 11). The same relation was determined for images recorded with two videoscopes (fig. 12).

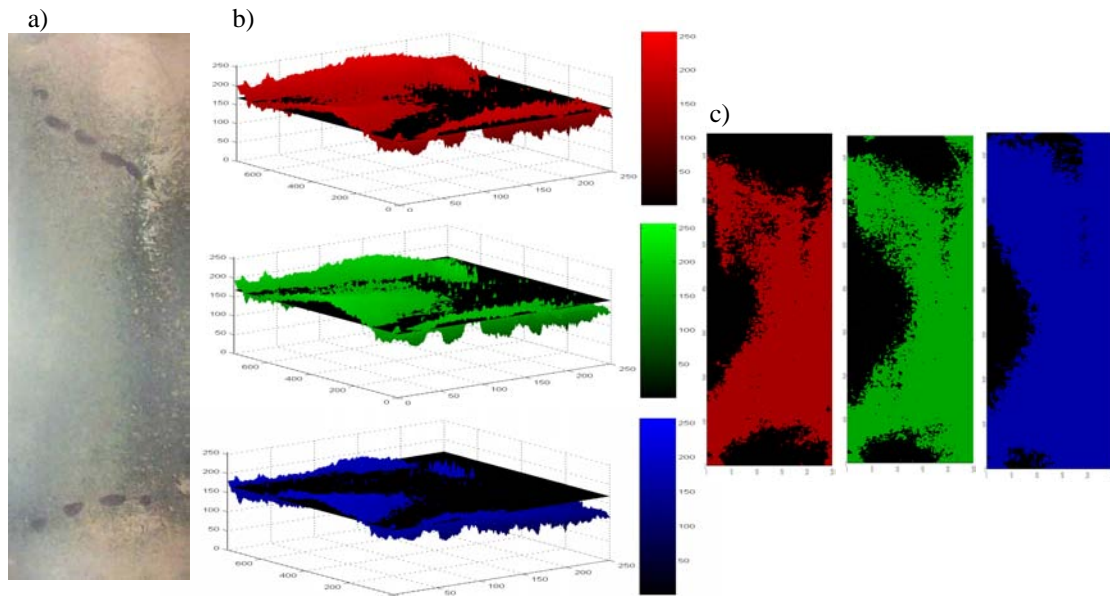
Fig. 10. Vane in state V: a) surface image; b) 3D distribution of basic RGB colours; c) vane surface viewed from below – the result of introduction of criterion plane
