ENDOSCOPIC IMAGE PROCESSING AND ANALYSIS OF PISTONS' SERVICE FAILURES OF MARINE DIESEL ENGINES

Zbigniew Korczewski

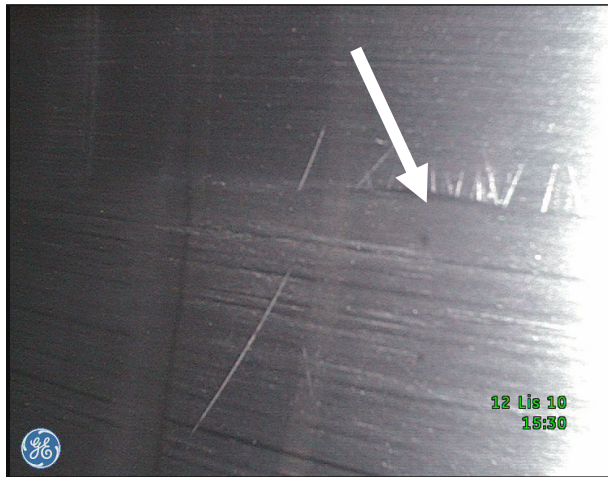
A considerable, local piston head's overheating, up to exceeding a plasticity border of the constructional material, causes its local upset. If a temperature growth of the piston's head is only temporary there could be also affected a temporary wearing down and even seizing the piston's crown in the cylinder bearing surface - Fig. 2a [4].

a) cylinder bearing surface - friction traces originated from the piston leading part

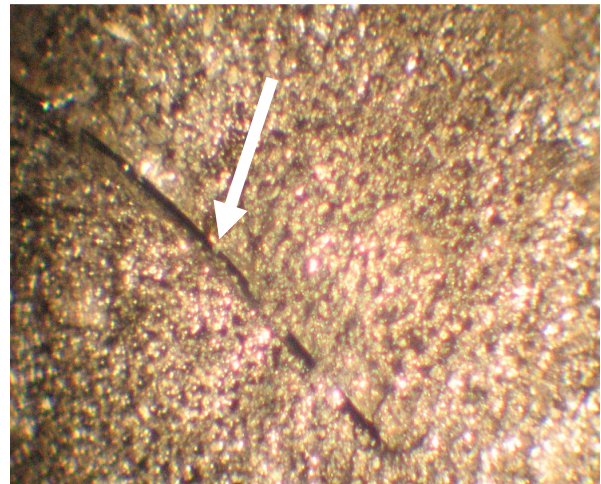
A low-cycle fatigue of the piston's head up to cracks' occurrence, connected with cyclic squeezing and spreading tensions of the constructional material represents a different consequence of this phenomenon - Fig. 2b. They result from cyclic, respectively: the material overheating and widening as well as its cooling down and shrinking, during the engine's work cycle realization.

b) piston head – a crack fatigue

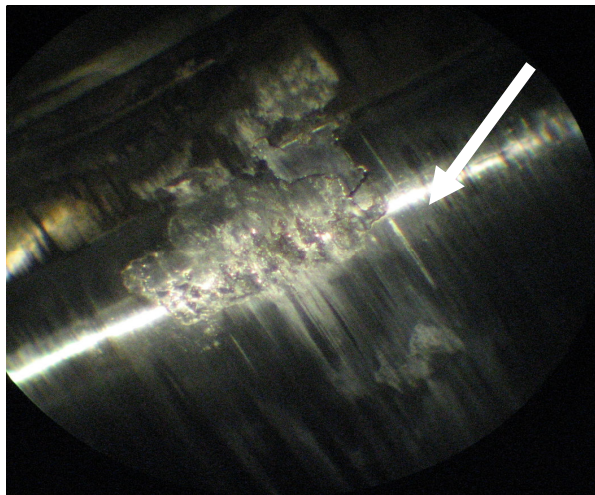
c) cylinder bearing surface – smearing traces of the piston material's layer (aluminum alloy)

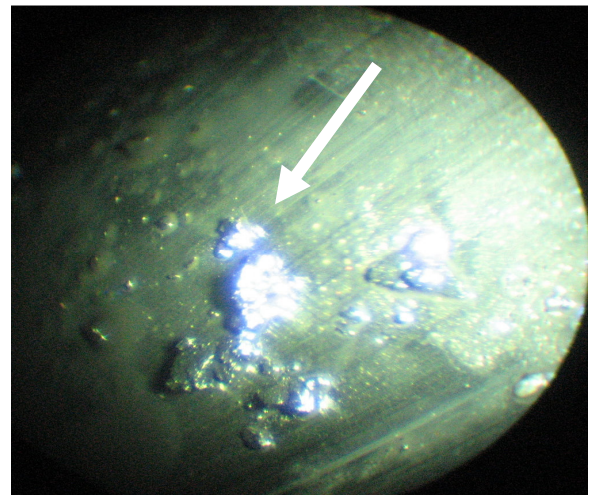
the piston head's temperature when the lubricating conditions get better. Unfortunately, it usually produces undesirable results - an intensive growth of the aluminum particles quantity in the engine's lube oil system - Fig. 2d.

d) cylinder bearing surface – metal fillings (aluminum alloy)

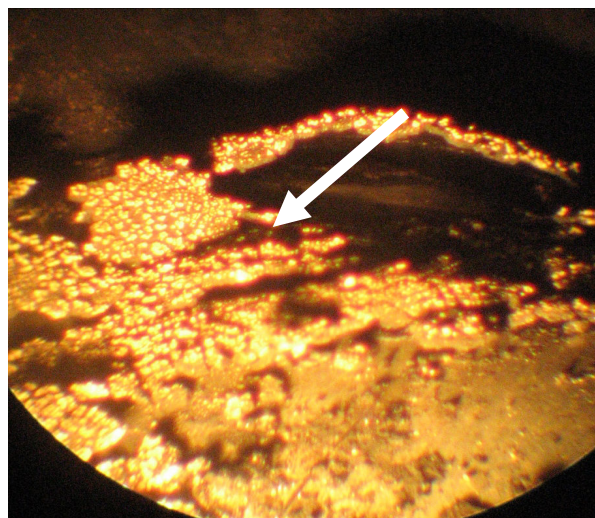
e) piston head – a thick layer of the carbon deposit

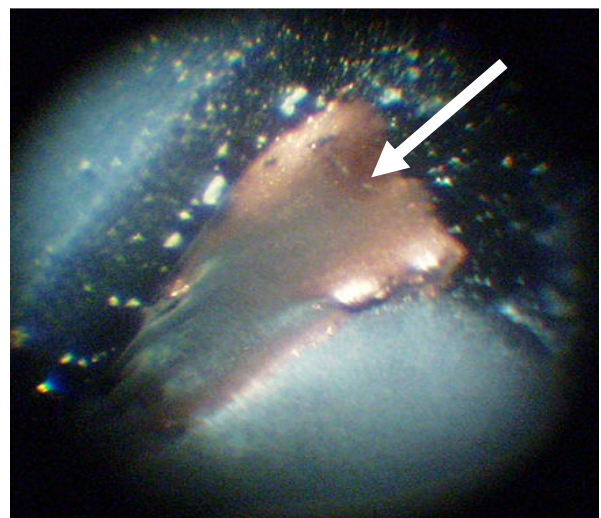
Very often, a self-ignition's time decay takes place along with detonating fuel combustion. In case of shifting the fuel burning beyond TDC an intensive temperature's growth of all the combustion chamber elements occurs (particularly the piston). A transfer of the combustion process on the expansion stroke (work), at an incomplete and imperfect character of this process, produces undesirable results with a quantity enlargement of carbon deposits settled on the surfaces that restrict the combustion chamber. A thick layer of the carbon deposit on the piston's head (Fig. 2e), coming into existence particularly intensely during the engine work on partial loads while it is maladjustment, worsens significantly the warmth flow conditions and consequently drives to the piston head's overheating - Fig. 2f.

f) piston head – a local overheating of the constructional material

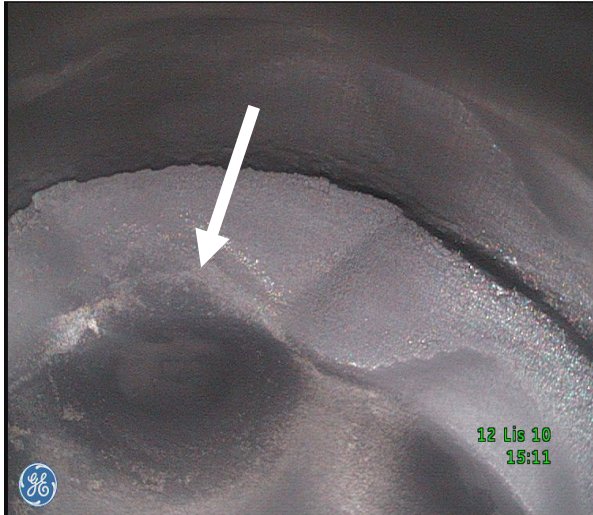
a) piston head – traces of the fuel after-burning

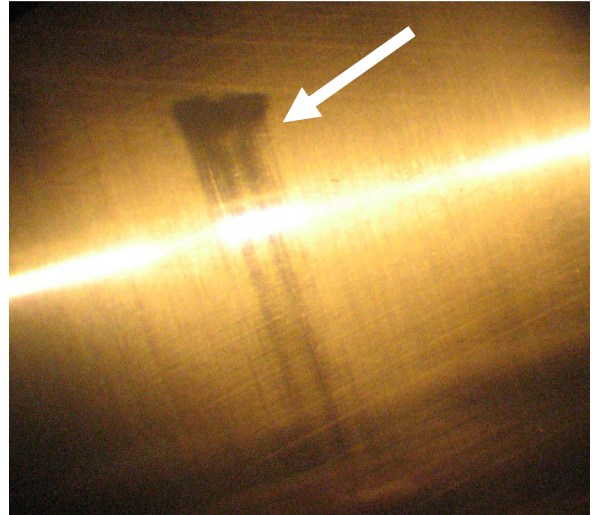
b) cylinder bearing surface – traces of the piston ring's seizing
