TADEUSZ MAJCHERCZYK*, PIOTR MAŁKOWSKI**, ZBIGNIEW NIEDBALSKI**

The influence of longwall exploitation carried out in the vicinity of a protection pillar on a rectified building

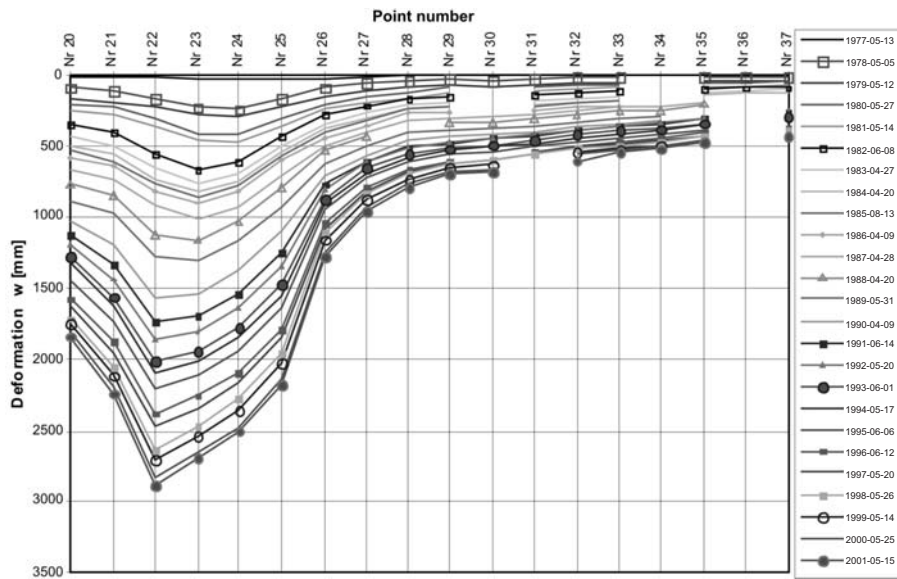
Fig. 3.1. Subsidence on the surveying line no. 21 in the years 1977–2001

Surface deformation surveying was carried out in the years 1977–2002 on the surveying line along the road connecting Dębina and Pniówek, which is located to the north west from the building. It proves that the process of continuous surface deformations occurred in the analyzed area incessantly (fig. 3.1). The phenomenon resulted from working out further seams of coal in the portion “B” by the “Pniówek” coal mine. The line’s points closest to the analyzed building indicated deformations of approximately 500 mm, growing systematically in time, which is typical for peripheral points in relation to mining exploitation.

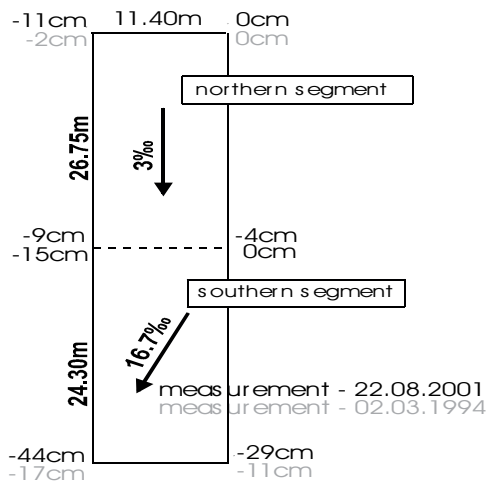
Fig. 3.2. Deflection of building sections

The measurement results of leveling cycles carried out already since 1994 were used for the sake of the building deflection estimation. It was concluded that in 1994 both segments – northern and southern – inclined 3.4‰ southward. In 2001 the northern segment didn’t change its deflection, whereas the southern segment increased its deflection up to as much as 16.7‰ south-westward (fig. 3.2).

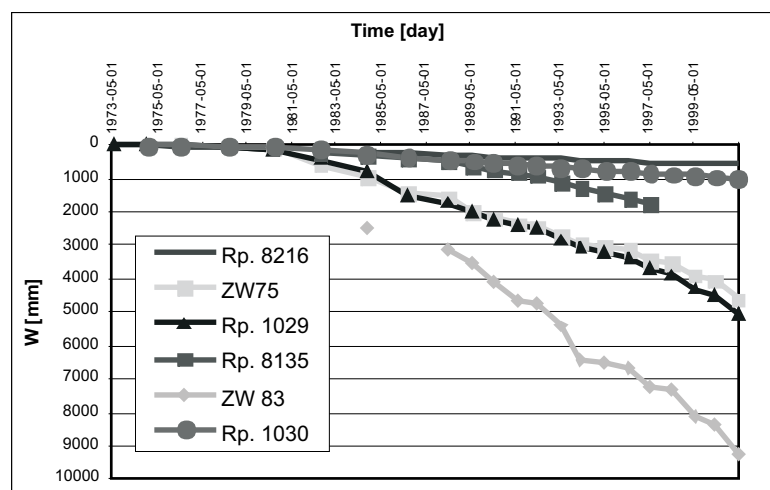
Fig. 3.3. Subsidence of surveying points in the building vicinity

While considering covering the surface in the area of the occurrence of discontinuous deformation forms, it should be kept in mind that they divide the highly urbanized regions (located eastward from the deformation area) from the less urbanized areas (located westward from the discontinuity zone). In the light of the hitherto executed geodesic research and surveying it may be presumed that the mining influences are cut by the above-mentioned discontinuous forms, which seem to be indicated by the subsidence of the surveying points ZW 83 and Rp. 1030, occurring in the analyzed region (fig. 3.3). Despite the fact that the surveying point Rp. 1030 was located in the area of exploitation edge, it indicated incomparably minor subsidence, 9 times lower than the subsidence of the surveying point ZW 83.

The above results indicate the activation of dilatation gap and considerable irregularity of subsidence of particular building segments. Serious subsidence rate in the south-western corner of the foundation, located in discontinuous deformation zone, should be of special concern. The deflection of the building in relation to the vertical was 16.7 mm/m, hence it exceeded the stipulated value of 15 mm/m, assumed as the limit of little inconvenience of building use. The potential possibility of higher inconvenience was the main reason for considering the range of planned mining and proper reinforcement of the building construction as well as for adjusting the object for the possibility of rectification.

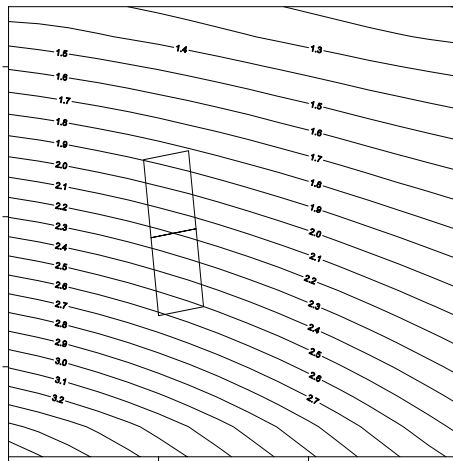
Fig. 4.1. Subsidence in the building vicinity in 2005

On the basis of the results analysis, presented in fig. 4.1 and fig. 4.2, it was assumed that on the northern side of the object the subsidence will not change considerably after commencing the exploitation of the seam 403/1. It will maximally reach approximately 1.81 m. In the analogical period, the subsidence in the southern part will reach approximately 2.6 m. A considerable increase of subsidence will occur as soon as the mining exploitation in the seam 403/1 approaches the analyzed object. Then the subsidence of both segments of the building will increase to approx. 2.49 m in the northern part and to approx. 3.52 m in the southern part, i.e. by approx. 0.68 m and 0.92 m respectively.

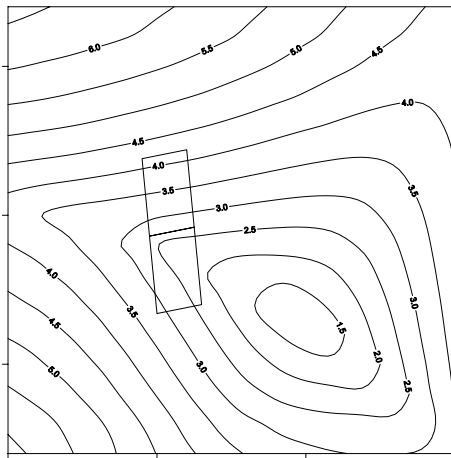
Fig. 4.3. Horizontal strains in the building vicinity in 2005

The distribution of horizontal strain presented in fig. 4.3 and fig. 4.4 indicates that from 1984 to the end of 2005 the total increase of horizontal strain, resulting from the mining

exploitation, should range between 2.6 and 4.2 mm/m. In 2007 the increase of horizontal strain was likely to reach 5.4 mm/m in the northern part and approximately 6.4 mm/m in the southern part of the building. The increase of strain in the analyzed object is primarily related to the progress of exploitation in the seam 403/1, especially to the wall B-5 approaching the edge of the protection pillar.

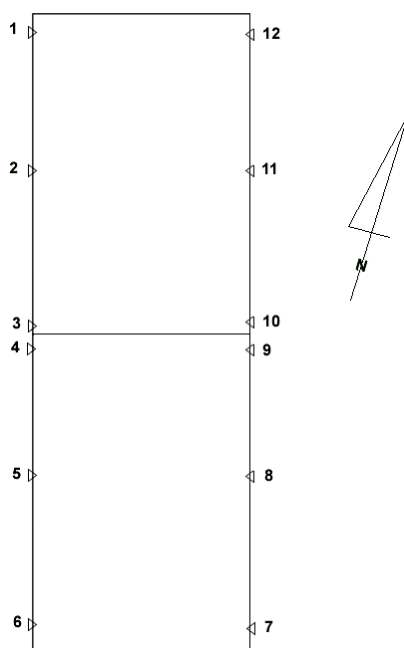
Fig. 6.1. Foundation benchmarks position on the building at Krucza St.

After completing rectification in the foundations of the object, additional geodesic benchmarks were fixed. They are currently fixed in the system of six in both dilated parts of the object (fig. 6.1). The altimetric measurements have been carried out regularly since June 28th 2002. From June 2002 to the end of 2007, for which prognostic calculations had been carried out earlier, the total of 12 measuring cycles were made. The northern segment of the building demonstrated regular subsidence in the period of monitoring, similarly to the period before leveling. The subsidence increased reaching the maximum values of approx. 0.08 m in 2007. The southern segment subsided irregularly and the maximum subsidence for the benchmark no. 6 recorded on September 18th, 2007 amounted to 0.17 m, which was thus twice as much as the subsidence of the northern segment. Hence, it may be assumed that in the period 2002–2007 displacements appeared in the vicinity of the building dilatation gap (Table 6.1). What seems to be of crucial for the comfort of the buildings use is the problem of irregular subsidence in the southern segment. Until the building rectification, i.e. until June 2004 this difference was $\Delta w_{6-9} = 0.016$ m, which corresponds to 0.7‰. Irregular subsidence of the southern segment reappeared also between September 2005 and November

2006, when the difference of subsidence of benchmarks no. 6 and no. 9 was $\Delta w_{6-9} = 0.023$ m, i.e. 1.04‰. In September 2007 this disproportion reached as much as 0.092 m, i.e. 4.2‰. These values, however, are not as high as in the period 1997–2002 and, hence, they were not dangerous for the analyzed object. Nevertheless, the occurrence of irregular subsidence of the southern segment, with parallel lack of such a phenomenon in the northern segment, was

In order to provide current supervision of the movements of the building and its groundwork, it was recommended to continue periodical observations of altimetric points located on the building foundations. Additionally, it was suggested to make a stabilization for analogical ground points in the vicinity of the building and a coordinated altimetric measurement for both groups of points in fixed intervals of time, in relation to constant altimetric points.
