FAILURE OF GAS TURBINE CONE BURNER BY CARBURIZATION

Abstract

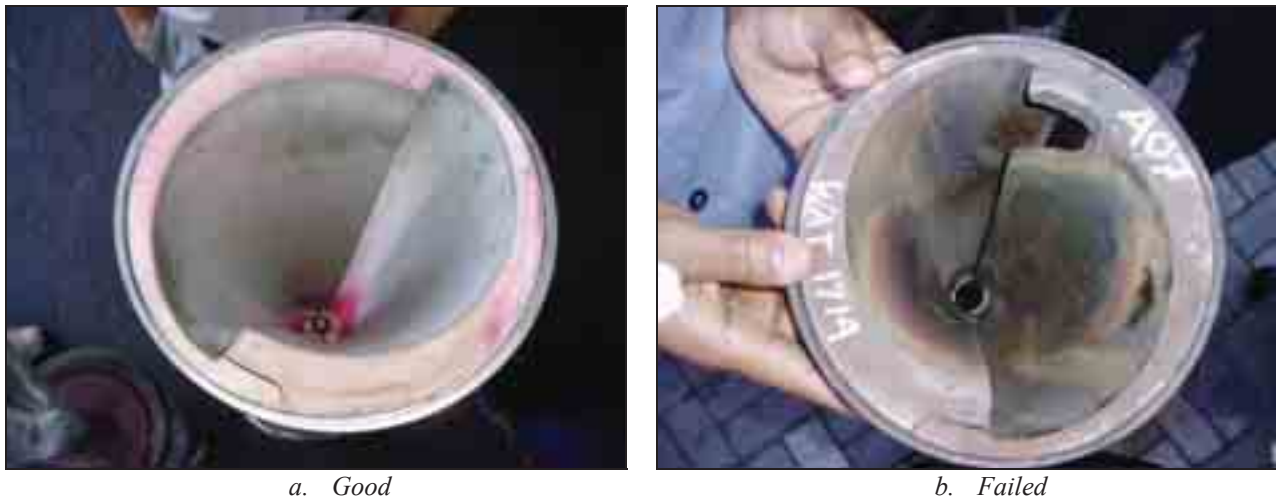
Fig. 2. Comparison between good and failed cone burners

Periodic maintenance schedule recommended by the Original Engine Manufacturer (OEM) is 24,000 equivalent operating hours (EOH), however the recommended service hours cannot be achieved because the hot gas path especially the cone burners were failed every 6,000 EOH even the fuel and water flow have been adjusted and optimized accordingly. Sixty percent of the burner cones failed and has to be replaced with the new one after 18,000 EOH instead of 48,000 EOH as stated in the engine manual. Fig. 2 shows the comparison between good and failed cone burner. The exposed surface of a new cone burner was coated by thermal spray to prevent direct contact with the combustion gas. Failure occurred on the edge side (Fig. 2b). The burner life was extended by welding repair followed by coating of the damaged section for every 6,000 EOH.

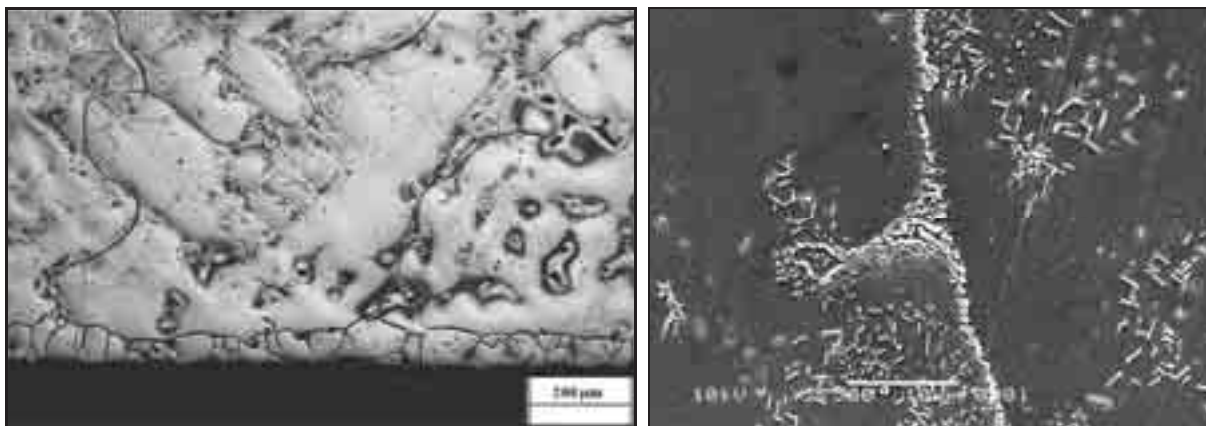
Fig. 3. Microstructure of cone A, lowest temperature section

Microstructure of cone A at the lowest temperature section is shown Fig. 3. The microstructure consists of austenitic matrix and fine carbide distribution along grain boundaries and inside the grain (Fig. 3b). Cone burner was manufactured by casting as indicated by the irregular and elongated grains geometry.

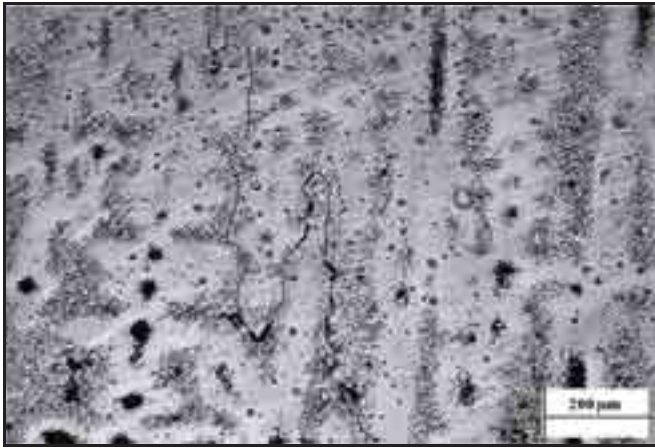
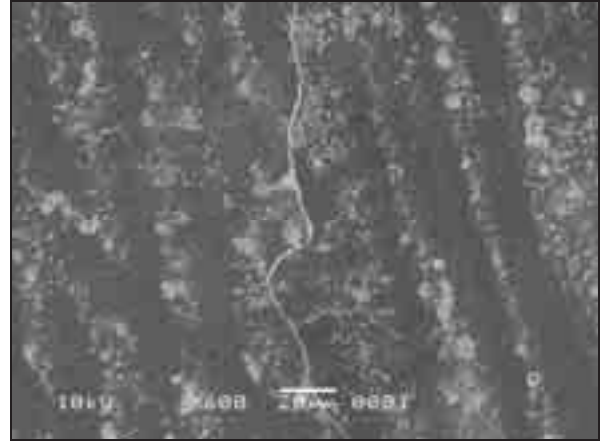
Fig. 4. Microstructure of cone B, lowest temperature section

Figure 4 shows the microstructure of cone B from the lowest temperature section. Cone B is also manufactured by casting as shown by the geometry of the grain. Carbide precipitates were evident along grain boundaries and inside the grain. Carbide volume fraction in cone B is much higher than that of cone A because cone B has been exposed longer than cone A. Carbide precipitation will increased with higher exposure (aging) time.

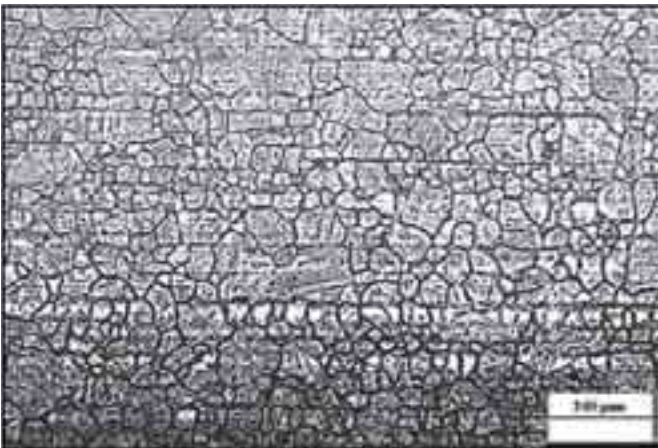
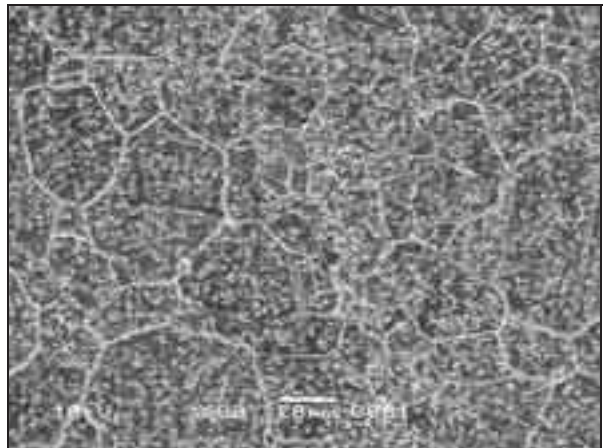
Fig. 5. Microstructure of material for repaired

The fresh material for repair is not available because the repaired process was done by outside workshop, therefore the observation has to be done on repaired section at the least attack part. The microstructure consists of equiaxed austenitic matrix grains (Fig. 5). Material for repair is not cast material but hot rolled plate under solution-annealed condition. Fine carbide precipitates in material are due to the effect of exposure during service.

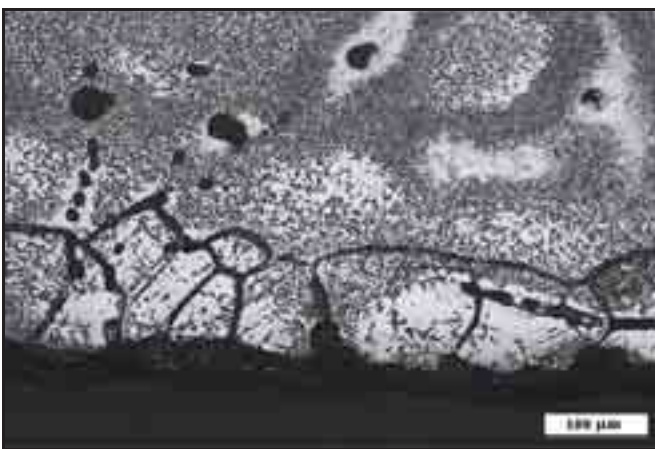
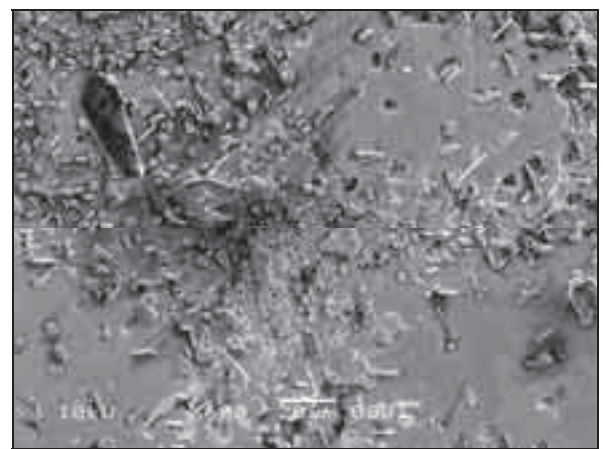
Fig. 6. Microstructure of damaged cone A

Microstructures of the damage cone burner are shown in Fig. 6 to 8. Carbide precipitates volume fraction increase significantly even the maximum carbon content in Hastelloy X is 0.1%, therefore carbon in the combustion gas diffused into material (carburization) during the service. Carburization occurred because the service temperature is above 650°C and carbon potential in combustion gas is high.

Carbides in cone burner material consist of primary and secondary carbides. Primary carbides are formed during casting while secondary carbides precipitate and growth during service (aging). Two types of carbides were examined, fine, and coarse carbides (Fig. 6b). Summary of examination is shown in Tab. 3. Aluminum in the measurement result is the trace of alumina particle for polishing.

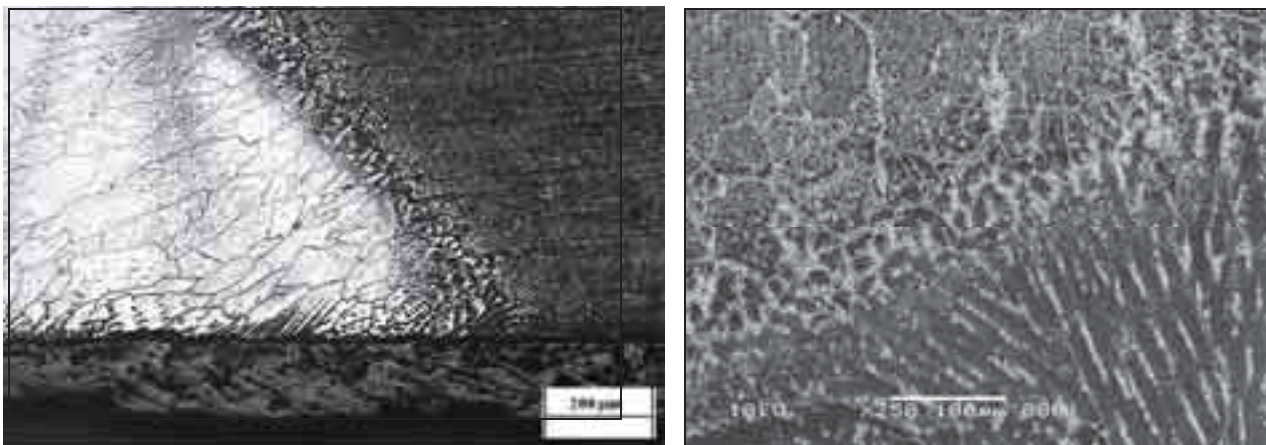
Fig. 8. Microstructure of damaged material for repaired

Figure 8 shows the microstructure at the interface between cone burner base metal (bright) and repaired material (dark). Carburization in repaired material is much severe compared to that of base metal (Fig. 8a) because carburization occurred through grain boundary diffusion [3]. Grain boundary diffusion rate of carbon in repaired material is much higher than the base metal because the repaired material has much finer grain size. Volume diffusion dominant in the near surface region.

coating on the edge breaks, the fresh surface is exposed to the carbon environment and initiates the carburization attack. Welding repair has successfully extend cone burner life but longer life extension can be expected if material for repair has a coarse elongated grains similar to that of cone burner material.
