A. ZIEWIEC*, J. CZECH**, E. TASAK*

WELDED JOINT CRACKING IN MARTENSITIC STAINLESS STEEL PRECIPITATION-STRENGTHENED WITH COPPER

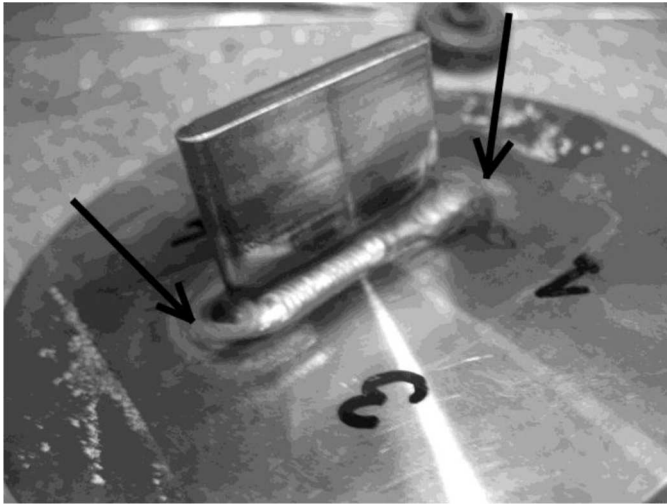
Fig. 1. Example of test weld joint configuration. Areas where cracking occurred most often (fillet weld curvatures around the member plate) are pointed with arrows

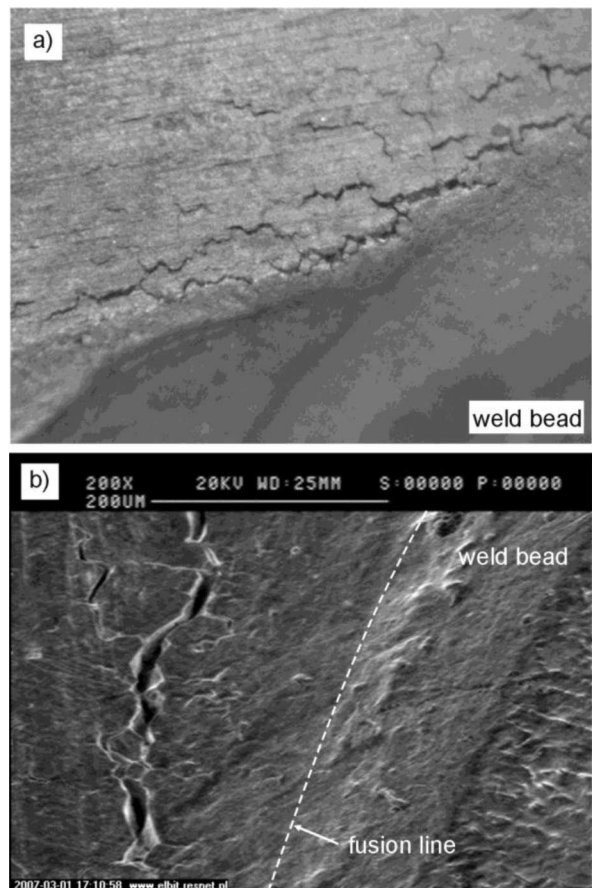
However, both FPI and visual detection techniques were limited by local oxide scale in the affected HAZ. The oxide scale prevented visual observation of the metal surface beneath the oxide and the mechanical removal of the oxide usually involved removal of metal to a thickness exceeding the average depth of the micro cracks. The oxide scale itself was also often cracked or delaminated from the base material in some areas: features which sometimes retained penetrant and resulted in false indications. For these reasons the most reliable technique of micro cracks detection was by examination of metallographic cross sections of areas identified by stereoscope microscope (using up to 63x magnification). In order to characterise the cracks and investigate their origin, metallographic sections were prepared and examined with both: a light microscope and a Scanning Electron Microscope (SEM). Search results for possible preventative measures were outlined. Typical appearance of the observed defects is presented in Fig. 2.

Fig. 2. Cracks in HAZ of 17-4PH steel welded with GTAW method a) cracks observed by stereoscope microscope, b) cracks observed by SEM

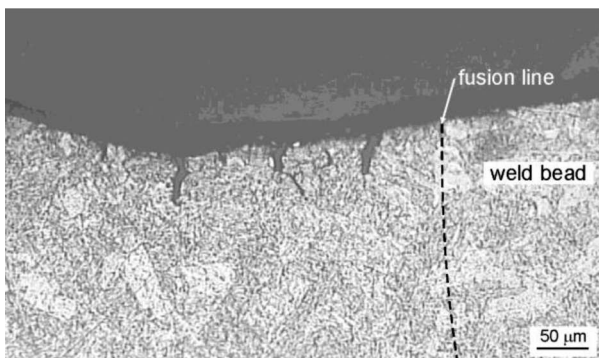
Figure 3 illustrates cracks on a metallographic section in the plane perpendicular to the base material surface and perpendicular to the fusion line. Cracks have an intergranular character (Fig. 4) and appear not only as adjacent to the fusion line but also at certain points in the HAZ away from the fusion line. They can be characterised by their significant width up to do 15 μm

and average depth of $50\ \mu\text{m}$. The internal surfaces of the cracks are oxidised and their bottom has form of a rounded wedge. The significant width and rounded bottom lead to the conclusion that the cracks originated as a result of large plastic deformations. These observations indicate that cracking was taking place when the value of temperature of the HAZ was high enough to promote oxidation by air in contact with the hot metal surface. At the same time, large deformations must have resulted from stresses induced by the welded joint constraints. This evidence has led to us to reject the hydrogen embrittlement hypothesis of the cracking mechanism and resulted in a new hypothesis stated that the observed defects are hot cracks. Chemical analysis of the base material showed a very low level of sulphur ($0.001 \div 0.003\%$), allowing us to eliminate sulphur as a factor in the hot cracking mechanism in the HAZ.

Fig. 3. Intergranular character of cracks in the HAZ

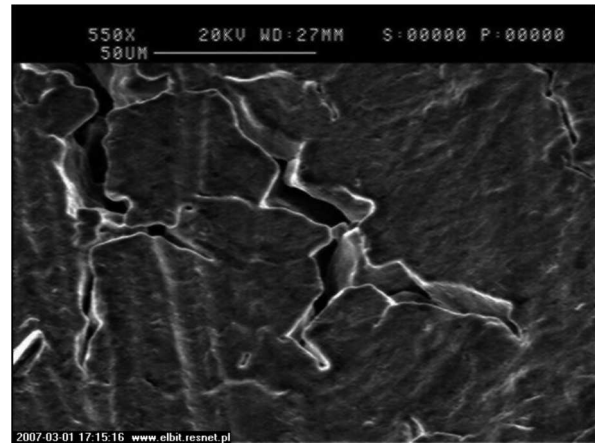
Fig. 4. Intergranular character of cracks in the HAZ. Significant width of the cracks is distinctive

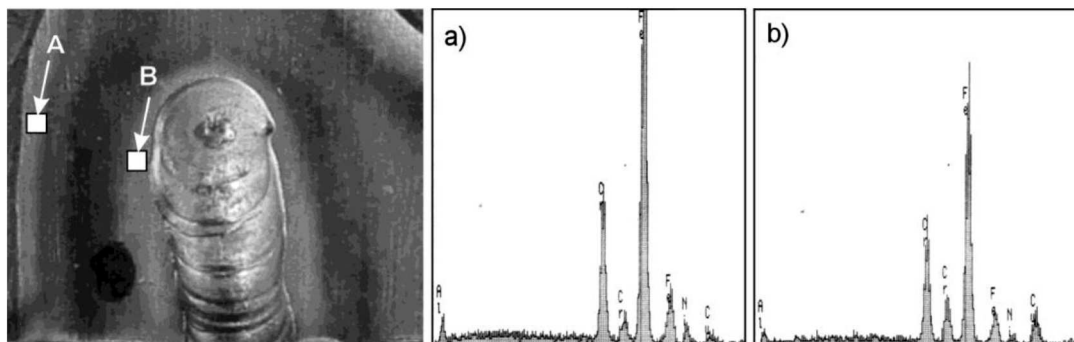
In spite of welding in a protective atmosphere of very high purity shielding argon in the so called “argon balloon”, the steel surface in the HAZ was discolored (Fig. 5). Titanium sample piece welded in the same conditions was not discolored in the HAZ. It demonstrates that the argon used as a protective atmosphere was of high purity and that the dark tarnish on the 17-4PH steel surface is not a result of oxidation processes resulting in oxide scale formation. Chemical microanalysis (using SEM Energy Dispersive X-Ray EDX) in the area of HAZ (Fig. 5b) and beyond the HAZ (Fig. 5a) has shown a distinct enrichment of copper in the HAZ area. Similar martensitic steels which do not contain copper (e.g. X3CrNiMo13-4) do not exhibit the susceptibility to the formation of micro cracks that is observed in the HAZ of 17-4PH steel, which contains $3 \div 5\%$ of Cu. These observations have led us to the hypothesis that the presence of Cu is a primary cause of the hot crack formation.

Fig. 5. Colored tarnish in HAZ along with depiction of chemical microanalysis areas: a) microanalysis deriving from area A, b) microanalysis deriving from area B

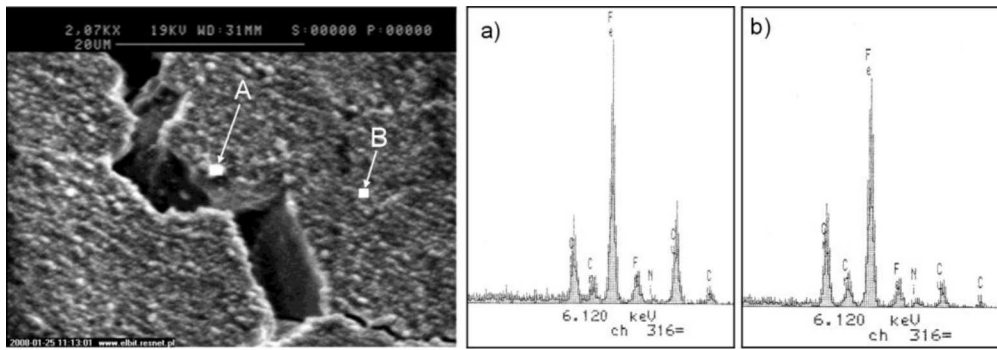
Fig. 6. Surface condition in the HAZ in the vicinity of the crack along with depiction of chemical microanalysis areas; a) microanalysis deriving from area A (crack edge), b) microanalysis deriving from area B (slightly off-set from crack edge)

Detailed analysis of the surface in the high temperature area of the HAZ has shown that the products deposited there have morphology typical of gas phase deposition (Fig. 6). The deposition products are enriched in Cu and depleted in Ni (Fig. 6b) when compared with the nominal chemical composition of the base material analyzed beyond the HAZ (Fig. 5a). Copper enrichment is especially pronounced at the edge of the crack (Fig. 6a).

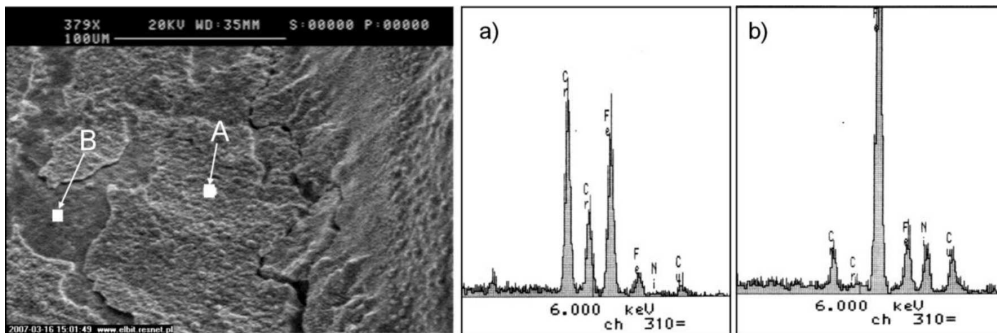
Fig. 7. Cracked and spalling oxide scale in the HAZ in the vicinity of the crack: a) microanalysis of the oxide scale (area A), b) microanalysis of the base metal surface where scale was removed (area B)

In case of imperfect positioning of the welding torch, insufficient shielding of the welded area may occur resulting in the formation of a thick oxide scale. Oxide scale tends to crack and spall during base metal cooling. Fig. 7 shows an example of a thick layer of oxides. Microanalysis of the oxide scale and of the steel surface beneath the scale is also presented in Fig. 7. Microanalysis suggests that selective oxidation has taken place and formed oxides containing mainly Cr and Fe with small amounts of Cu (Fig. 7a). The steel surface underneath the scale is distinctively enriched in Cu and Ni and noticeably depleted in Cr (Fig. 7b).

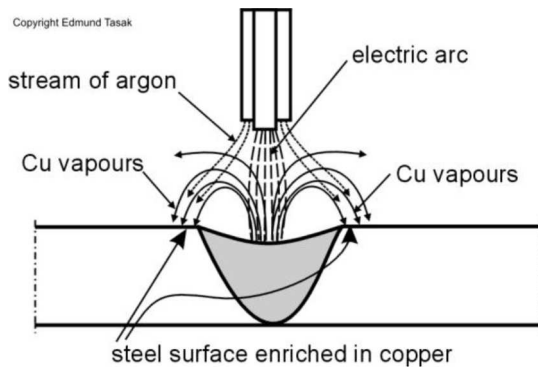
Selective oxidation may occur in the event of incomplete protection of the steel surface from oxygen. Selective oxidation causes steel surface depletion in Cr, Mn and Si. Copper and nickel in the presence of Cr and Fe do not react with oxygen and therefore the steel surface under the oxide layer is enriched in Cu and Ni. An example of surface enrichment in Cu and Ni under the oxide layer is illustrated in Fig. 7. However, at the edge of the cracks and inside the cracks Cu enrichment and Ni depletion (in comparison with their nominal concentrations) are observed. If there is proper shielding the chemical composition in these areas cannot be a result of selective oxidation. Therefore the only explanation for steel surface enrichment in Cu is intensive evaporation of Cu from the weld pool. The boiling point of Cu is 2567°C and is lower than the boiling points of Chromium and Nickel; 2672°C and 2913°C respectively. Therefore during the welding process Cu is evaporating most intensively from the welding pool as a result of high temperature of the welding arc. Copper vapours are not freely released since they are entrained in the shielding gas flow and as a result they are directed towards the base metal surface where they are deposited by condensation in the cooler

HAZ area. Cu vapor deposition mechanism scheme is illustrated in Fig. 8.

Fig. 8. Mechanism of surface enrichment in copper in the HAZ area. Copper and Cu oxides vapours deposit and condensate
