Current state of the waterway along the Warta and Noteć Rivers

Jan Kulczyk, Prof.
Radosław Werszko, D.Sc., Eng.
Wrocław University of Technology

In June 2004 took place an inspection trip aimed at assessing current state of the east-west waterway connecting the Odra and Wisła Rivers; during the trip a photographic documentation of the region was made as well. The below presented text contains also some conclusions resulting from the trip.

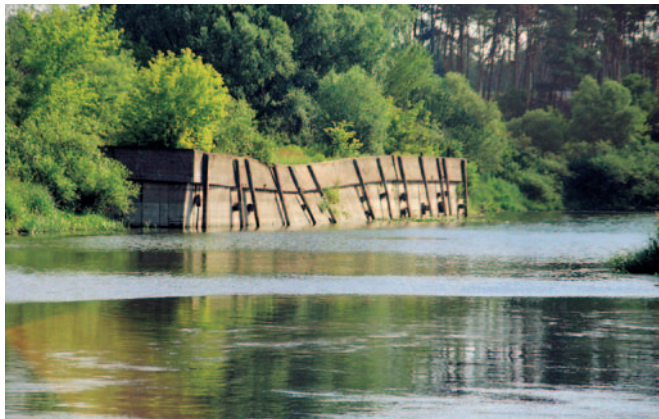
belonging to Bydgoszcz Shipping Company, or the winter stay for inland navigation barges at Krzyż. Many terminals are devastated, overgrown and deprived from mooring devices (Photo 3), and some of them should be presently deemed not existing at all. Harbour terrains in Poznań have been handed over for development of residential buildings, this way the city has been deprived from any possibility of receiving greater floating units. Moreover there is no real terminal equipped with any basic infrastructure.

Photo 3. (J. Kulczyk, R. Werszko) The devastated terminal in Oborniki upon the Warta .

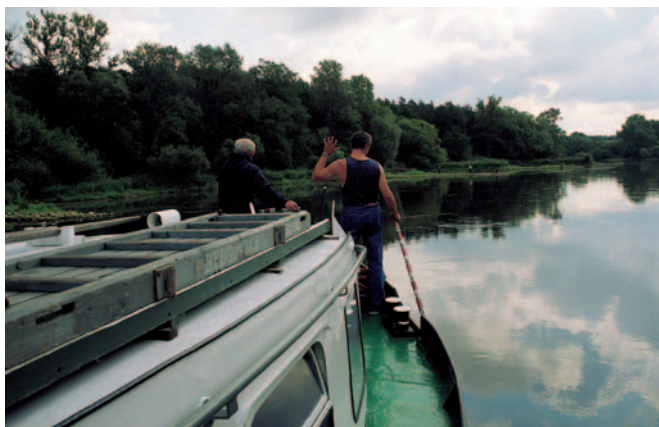
Almost all navigational obstacles are associated with a low water depth state (Photo 4). Lack of water in rivers, especially in summer, is associated with the general hydrological situation in this part of Europe, which today has a permanent character. This leads to appearing very shallow places which limit the passage depth for an entire waterway section even to 0.5 m that actually makes cargo shipping impossible and leaves the waterway useful to tourist shipping only. A section particularly shallow and difficult for navigation is the navigable part of the Upper Warta – beginning from the Prosna estuary to its inlet to the Ślesin Canal.

Photo 4. (J. Kulczyk, R. Werszko) A shoal patch of about 1-1.2 m water depth and many erratic boulders resting on the river bed section of some kilometers in length and located close to Puszczykowo upon the Warta. A crew member is heaving the lead and showing its result to the ship master .

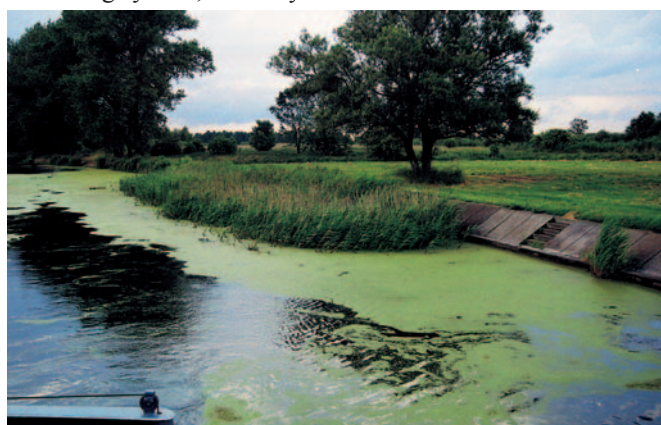
From the point of view of ship traffic an excessive quantity of plants overgrowing the waterway constitutes an obstacle (Photo 6). It causes disintegration and devastation of bank walls and water structures, an increase of ship resistance and it makes ship manoeuvring more difficult. Water plants, if wound around screw propeller, lead also to propulsion efficiency dropping and ship engine overloading, and clogging up the water inlet to cooling system, that may result in a serious failure.

Photo 6. (J. Kulczyk, R. Werszko) The overgrown outer harbour of Sluice no. 4 at Frydrychowo upon the Upper Noteć Canal .
