Waterway of the Middle Vistula (Wisła) and the Bug

Piotr Kuźniar, D.Sc., Eng.
 Stanisław Pisarczyk, Prof.
 Eugeniusz Wilk, D.Sc., Eng.
 Institute of Water Supply and Water Engineering,
 Warsaw University of Technology

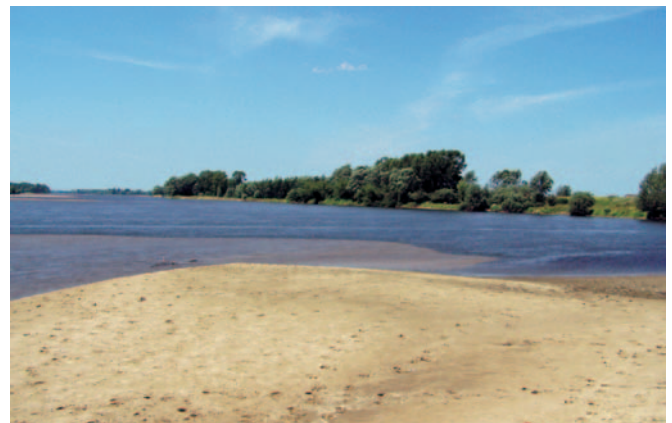
Then in the central part of the river-bed systematic accumulation of tracted rubble starts to occur, gradually covering larger and larger part of the width of the bed's cross-section and shifting the flowing water together with a part of the rubble material towards the banks. Along with water-level sloping larger and larger areas of low sandy islands emerge and narrow and deep beds similar to "chutes" appear close to the banks. In some cases water inflow to a "chute" occurs laterally to the bank (Fig.2).

Fig. 2. Lateral transition of the stream-way towards the river bank .

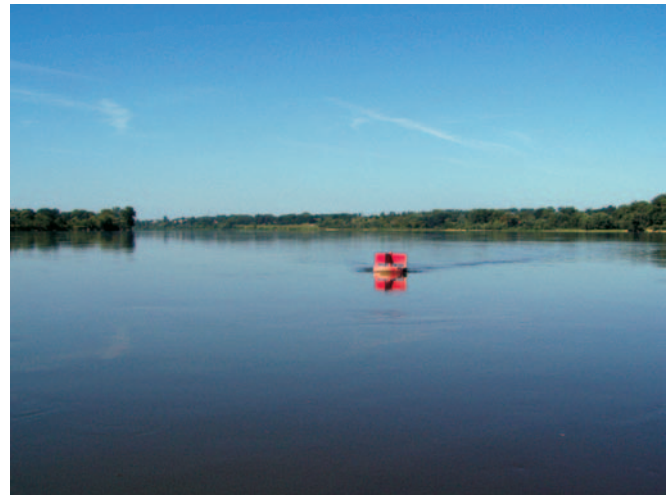
An important limitation for navigation on the Bug are curvature radiuses of the waterway. Taking into account the river bank curvatures one can expect the smallest radiuses to have about 100 m. On the bends of large curvatures the waterway width can be decreased – due to flow concentration – even to 15 ÷ 20 m (Fig.4). And, relatively favourable navigation conditions are observed along eroded banks. The stream –way is shifted towards the concave bank and only fallen-down trees can constitute an obstacle. In many cases the minimum width of the Bug waterway and its minimum radius can amount to a somewhat smaller values that those required by the rules.

Fig. 4. A typical course of the Bug river- bed .

Floating objects should then reduce its speed.

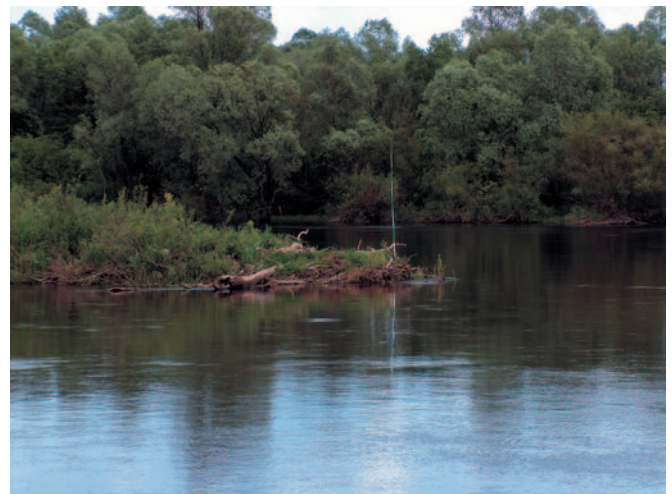
Though in the information materials [Informator 1961] the highest navigable water-level is given higher than the warning state, these authors have assumed that navigation will be continued only at the water-level contained within the river banks. Number of islands located in the main river-bed both of the Vistula and the Bug makes navigation at the higher water states more hazardous (Fig.5).

Fig. 5. Mark signing the cape of the island on the Bug waterway .
