DYNAMIC STATE ASSESSMENT OF THE WATER TURBINE WITH THE POWER OF 600 kW

Grzegorz ŻYWICA, Paweł BAGIŃSKI, Łukasz BREŃKACZ

Institute of Fluid-Flow Machinery, Polish Academy of Sciences
80-231 Gdansk, Fiszerka 14 str., gzywica@imp.gda.pl

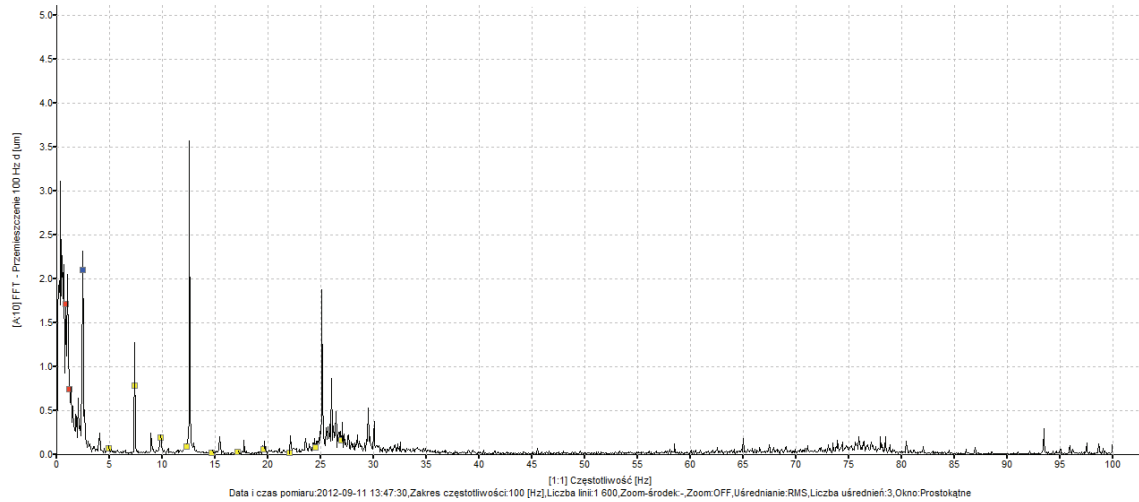
Analyzing the vibration spectrum shown in Figure 4 we can see the dominance of the following components of vibration. At very low frequencies (up to 2 Hz), components were associated with the resonance frequency of the system, which results in the vibration of the whole machine and the foundation. At a frequency of 2.5 Hz the rotational speed component was observed (for the water turbine shaft). At 7.5 Hz we can distinguish the component associated with the shaft misalignment or bend, but its amplitude was lower than the synchronous component. At a frequency of 12.5 Hz synchronous component of generator shaft appeared, and at 25 Hz the increased amplitude of vibration testified about a misalignment or deflection of the shaft. Other components of vibrations in Figure 4 was characterized by a much smaller amplitude. Since in the case of measuring the amplitude A_{p-p} vibration limits for new machines are not exceeded even once, it can be concluded that the observed symptoms of various defects were at an acceptable level. Synchronous vibrations of both shafts were relatively low, and the successive harmonics were reduced almost twice, which meant a slight bend or misalignment.

Fig. 4. Frequency spectrum of the vibration amplitudes measured at node III in the direction Y with the selected synchronous frequency of water turbine's shaft at 2.5 Hz (blue dot) and its harmonics (red and yellow dots)

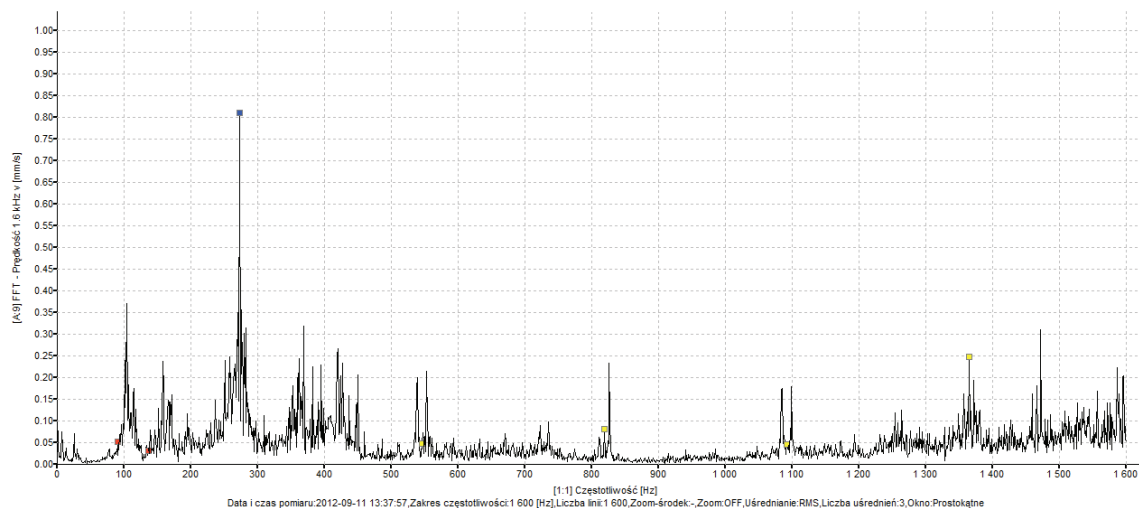
At higher frequencies, for all the measuring nodes similar vibration spectra were recorded. Characteristics shown in Figure 5 was determined for the measured signal at node II in the direction of the Y axis (on the flange connecting the generator with the transmission gear). The recorded vibration signal allowed to draw the following conclusions. The dominant component (272 Hz frequency) of the resulting characteristics relates to the toothed ring's meshing frequency (it was marked by a blue point and its harmonics by yellow and red points). The origin of the vibrations of toothed gear also testified clear sidebands. Elevated levels of vibration can also be observed in successive harmonic frequencies of toothed ring's meshing: 544, 816, 1088, 1360 Hz. At the frequency of 103 Hz a component occurred resulting from the frequency of meshing the satellite wheels with the toothed ring. Under the frequencies within the range of 170 Hz appeared increased vibration levels that could be associated with the co-operation of the satellite wheels with the central wheel of the planetary gear. Other areas of high vibration levels were difficult to clearly interpret.

Fig. 5. Frequency spectrum of the vibration velocity measured at measuring node II in the Y direction with the marked frequency of toothed ring meshing with the planetary cage at 272 Hz (blue dot) and its harmonics (red and yellow dots)

The study clearly showed that the cause of elevated levels of rms values of vibration velocity was the operation of planetary gear, and more specifically the lack of smooth cooperation of gears. Since the vibration of the machine was measured on the housing, the registered signal was dominated by vibrations coming from the toothed ring cooperation with the planetary gear. This ring was permanently connected to the gear's body, resulting in the direct transfer of vibrations to the housing.

The analysis conducted of vibrations therefore clearly indicated the source of high level of vibrations, which impacted directly on the acceptable level of vibration (for new objects which are ready for use). The cause of the elevated vibration level was due to the planetary toothed gear. Since this was a new gear, it was unlikely that such quick wearing or damage could have occurred, so this evidenced by low accuracy performance of toothed wheels.

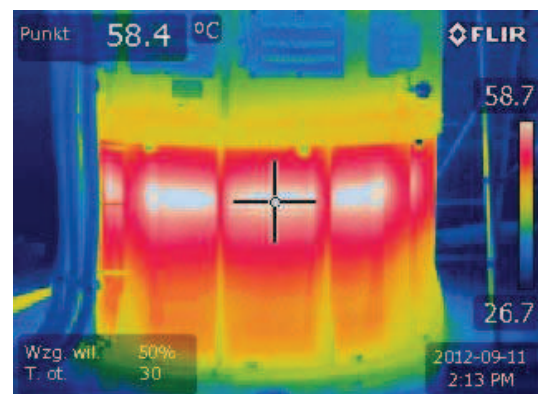
Fig. 6. The temperature distribution on the external surface of the gear housing.

In case of the examined water turbine no excessive temperature levels were observed for any of the controlled parts. The highest temperature in the housing of toothed gear was 59.7 °C and it was in the area of connection of toothed ring with the housing (Fig. 6). The temperature on the outer surface of the generator was up to 46.4 °C in the vents, where hot air was removed. Housings design prevented temperature measurement directly on the bearing housing, but the steel elements connected to these retainers had a low temperature. It can be concluded that the control of the temperature distribution showed no symptoms of excessive wearing or damage.
