Conservation studies of the ruins of the Gothic Kazimierz castle (2nd half of the 14th century) in Koło (Gozdów)

Introduction

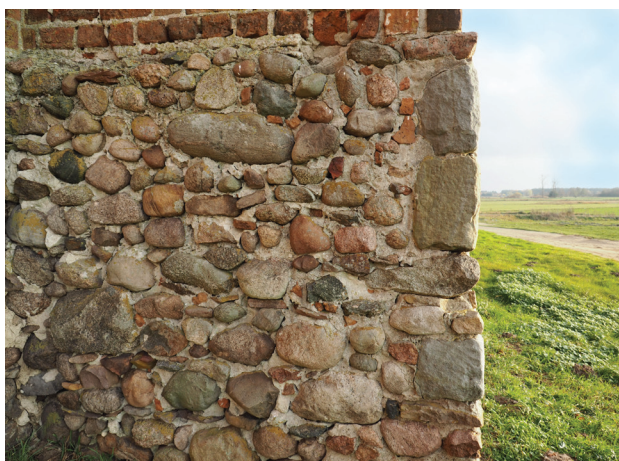
Fig. 2. Castle in Koło. Fragment of a buttress with a restored boulders faced wall with sandstone blocks (photo by K. Polak, 2020)

Sandstone blocks from Brzeźno³ [13] (Fig. 2) were also used for the repair of the plinth, probably coming from the ruined parts of the residential tower. This is indicated by the type of material and similar dimensions and method of processing.

Sandstone squares set between granite boulders require special attention. The condition of these elements is poor. The stone has disintegrated, locally delaminating. The edges of the blocks are weakened and crumbling. The surface is covered with unevenly dark layers. The disturbing state of preservation of the sandstone squares results primarily from the intensive action of the destructive factors on the porous rock surrounded by materials with different capillary properties: igneous rocks, which are the main building material of the wall and mortars.

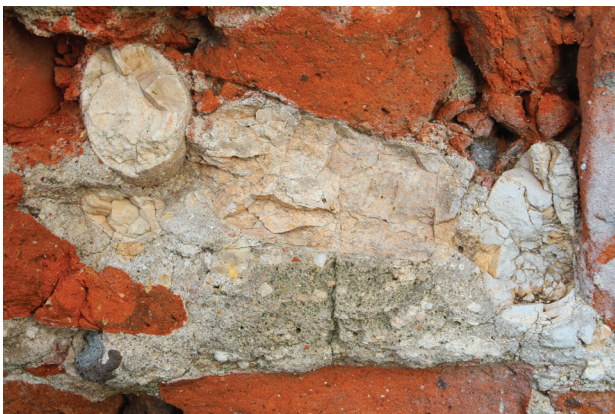
Fig. 4. Castle in Koło. Close-up of the mortar in the joint with visible fragments of calcined limestone (photo by K. Polak, 2020)

cate carelessness of contractors or imperfect production technology. This conclusion is confirmed by in situ observations. In many places, lumps and crumbs of binder of various sizes and shapes are visible on the fractures of the mortar. They occur irregularly, occasionally in clusters.

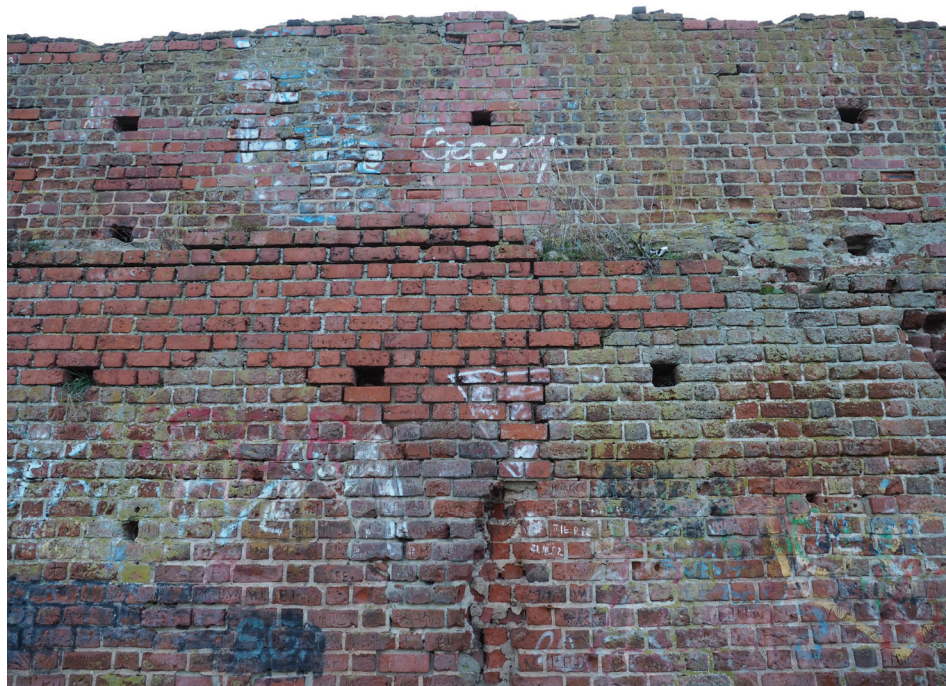
Fig. 6. Castle in Koło. The inner side of the western wall with numerous graffiti and complemented bricks on the wall face. The softly ending crown of the breast wall is noteworthy (photo by K. Witkowska, 2020)

Graffiti as well as numerous signatures and initials engraved in bricks, especially numerous on the walls from the side of the courtyard, should be mentioned as another damage that did not significantly affect the state of preservation, but negatively changed the appearance of the wall (Fig. 6). The painted inscriptions disturb the perception of the monument and, despite a certain cultural value, should be treated as an act of vandalism and removed.

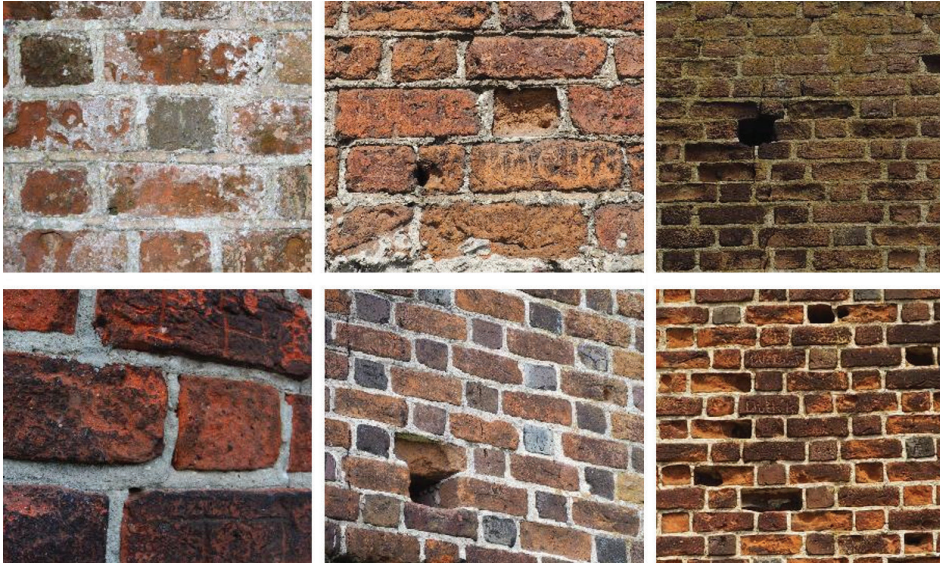
A major conservation and restoration problem is the state of preservation of the bricks (Fig. 7). Most of their face has not been preserved. Its destruction is most often the result of washing out or shedding of the surface layer. In many places, the cavities form depressions and niches, sometimes covering the entire volume of the brick. They are visible from a distance as soft-edged cavities. It has been assumed in the literature that this type of damage is associated with the presence of nitrifying bacteria, which, as a result of metabolism, produce acids capable of decomposing rock-forming minerals (aluminosilicates in this case). Damage initiated by bacteria is magnified and intensified by the action of other factors, e.g., wind. The conducted microbiological tests did not confirm the excessive content of nitrifying bacteria on the surface of the damaged bricks⁹, but their slow and long-term effect is possible.

Fig. 7. Castle in Koło. Examples of the state of preservation of the medieval face of the wall (photo by K. Polak, 2020)

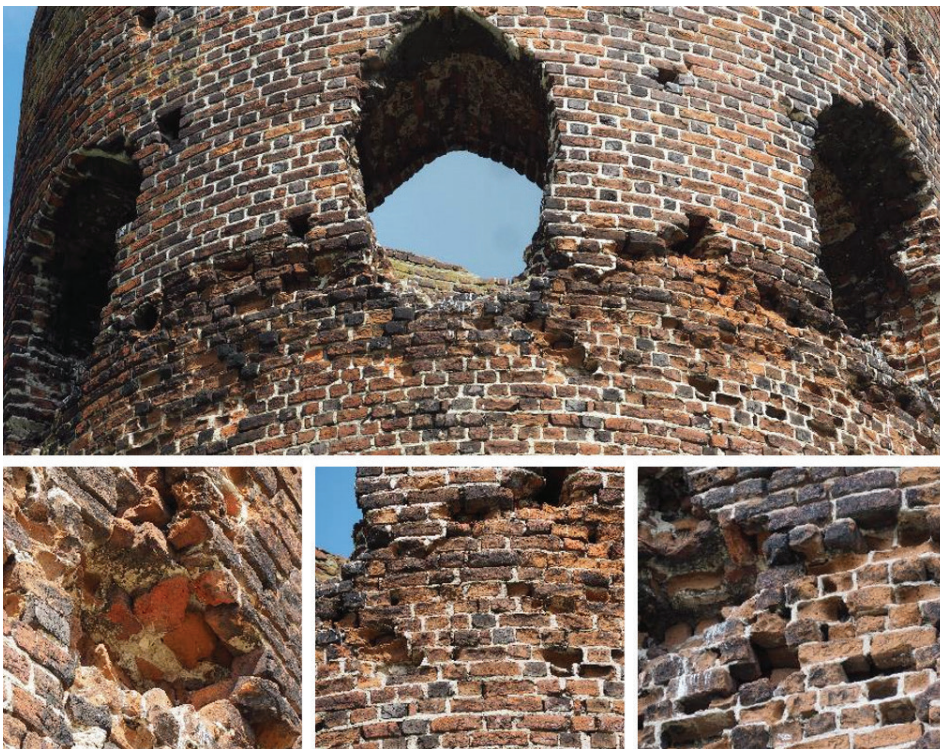
Shreds, forging and similar places are in destruct condition. These areas are dominated by damaged, irregularly cracked and crumbled bricks bonded with mortar that is crumbled, uneven, with many depressions, voids, etc. (Fig. 8).

Fig. 8. Castle in Koło. Examples of the state of preservation of the tower walls (photo by K. Polak, 2020)
