The role of reliable mining and construction analysis in adjudicating mining damage claims

Wojciech Kocot

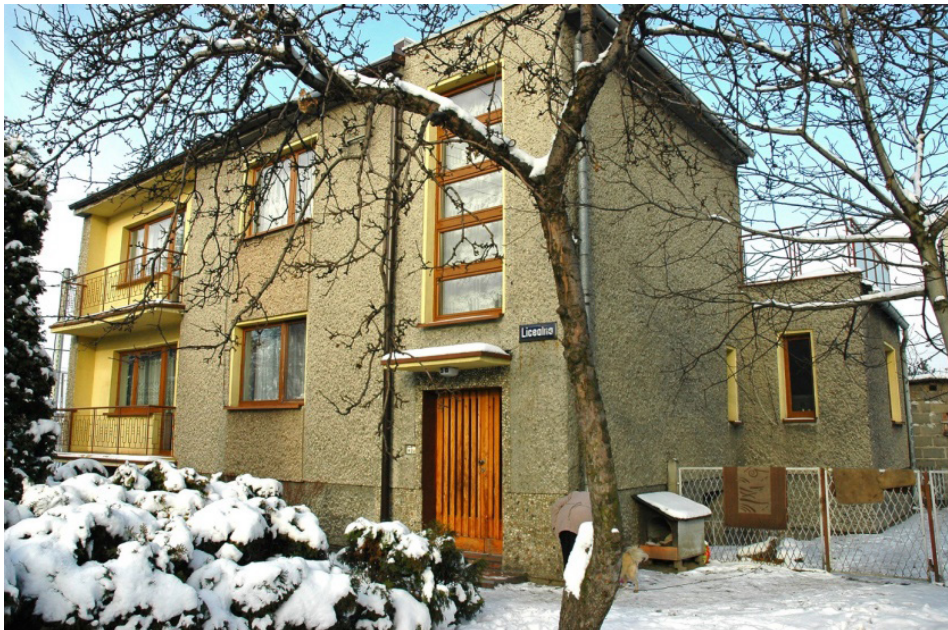
Fig. 1. View of the building from the south-east. *Source: author*

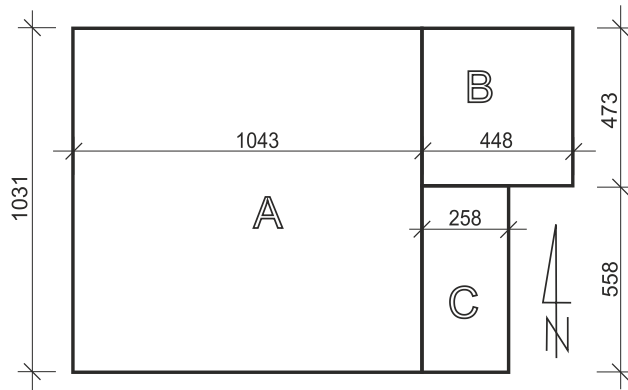
Fig. 2. Individual stages of building erection. *Source: author*

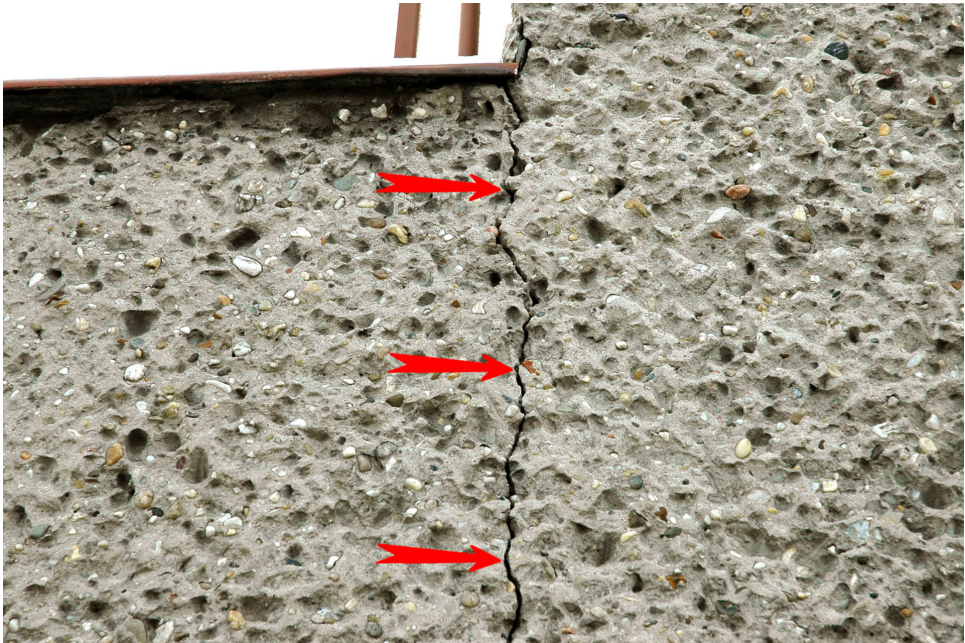
Fig. 3. Fragment of the northern wall – vertical crack at the junction of the extension C with the main body of the building. *Source: author*

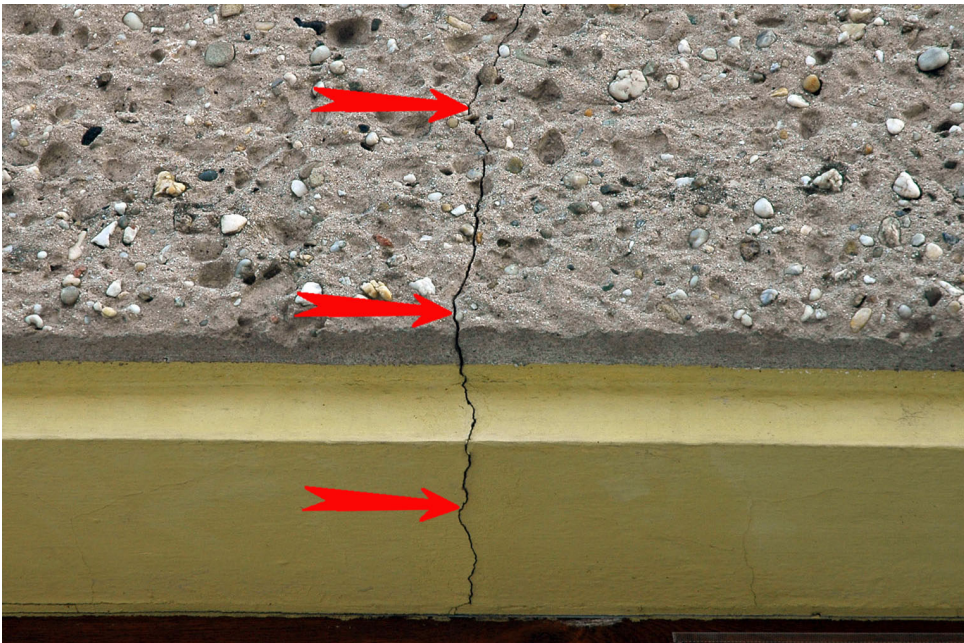
Fig. 4. Fragment of the western wall – vertical crack above ground floor window opening. *Source: author*

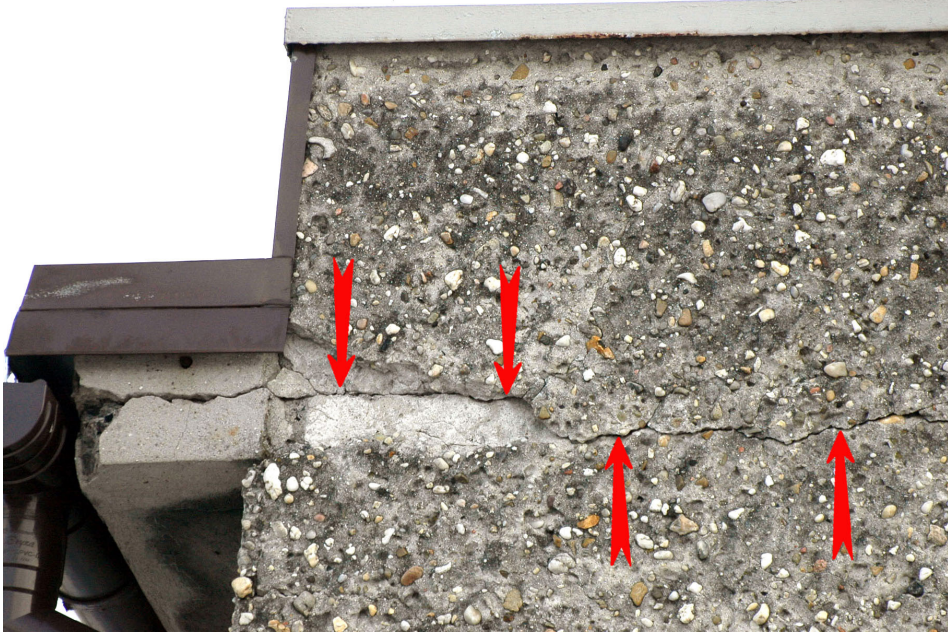
Fig. 5. Fragment of the western wall – visible horizontal cracks along the upper and lower surface of the ceiling slab. *Source: author*

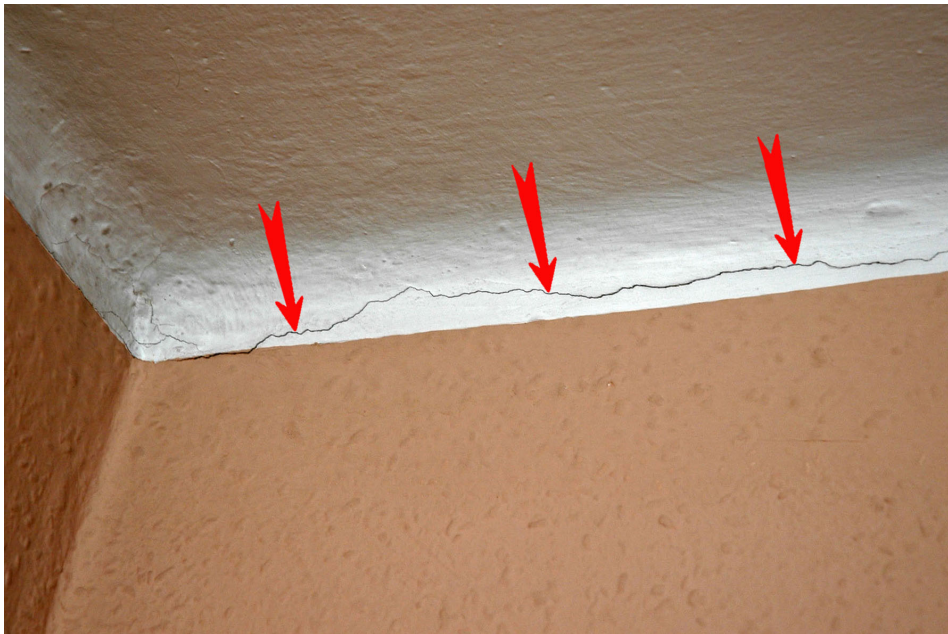
Fig. 6. Gap of up to 1.5 mm between ceiling and first floor interior wall. *Source: author*

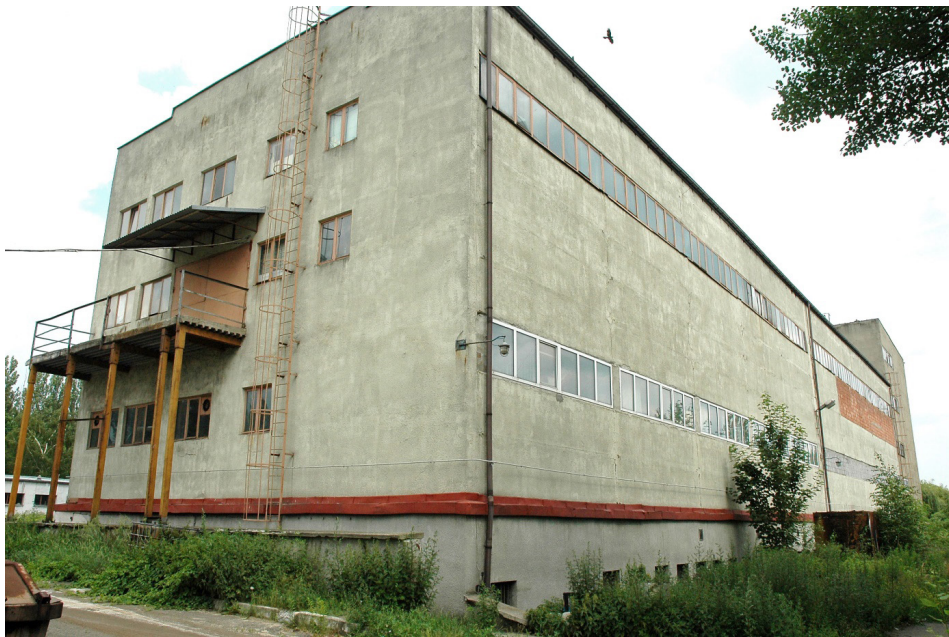
Fig. 7. The industrial building in question – view from the south-west. *Source: author*

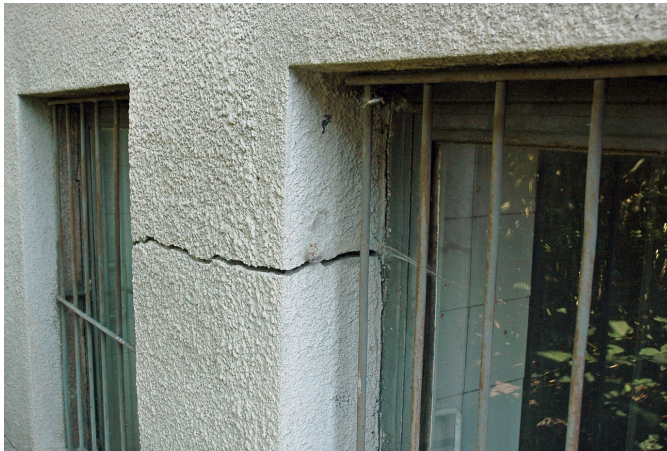
Fig. 9. Fragment of the basement wall of segment 1 – visible cracks in the inter-window pillar from the outside and no damage at this point inside. *Source: author*

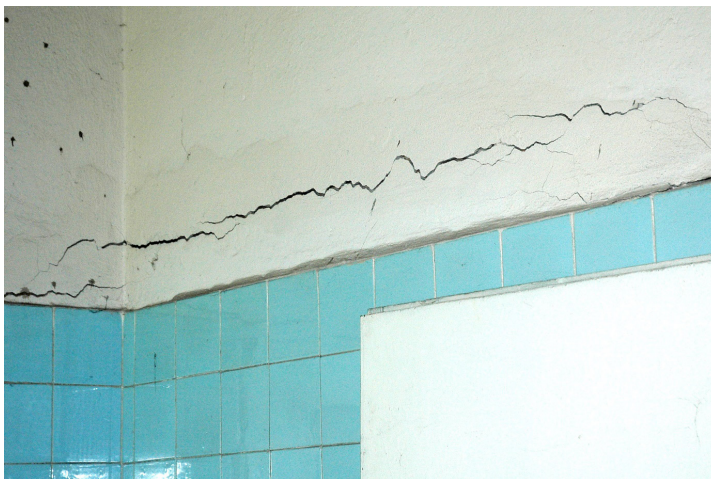
Fig. 10. Horizontal cracks in masonry partitions in basements. *Source: author*

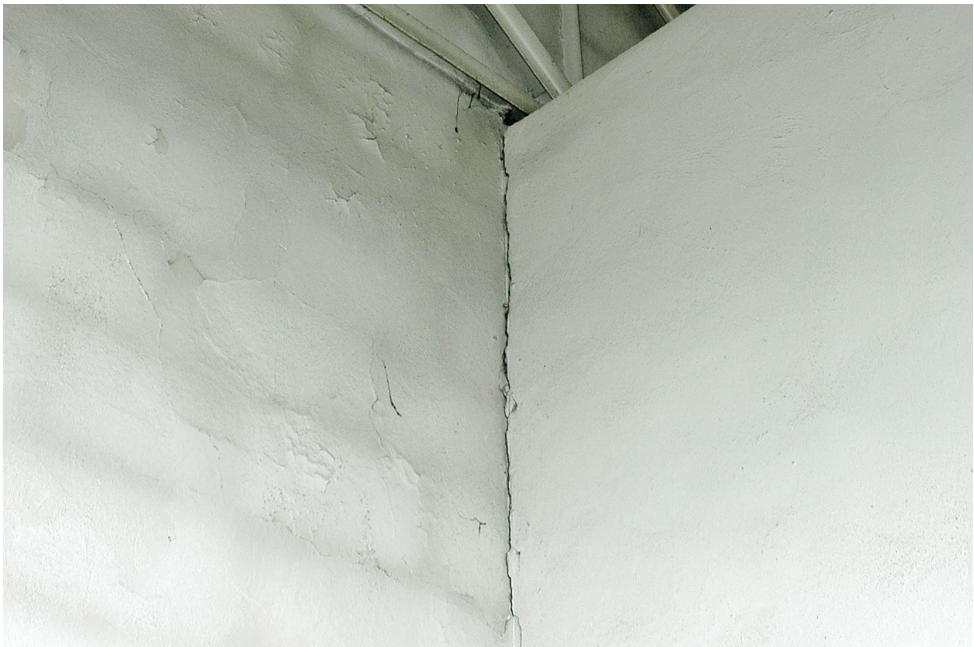
Fig. 11. Cracks at the junction of the masonry partition wall of the second storey with the western gable wall.
Source: author

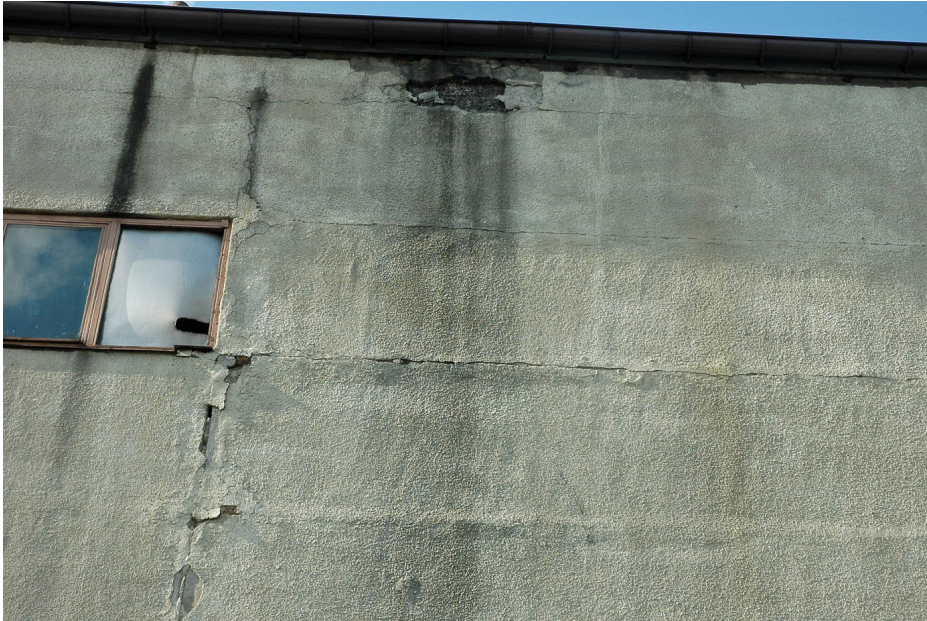
Fig. 12. Western fragment of the northern wall of segment 1 – visible cracks and chipping cracks and chipping of plaster at the joints of prefabricated housing elements and dark damp patches. *Source: author*

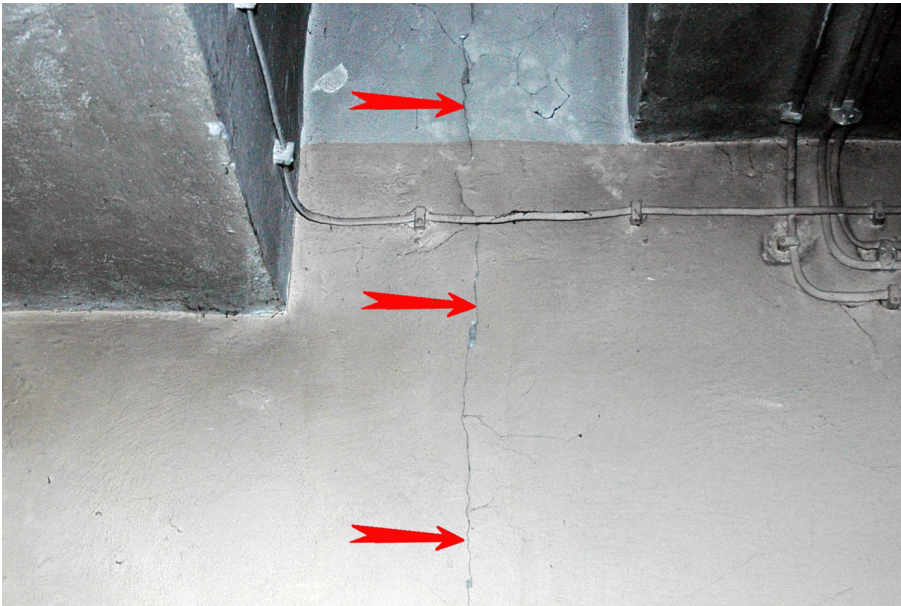
Fig. 13. 1 mm crack at the bricked up and plastered expansion joint between segments 2 and 3 at ground level. *Source: author*
