SELECTED ASPECTS OF THE STRUCTURAL ANALYSIS OF THE NORTH DOME IN THE "FOUR DOMES PAVILION"

The subject of the paper is north dome of the Four Domes Pavilion in Wroclaw, which was erected according to the project by architect Hans Poelzig in 1913. The geometry of the dome (plan, rise, thickness) has an essential influence on the stress distribution in the structure and may be a crucial factor determining the cracking pattern. The results of the study of archival documents and numerical analysis indicate that there is a need for increasing the bearing capacity of the structure. After carrying out 3D FEM analysis, it was decided to apply strengthening technology based on the FRCM system with carbon and P.B.O. fibers on the surface and on the external ring of the dome.

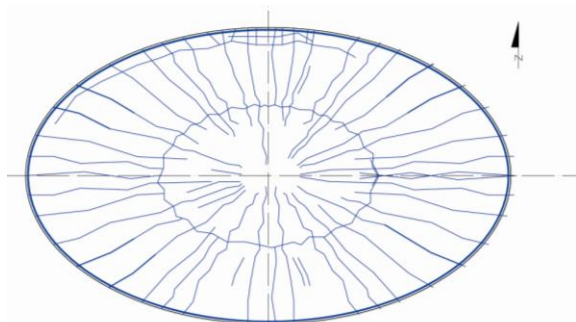
During on-site visits to the building, a cracking pattern that is typical of dome-type roofs was identified in the longitudinal and latitudinal direction [2]. The shell of the dome is cracked from the inside as well as from the outside. On the outside, a horizontal (latitudinal) distribution of cracks is visible, running down approx. $\frac{1}{4}$ of the circumference of the dome in its north-western section. On the inside, the most severe cracking was observed around the whole circumference in the direct zone of support. Additionally, longitudinal cracking (densely distributed) was localized, as well as latitudinal cracking in the lower sections and at half the dome height. Latitudinal cracking at a height of 50-100 cm above the supporting point coincide with cracking on the inside (Fig. 3).

Fig. 3. Bottom view of dome roof with a schematic depiction of the cracking pattern.

The top ring is characterized by vertical cracking as well as cracking over the supports (columns) as well as in the bay (in the middle of the window opening). These cracks are densely distributed and, in the majority of cases, their width does not exceed 0.1 mm. Triangular ceiling structures under the middle ring and above the columns and pillars indicate cracks which coincide with yield line patterns of ceiling structures of a triangular geometry. The uncovering of foundations available during the on-site visit under column K7 and pillar F did not reveal damage to them.

- 3) Latitudinal and longitudinal cracking over 1mm in width result from insufficient reinforcement of the dome shell, especially in the support zone.
- 4) Some of the narrower cracks (0.1-0.3mm) are of a thermal nature.

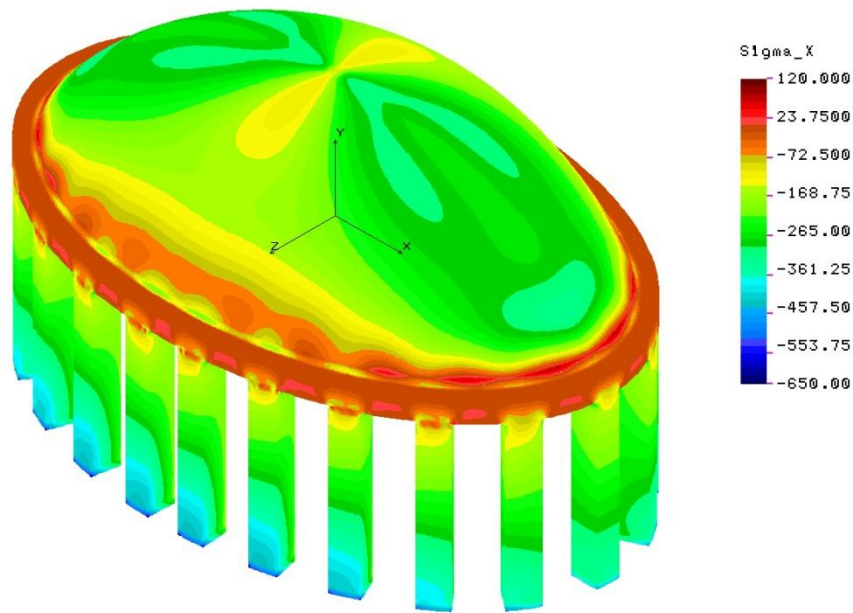
The elliptical geometry of a dome determines the distribution of stresses concentrated at the base of the dome shell (Fig. 4).

Fig. 4. Distribution of σ_x stresses [kPa]

- 5) The map of tensile stresses coincides with the state of cracking on the inside surface of the dome. Tensile stresses are highest at a level of approximately 50cm above support ring of the dome shell.
