THE FRACTOGRAPHIC INVESTIGATION OF AN AEROENGINE ACCESSORY GEARBOX QUILL SHAFT

This paper analyzes the fracture of the quill shaft. An investigation of a twin-engine trainer aircraft incident has been reported. The incident occurred due to the right electric generator out and low oil pressure. The main failure based on the warnings and the subsequent incident was identified. The failure involved the fatigue fracture of the quill shaft on the J85 turbojet engine's accessory drive gearbox (ADG) and Input Drive Assembly (IDA). It was determined that the fracture had been originated by the torsional loads impacting the quill shaft that connects the ADG and IDA. The quill shaft was broken as the loads exceeded the limit values designed by the manufacturer as a system protection part. Although the main failure was successfully identified, further analysis regarding the reaching to the triggering cause of the fracture was performed. Through the detailed fractographic and metallographic studies, the root-cause of the fracture was determined as the misalignment of the quill shaft between ADG as the driving unit and IDA as the driver unit.

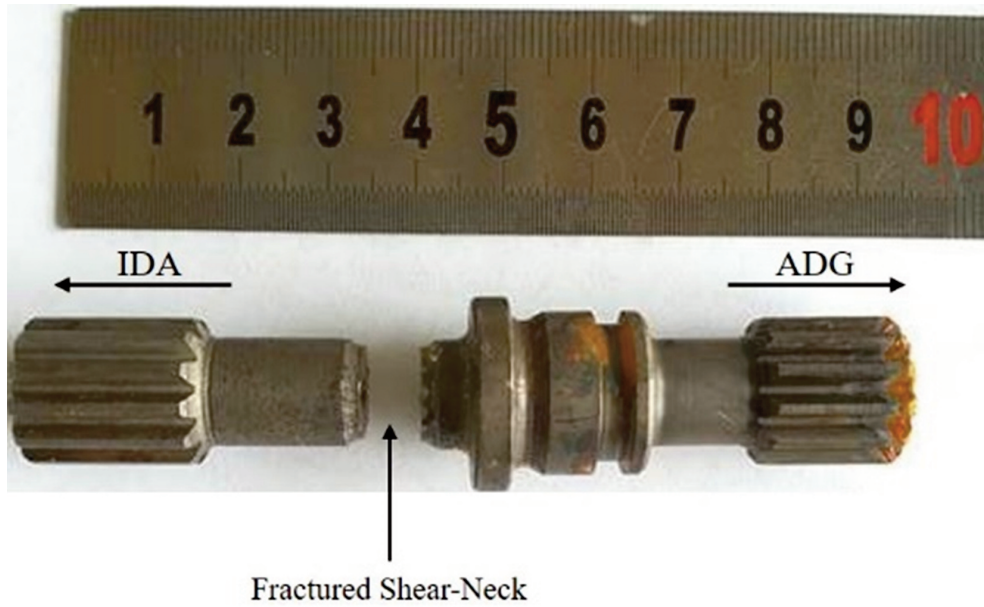
Respectively, ADG and IDA were controlled visually. Firstly, ADG was disassembled and IDA was opened for further study. Examination revealed that lateral fracture separated the shaft from the shear-neck section. As it was mentioned earlier, the purpose of the shear-neck is being fractured when the torsional loading exceeds the designed limits of the ADG's coupling shafts. As it is shown in Figure 5, the quill shaft is fractured from the shear-neck section.

Fig. 5. The Fractured Shear-Neck of the Shaft.

It was observed that on the right side (ADG side) of the shaft, there are corrosion concentration sites that might be occurred because of misalignment. Moreover, pitting corrosion was observed on the grooved area of the shaft. The oscillatory cyclic load between shafts can cause fretting corrosion and hence result in wear of surfaces. The fretting wear was considered as originated from bending forces that lead to crack nucleation and hence the corrosion propagation through the micro-cracks [8]. In other words, irregular and excessive contact is a literal conclusion of the shaft misalignment during the assembly of the ADG and IDA. However, tilt behavior can cause an angular misalignment between units (In this case ADG and IDA) accelerating the fretting and abrasive wear [9]. The fretting increases as the lubricant deteriorate and in the presence of surface irregularities such as dents or scratches [10].

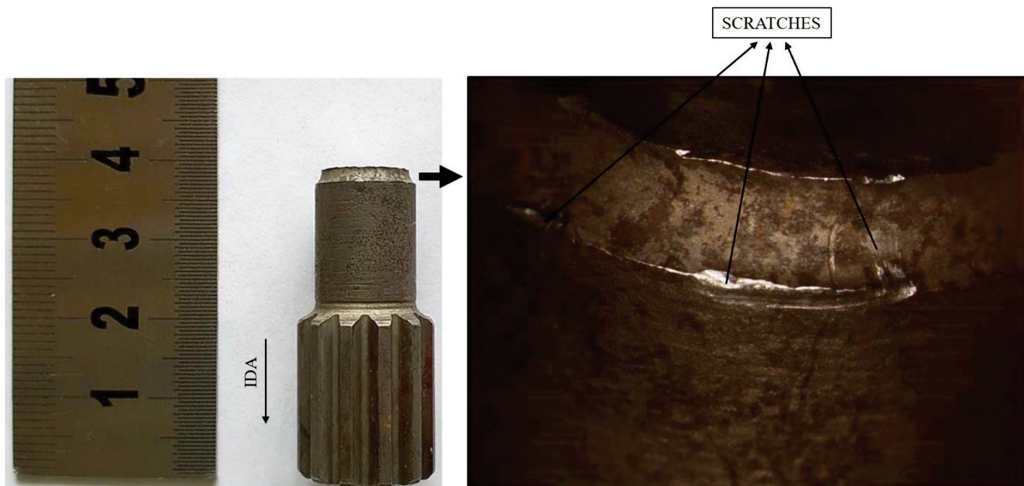
The Field Emission Scanning Electron Microscope (SEM), Fluorescent-Penetration Inspection (FPI), Binocular Stereo Microscope (BSM), Image Analyzer (IA), and Rockwell Hardness Measurement device (RHM) methodologies were used for the fractographic analysis of the fractured shaft. It was determined that there were damages such as fretting and scratching in the fracture zone, due to the impact intersecting with the fracture cross-sectional surface as it is shown in Figure 6.

Fig. 6. The Fretting and Scratching in the Fracture Zone of Non-Corroded Side of the Shaft.

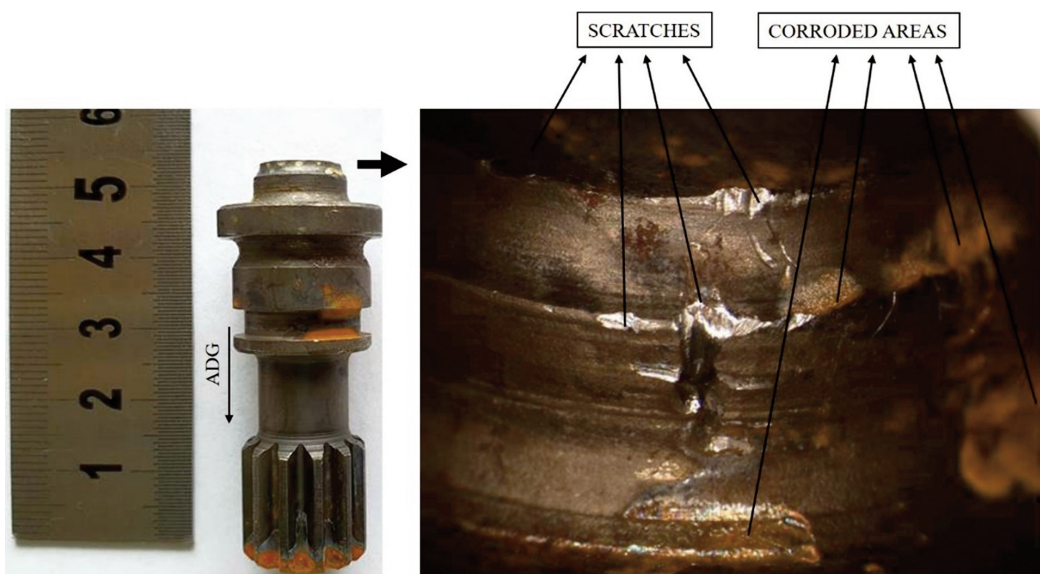
Micro-cracks and scratches are clearly seen on the sheared surface of the shaft as a result of BSM and IA based investigation. Also, the scratches and corrosion concentration areas are shown in Figure 7.

Fig. 7. The Fretting and Scratching in the Fracture Zone of Corroded Side of the Shaft

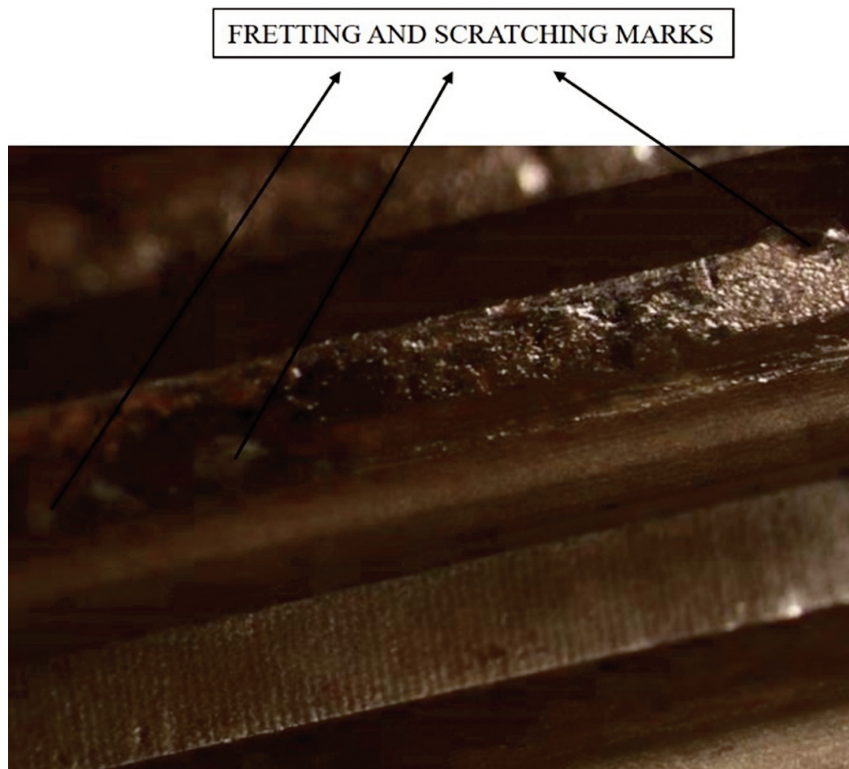
Fig. 8. The Fretting and Scratching Marks.

Due to irregular loads originated from misalignment, the shaft is predominantly subjected to torsional overloads. This overloading led the RPM decrease below 10,800 as it was regulated to revolve between 10,800 to 12,600. Consequently fretting was promoted with the empowering effect of misuse of lubricating. The fretting and scratches marks are shown in Figure 8.

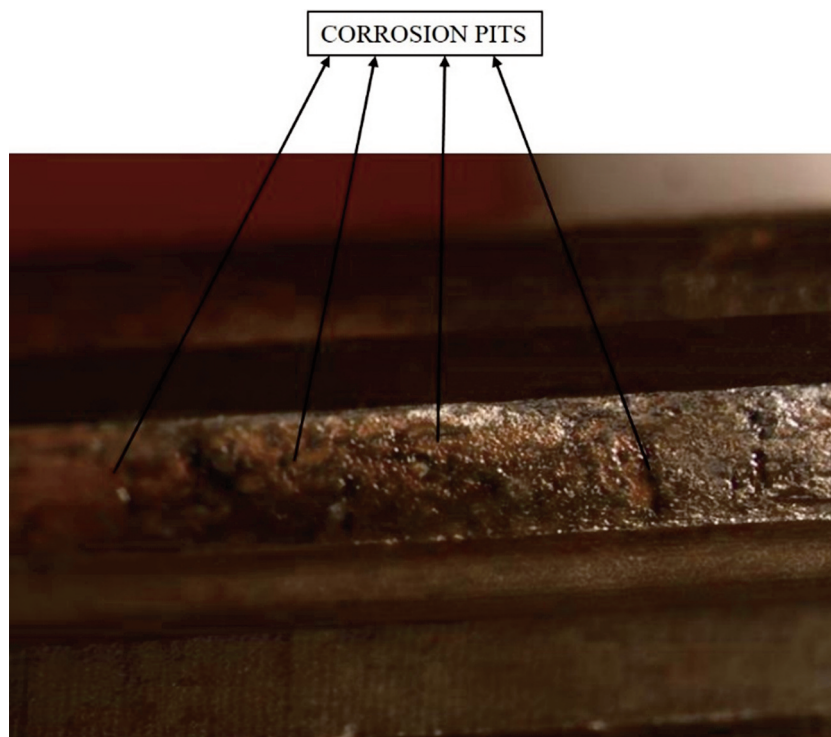
Fig. 9. The Corrosion Pits Formed in the Fritting Section.

As it was mentioned, the corrosion nucleation is initiated by the misalignment. The fretting wear originated corrosion pits are shown in Figure 9.

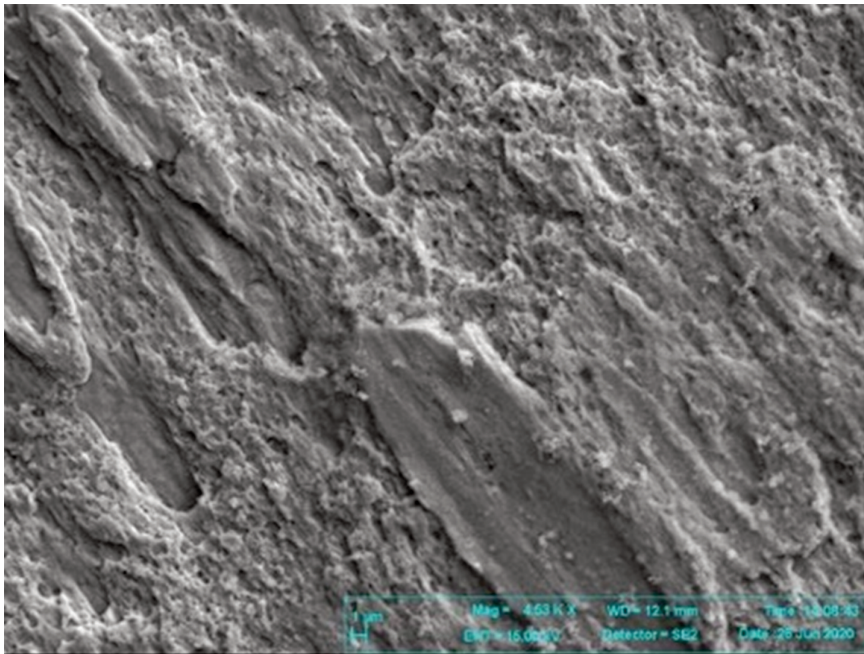
During SEM investigations, when fractured section surfaces were examined, it had been observed that the surfaces containing elongated dimples, which were formed in ductile type mainly due to torsional load of the surfaces as it is shown in Figure 10. It was observed that the dimensions of the dimples are approximate $\sim 150\text{-}200\mu$ in the lateral direction.

Figure 10. The SEM image of the Shear-Neck.
