## Geomorphological effects of the catastrophic drainage of artificial reservoir in the Młynówka valley at Górowo Haweckie, Poland

Dariusz Brykała  
Piotr Gierszewski

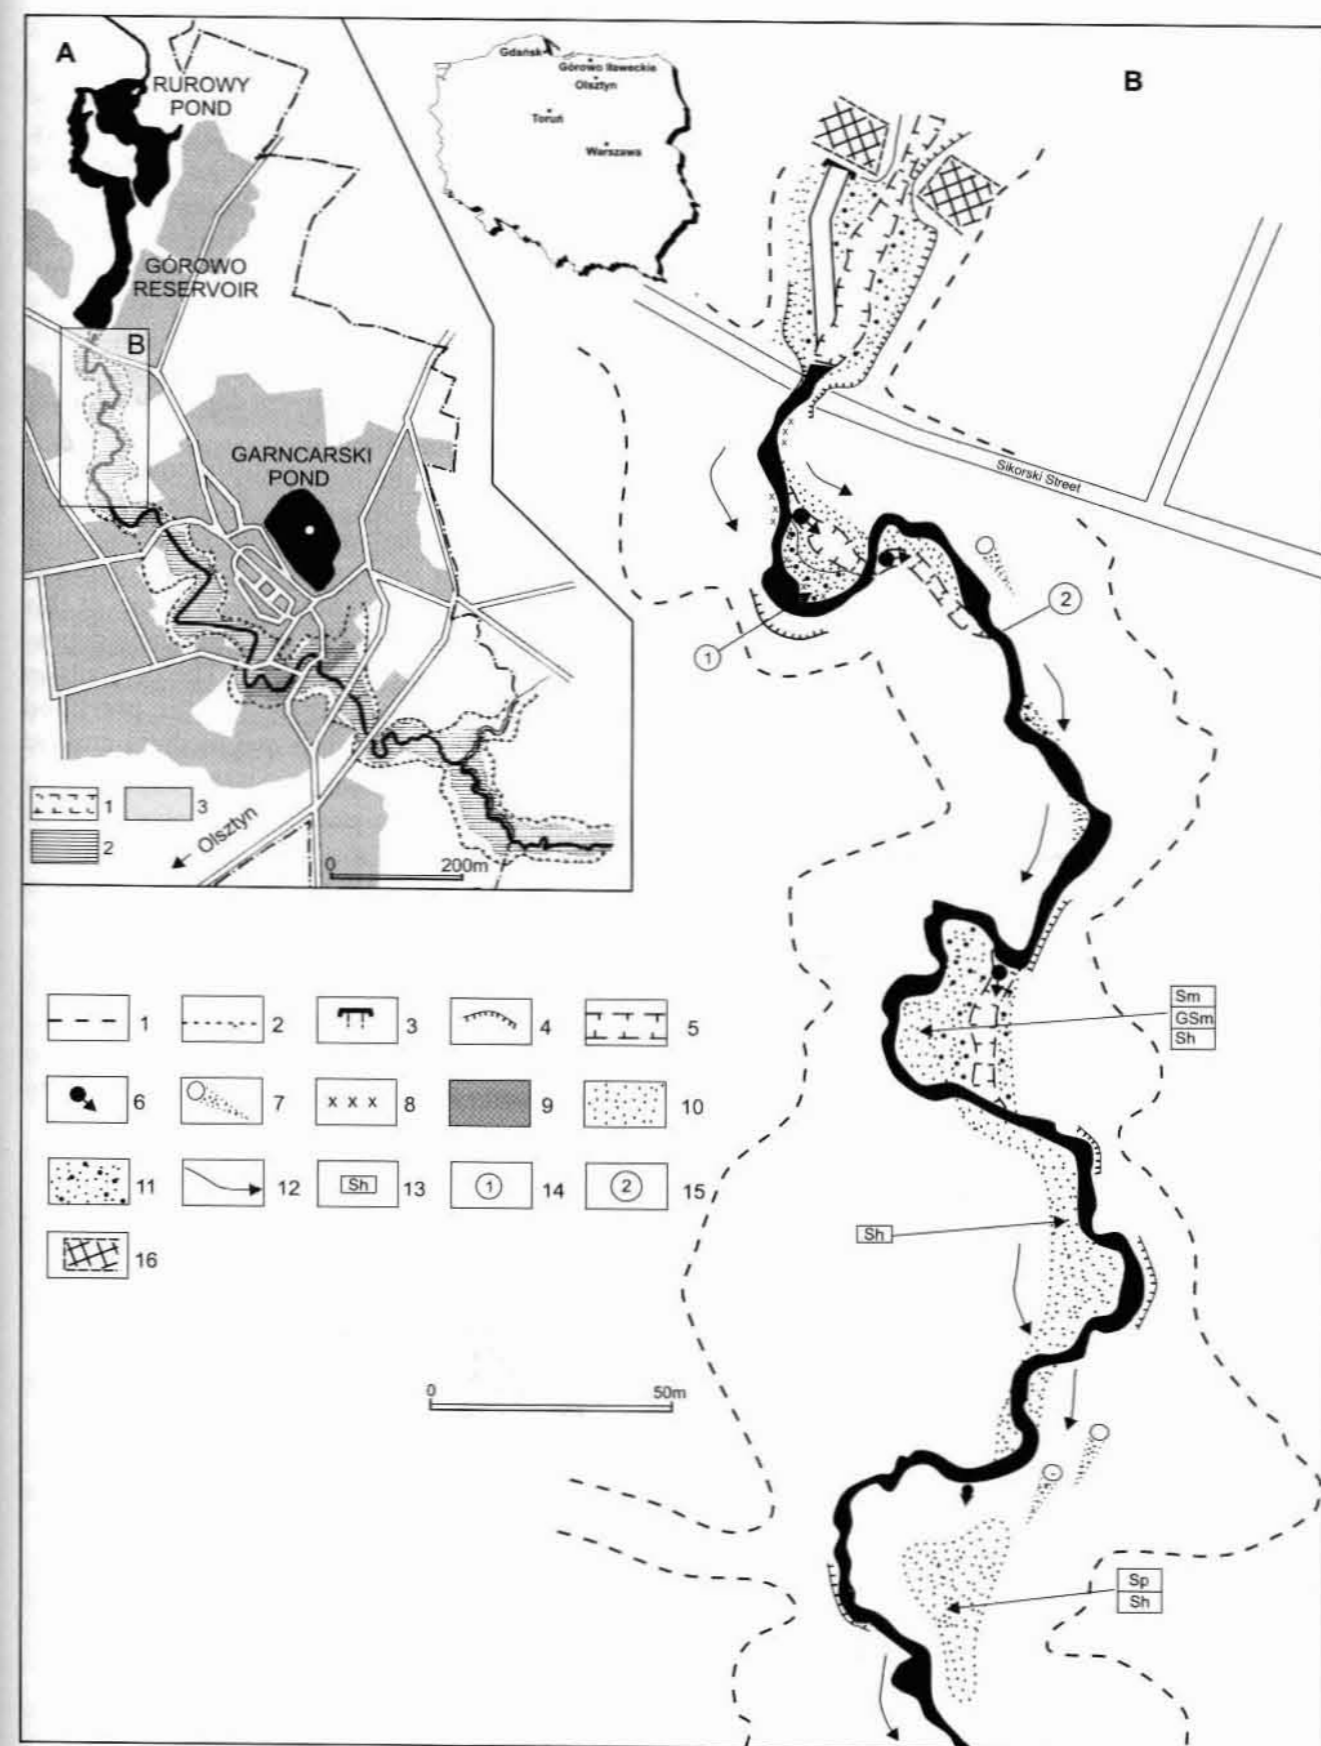
Fig. 3. Range of flood in the Młynówka valley on 3<sup>rd</sup> February 2000 (A) and sketch of the geomorphological transformations of its floor below the broken dam (B)  
 A: 1 – upper edge of valley, 2 – range of flood wave, 3 – build-up areas  
 B: 1 – upper edge of valley, 2 – range of flood wave, 3 – spillway and draining off canal, 4 – bank undercuttings, 5 – erosive and overflow channels, 6 – crevasses, 7 – sandy shadows, 8 – large boulders and fragments of construction materials, 9 – sandy-silty deposits, 10 – sandy deposits, 11 – gravelly-stony deposits, 12 – directions of flood water flow, 13 – lithofacial types of flood deposits, 14 – delta cone from Figs. 6, 15 – cross section from Figs. 8, 16 – broken dam

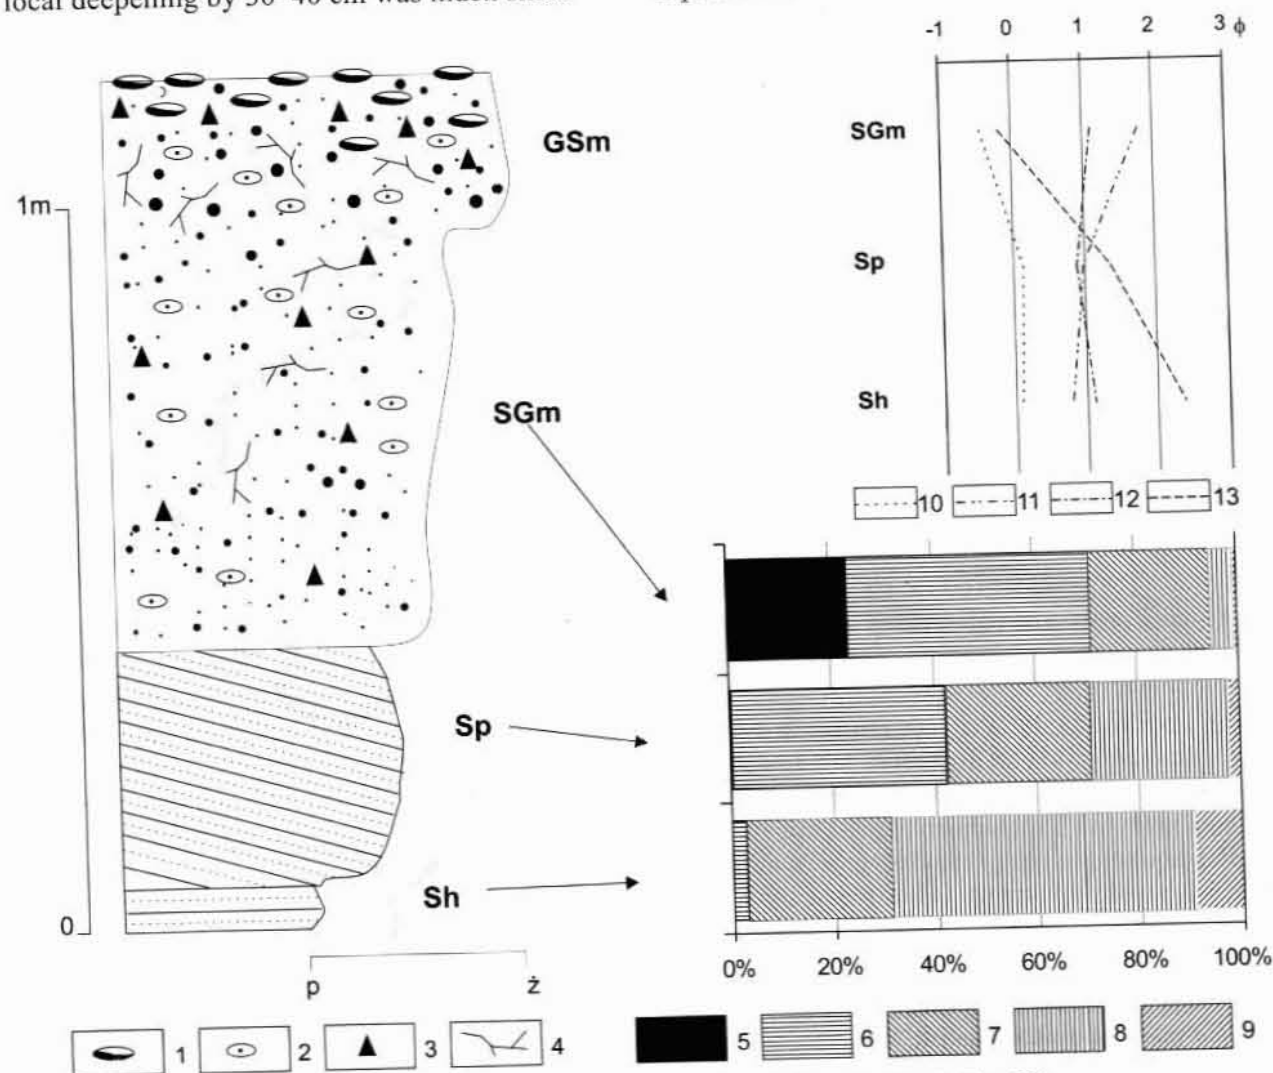
Two sequences have been distinguished in the structure of the flood cones. In the lower one horizontally stratified sandy deposits predominated, in the upper one massive gravelly deposits prevailed. A good insight in the structure of this type of forms is offered by the delta cone deposited below the dam (Figs. 5–6). The deposits in its front are clearly bipartite. On the pre-flood deposits there occurred fine- and medium-grained

Fig. 6. Structure and granulometric characteristics of delta cone deposits (localization in Fig. 3B)  
 1 – boulders, 2 – mud-balls, 3 – fragments of construction materials, 4 – plant detritus, 5 – gravel, 6 – coarse-grained sand, 7 – medium-grained sand, 8 – fine-grained sand, 9 – fine silt, 10 – skewness ( $Sk_1$ ), 11 – standard deviation ( $\delta$ ), 12 – kurtosis ( $K_c$ ), 13 – mean grain size ( $M_z$ )

laminated sands with a faint horizontal stratification (lithofacies Sh), changing higher up into vari-grained sands with prevalence of coarser fractions cross-stratified (lithofacies Sp). On the other hand, in the top there occurred massive medium- and coarse-grained sands with gravel accessory (lithofacies SGm). In the top part of the cone, 78 cm in thickness, there were numerous mud-balls, 3–8 cm in diameter, as well as pieces of wood, brick, construction materials and plant detritus. The character of the sedimentation points out that the initial stage of cone formation proceeded under sheet-flow conditions, which is documented by the occurrence of homogeneous lithofacies Sh sands in the bottom part of the sequence of deposits. Accumulation was taking place under supercritical flow conditions, corresponding (in transport of material) to the plane bed phase. A similar structure of the bottom part of flood deposits has been described by E.D. McKee *et al.* (1967). In the second sedimentation stage the flow was probably already partly channelled, evidence of which are the cross-stratified sands of lithofacies Sp and the sands and gravels of lithofacies SGm. Evidence of high flow energy and rapid deposition are the mud-balls laid in the deposit as well as the boulders up to 50 cm in diameter and fragments of the bridge construction found on the cone surface. A similar sequence of deposits has been found in other cone forms overlying point bars. Like in the case described above, they are characterized by reversed, and in

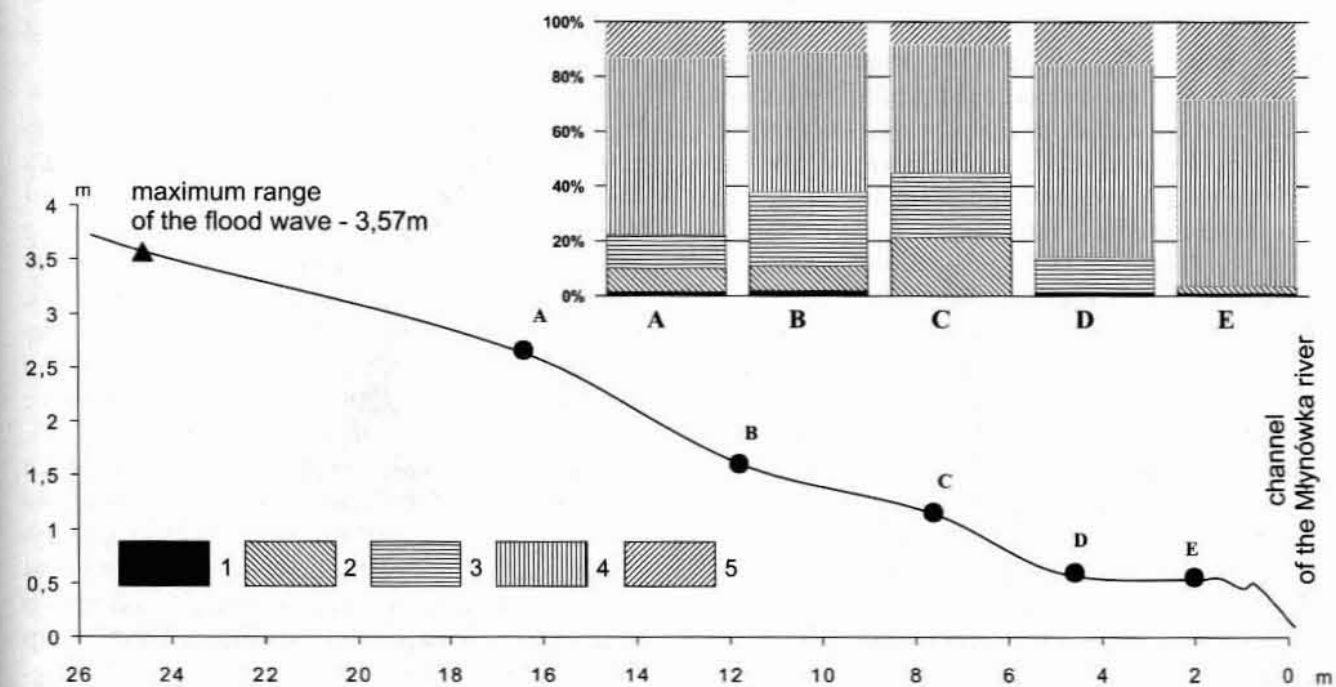
Fig. 8. Granulometric characteristics of deposits of sand covers in cross profile of the Młynówka valley (localization in Fig. 3B)  
 1 – gravel, 2 – coarse-grained sand, 3 – medium-grained sand, 4 – fine-grained sand, 5 – silt

rial ranging in thickness from 0.5 to 2 cm in the lower part of the slope to 20 cm in the valley floor. That deposit consists mainly of fine-grained sands. On the flat areas close to the channel there occur fine-grained sands with a considerable accessory of fine silts (Fig. 8). As we move away from the channel the material becomes coarser, most of it is medium- and coarse-grained sand. The presence of coarser fraction on higher, downsloping parts of the valley sides as well as the length and set of the lodged grasses are evidence of a considerable energy of the water in the course of flood wave falling. On flatter areas of the valley floor the fraction is finer, which is accounted for by a quieter type of sedimentation. After the waters had flown down into the channel, it was possible for the finest material to decantate in small depressions.

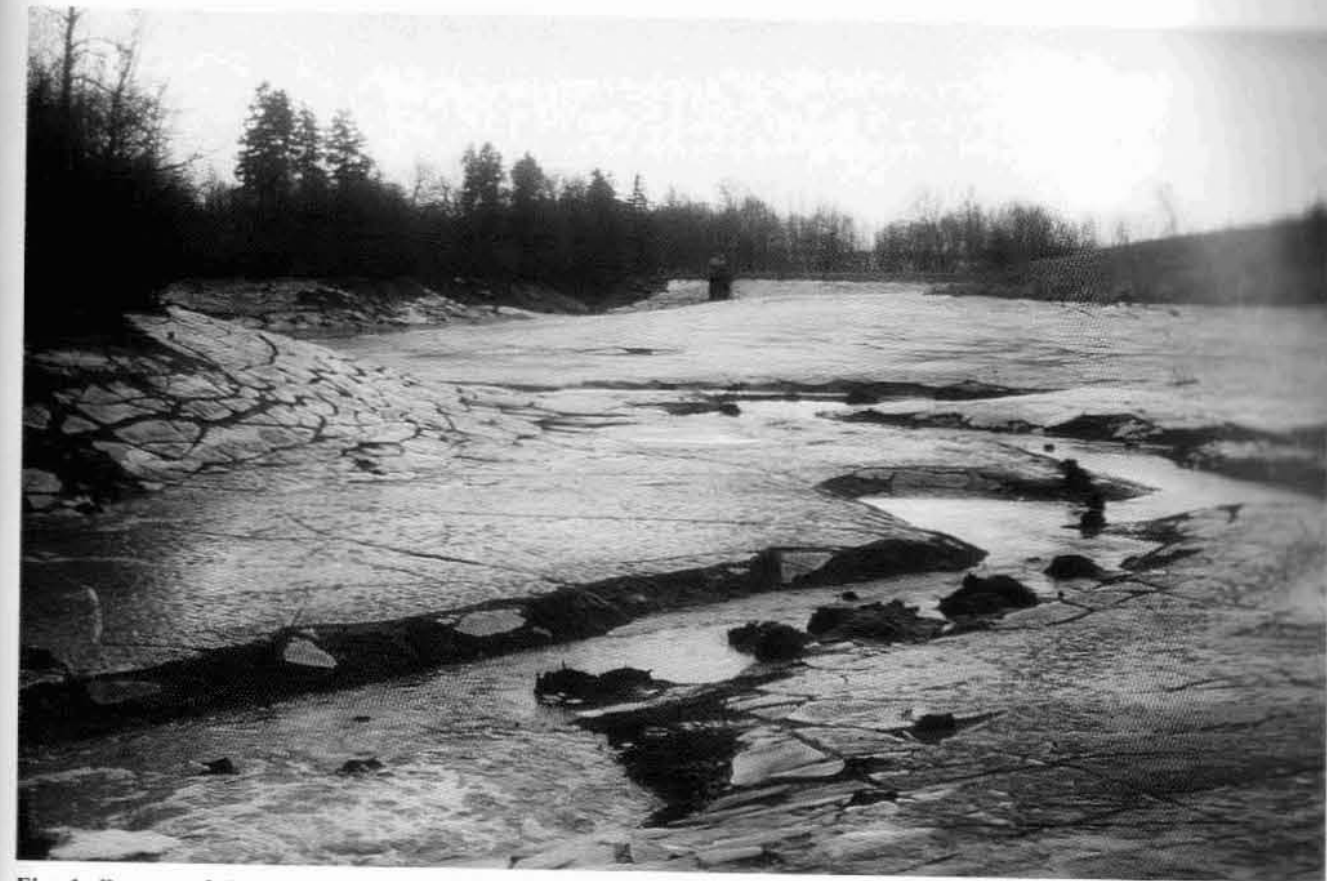
Fig. 1. Bottom of the Górowo reservoir after its catastrophic drainage on 4.02.2000

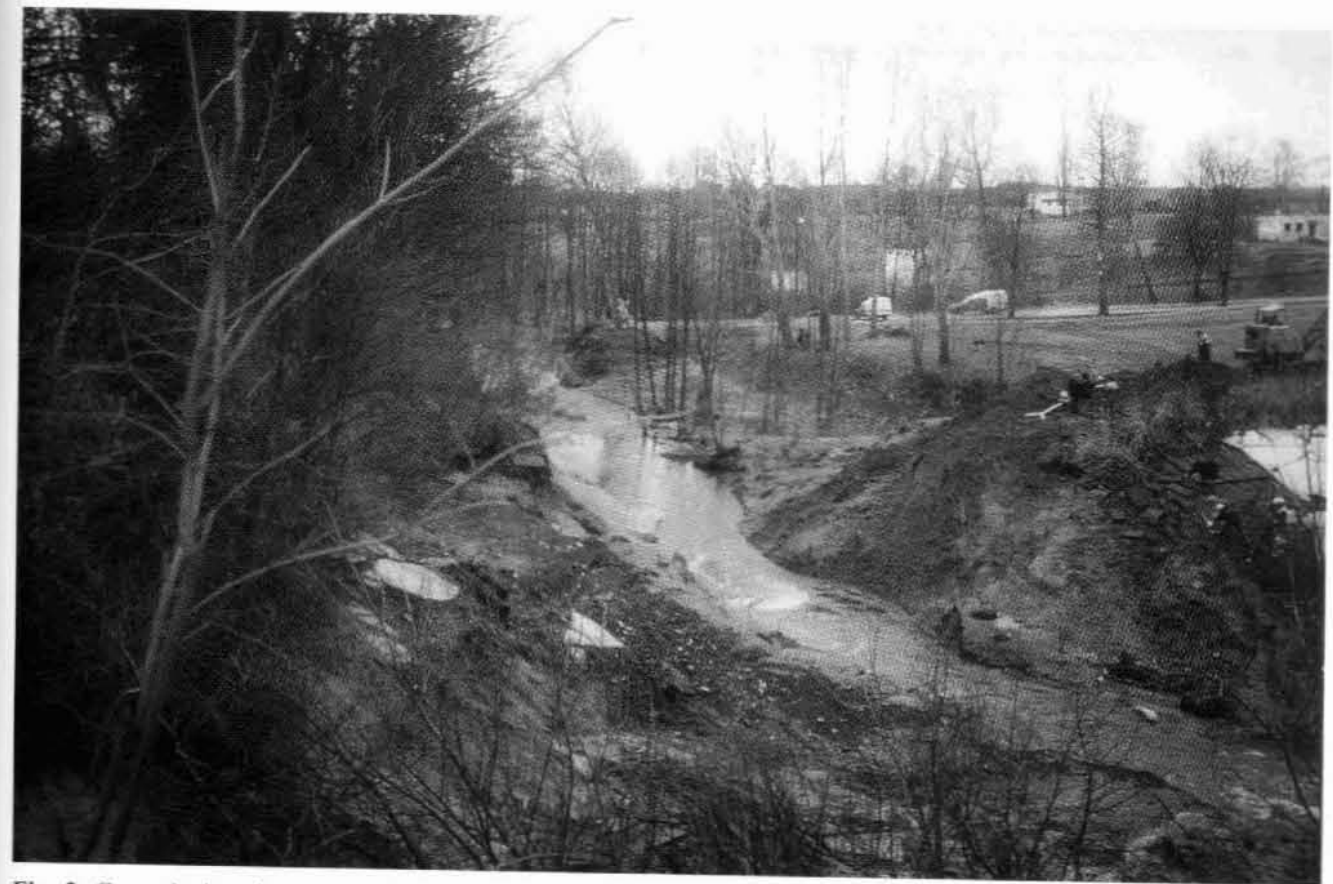
The direct cause of the dam breakage was the washing away of its crest, resulting from the fact that the permissible ordinate of water level in the reservoir had been exceeded. That situation to-

gether with a sudden thaw and rainfalls were conducive to the water flowing over the lowered part of the dam crest. The water flowing down the side of the dam caused its erosion, which weakened its stability and consequently led to its further being washed away. The resulting breach reaching down to the dam's base was 107 m<sup>2</sup> in area (Fig. 2). The breakage of the dam happened at about 0<sup>30</sup> a.m. on 3 February 2000. The flood wave moved very fast. As follows from the report of Powiatowy Sztab Kryzysowy (the local crisis headquarters), at about 1<sup>00</sup> a.m. the whole river valley within the town boundaries was under water (Fig 3A). According to estimates, the mean intensity of water discharge through the breach was ca 28 m<sup>3</sup>s<sup>-1</sup>. It can be assumed that the maximum values were much higher. The scale of the flood is demonstrated by the value of 1% flood probability, which has been assessed at 10.33 m<sup>3</sup>s<sup>-1</sup>, compared with the Młynówka's discharge just before the flood, which amounted to about 0.025 m<sup>3</sup>s<sup>-1</sup>. The mean velocity of the water discharge through the breach, calculated on the basis of the equation of the velocity of water discharge through a non-awash opening (Singh, Quiroga, 1988) was 4.1 ms<sup>-1</sup>. If we assume that, occasionally, the discharge velocity might have been greater, it would have allowed the transport of stones of considerable size. Levelling measurements have shown that the mean range of the flood wave was 3.3 m. There occurred, however, local backwater to 5 m associated with bridge sections of the river channel.

Fig. 2. General view down the river, in the foreground the broken dam

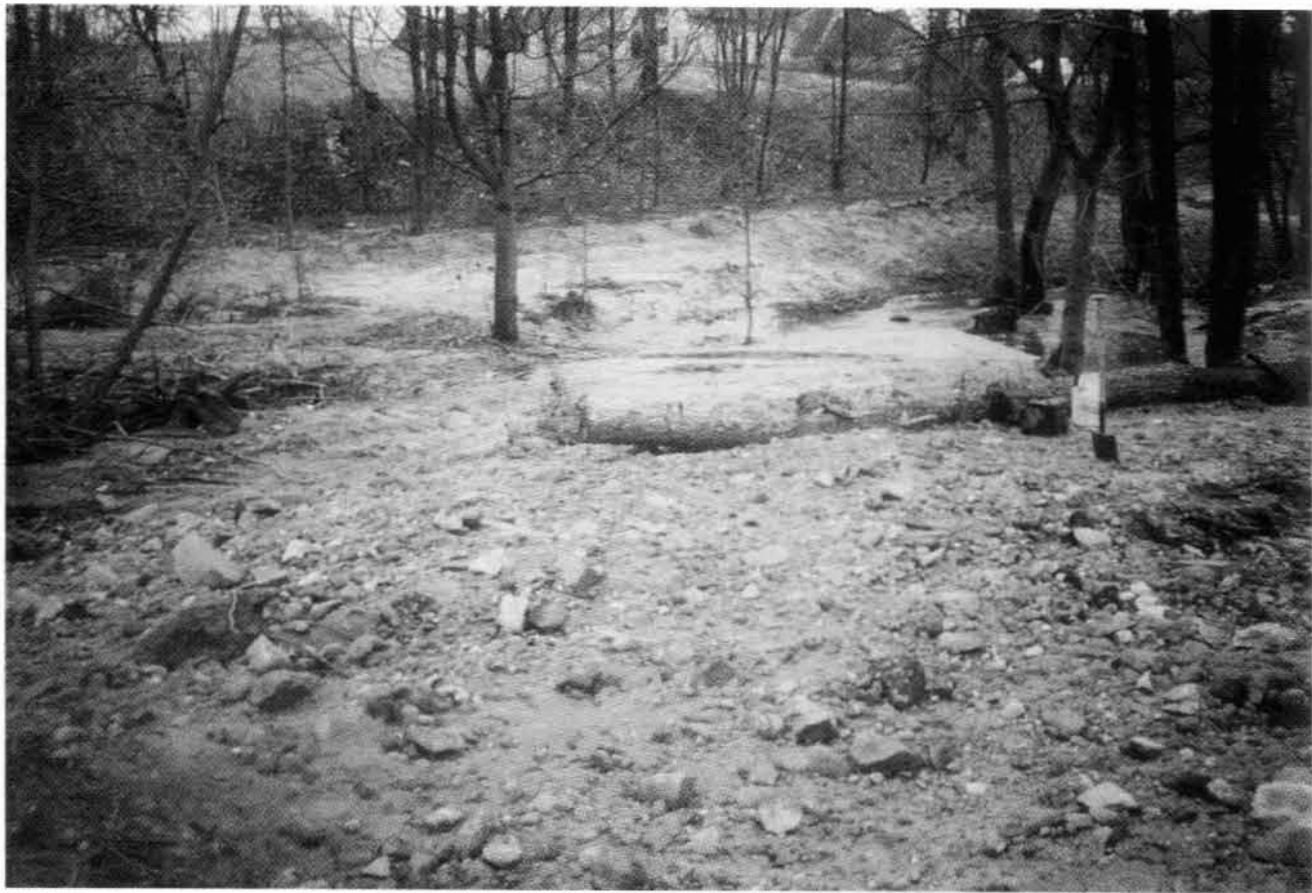
The effects of accumulative processes could be best seen in the most sinuous parts of the river. They have overlaid sandy-gravelly material onto fixed point bars in the Młynówka meanders. One of the best developed forms in that site is the delta cone, 23 m long up to 16 m wide and 1.6 m tall at the front, situated several dozen metres below the destroyed bridge (Fig. 3B, Fig. 4). Other accumulative forms are: crevasse cones, sandy shadows and sandy-silty covers deposited all over the flooded valley floor.

Fig. 4. Accumulative area of delta cone

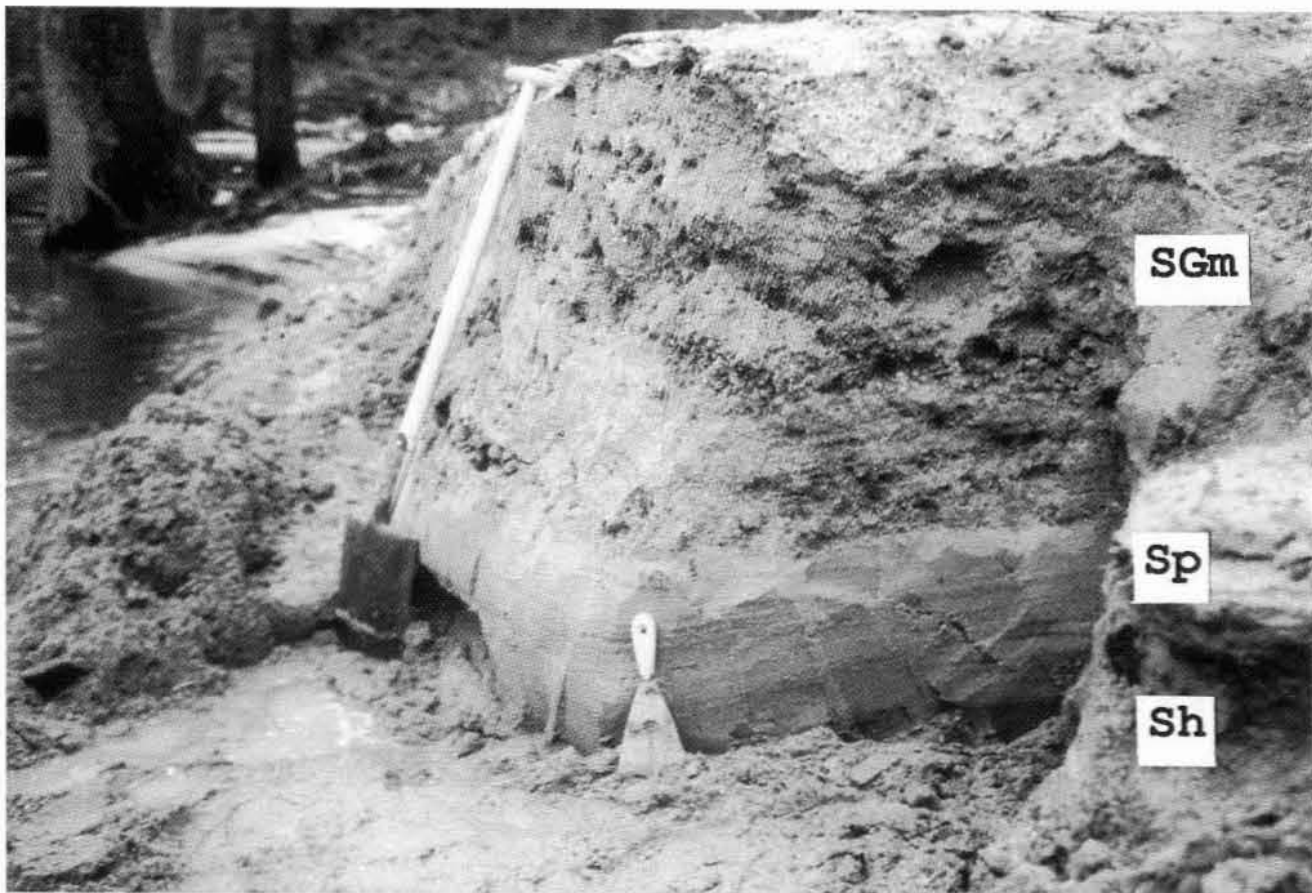
Fig. 5. Internal structure of delta cone front. For explanations of deposit sequence see Fig. 6

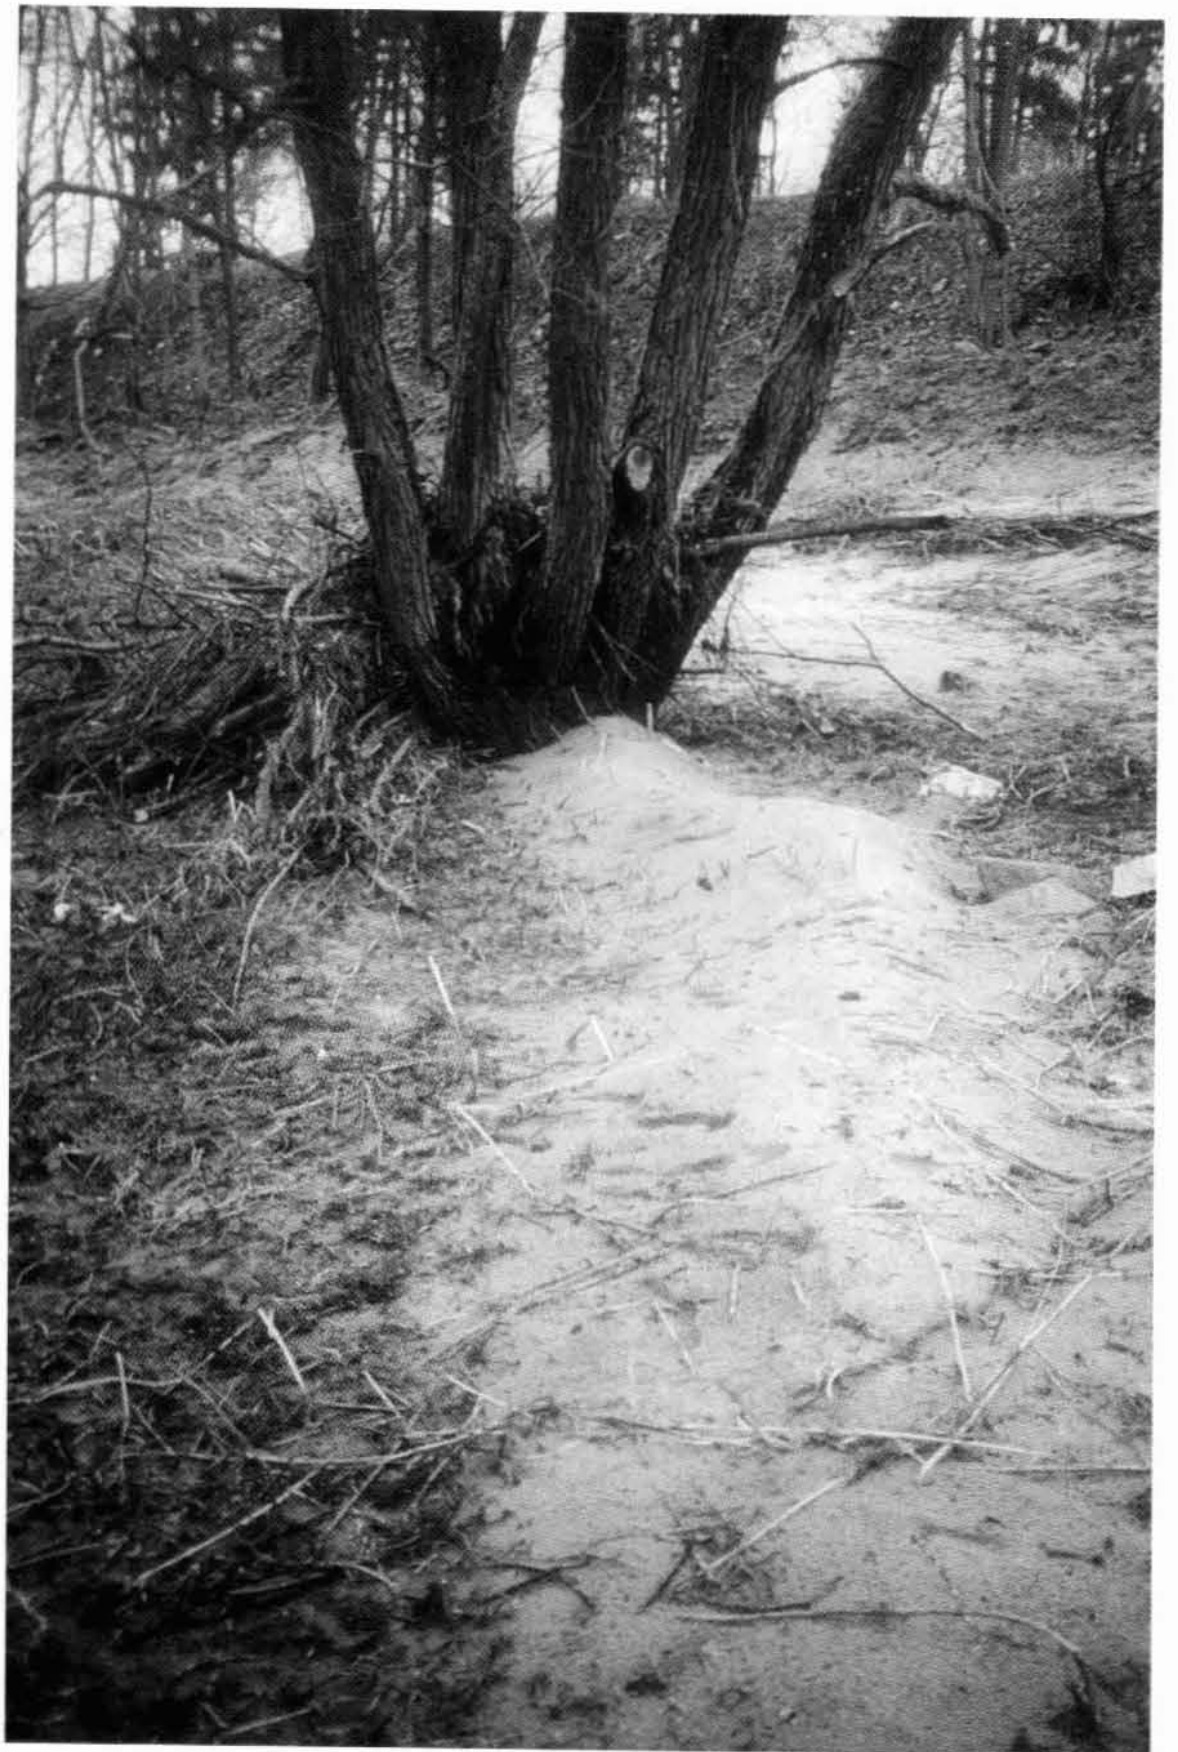
Fig. 7. Instance of deposition of sandy shadow behind an obstruction consisting of trees and plant jam
