MAREK INEROWICZ, BOŻENA JUSZKIEWICZ, MACIEJ WERNO

Department of Geoen지니어ing and Geoecology
Maritime Institute, Gdańsk

CLIFF RECONSTRUCTION AT JASTRZĘBIA GÓRA

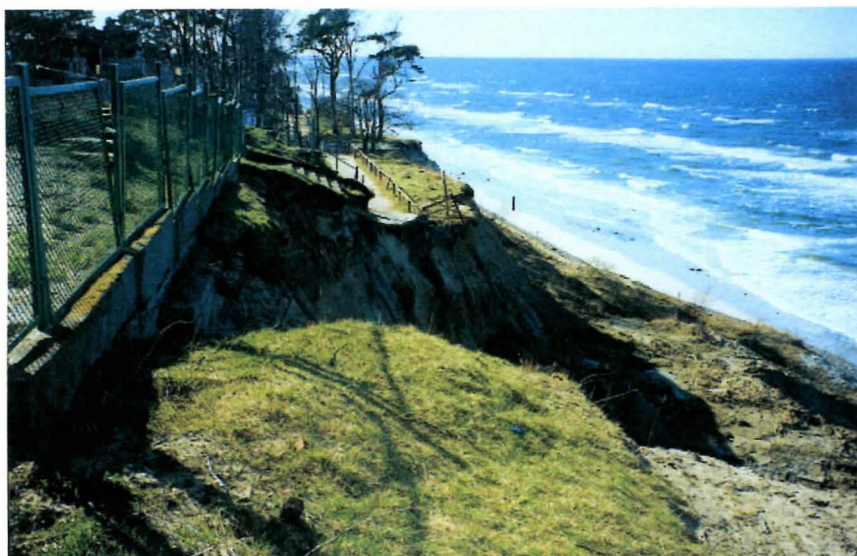
Fig. 1. Landslide in front of Villa "Mewa" – spring 1999

of the cliff became active, directly in front of recreation houses area, where the height of the cliff varies from 30 m on the east side (near the "Mewa" villa) to 20m a.s.l. at the Bałtycka Street. The first large landslide occurred in front of the Bałtycka Street, and resulted in a 5-metre retreat of the cliff edge. Then the neighbouring stretches became active, and a number of small surface slides took place. In spring 1999 the cliff edge retreated significantly in the region of km 134.315 of the kilometre of the Polish coastline. In effect, the promenade running along the cliff was destroyed, and the edge of the precipice moved to only 13 m from the nearest building – the "Mewa" (Figs. 1 and 2).

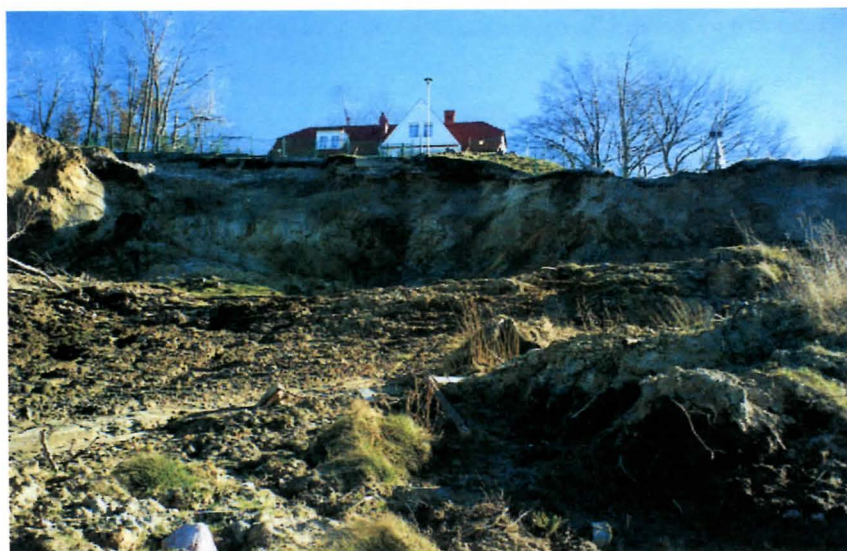
Fig. 2. Landslide viewed from the level of coluvium – spring 1999

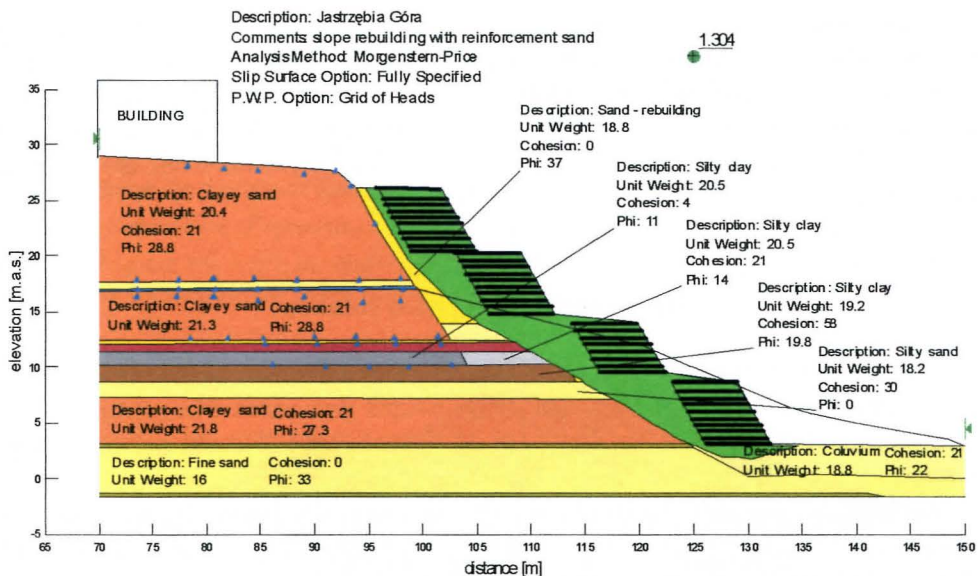
For such solution, the calculated coefficients of inner stability within reinforced soil blocks changes between 1.46 and 2.59, and the coefficients of stability for the soil wedges were 1.98 and 1.46 respectively. Calculations of global stability for the slip surface running outside the reinforcing system of the slope gave $F_{\min} = 1.3$ (Fig. 5).

Fig. 5. Characteristic cross-section assumed for calculations of cliff stability after the reconstruction – global stability

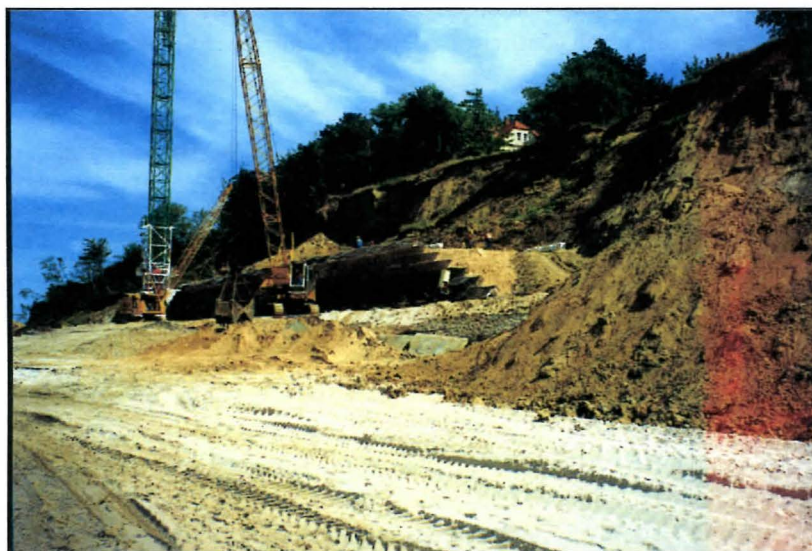
Fig. 6. Construction of block 'A'

5. Placing of consecutive layers as in p. 4 until block 'A' is formed (Figs. 6 and 7).
6. Constructing blocks 'B', 'C' and 'D' in a similar way, maintaining the continuity of draining cuts under block 'C' (Fig. 8).

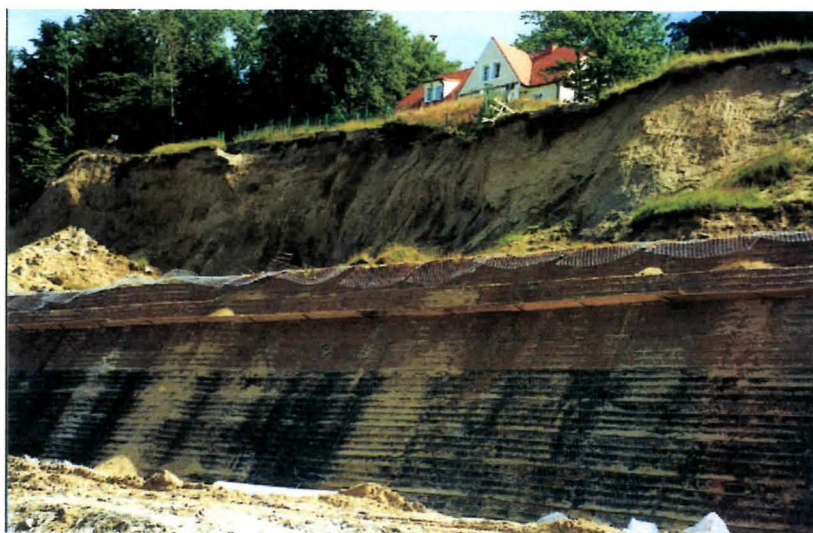
Fig. 7. Outer slope of block 'A' – the Green Terramesh system

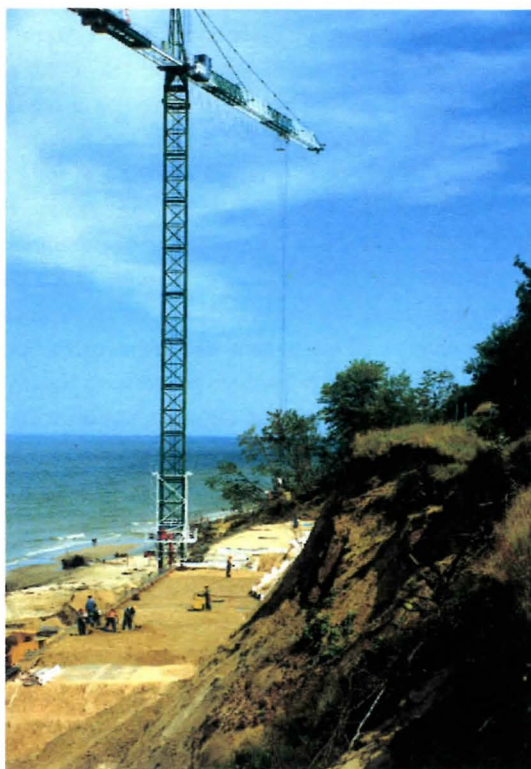
Fig. 8. Beginnings of work on block 'B'
