DRAGANA NIŠIĆ*[#], DINKO KNEŽEVIĆ*, NIKOLA LILIĆ*

ASSESSMENT OF RISKS ASSOCIATED WITH THE OPERATION OF THE TAILINGS STORAGE FACILITY VELIKI KRIVELJ, BOR (SERBIA)

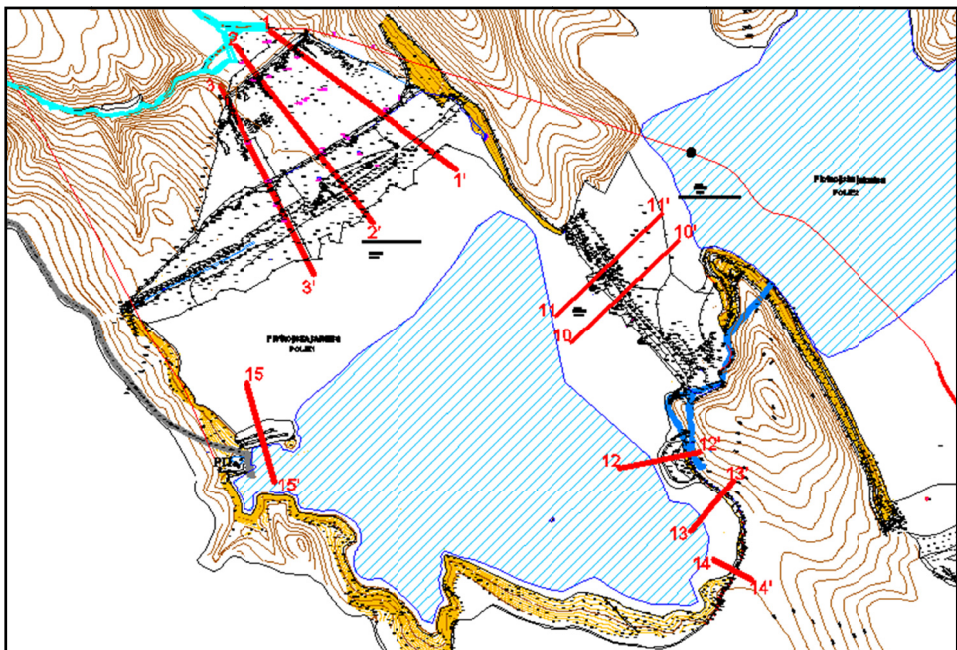
Bishop and Janbu methods were used to calculate the stability of the TSF (Table 6). Input data are shown in Table 5 and land profiles are shown in Figure 3.

After comparing these results it is possible to infer that the factor of safety obtained for dynamic loading is within the prescribed values, which confirms the stability of the TSF Veliki Krivelj in case of possible earthquake events (Institute for Standardization of Serbia, 1980; MMI Bor, 2016). Therefore, the likelihood of seismic hazard scenario is negligibly small, according to the table 1.

Fig. 3. Field 1 – TSF Veliki Krivelj with land profiles and corresponding stability calculations

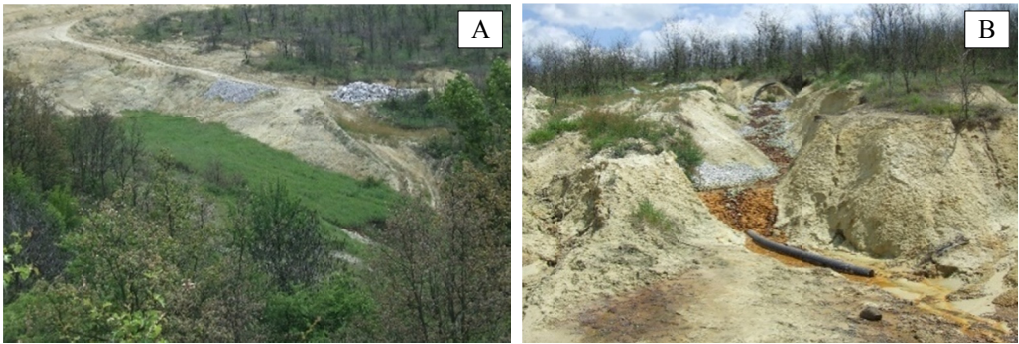
3. At embankment 1 there are 2 drainage systems, and the lower drainage system was noticed to function poorly, while the upper drainage system is out of operation and it is practically impossible to restore it. This situation causes the elevation of seepage water levels, erosion on the outer slope and therefore embankment instability (Fig. 5). The likelihood of failure due to drainage system malfunctioning is high.

Fig. 5. A specific phenomenon occurring at the outer embankment slope 1: (A) lush grass in the humid zone, (B) gully formed by water discharged due to non-functional drainage

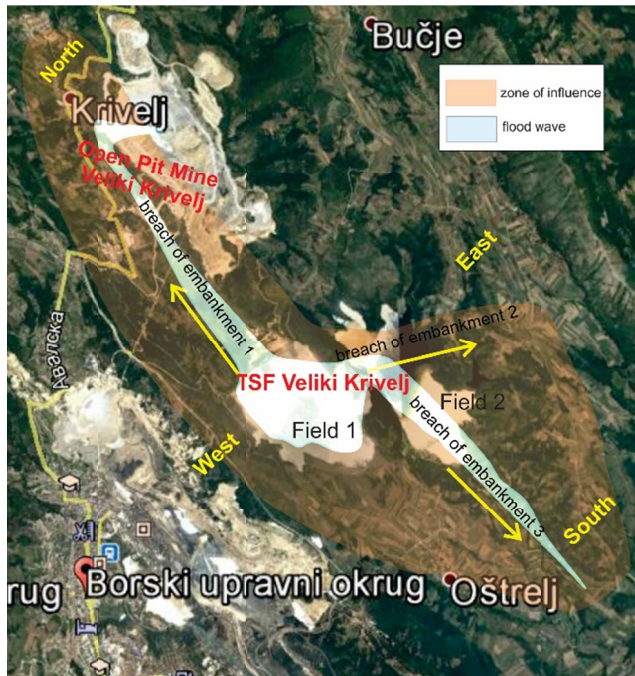
With regard to tailings slurry travel distance after discharge it is very difficult to determine how far it will “advance” in the event of failure. For this purpose, we used a simple qualitative assessment method called Zone of Influence. The Zone of Influence is the area that could be affected by the slurry flood wave. The limits of this zone for TSF shall be determined as follows (Blight, 2009):

Fig. 4. The Zone of Influence at the TSF Veliki Krivelj

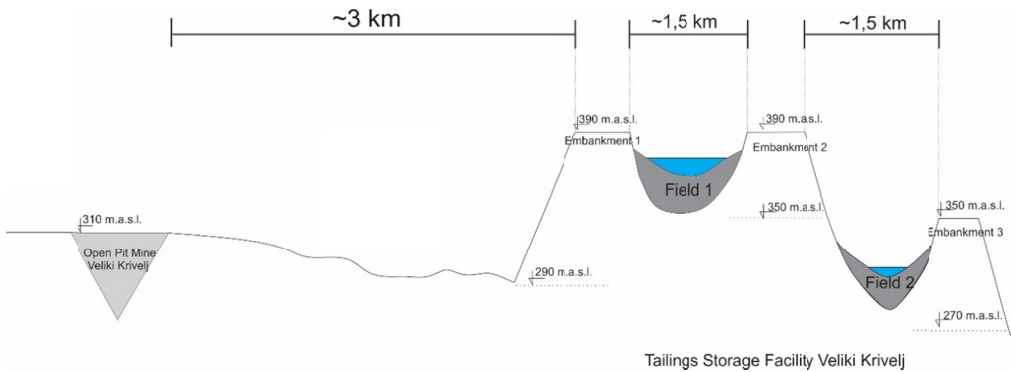
In the event of breach or slurry spillage over the crest of embankment 1, the flood wave would practically take on the one-dimensional model of movement and would necessarily reach the Open Pit Mine Veliki Krivelj. Since the mine site is located at a lower altitude than the TSF (Fig. 5), and considering the low resistance of the land relief, across which the flood wave is moving, the wave would eventually flow into the mine site.

Fig. 5. Position of the TSF Veliki Krivelj relative to the Open Pit Mine Veliki Krivelj (not to scale)
