# ŁAZIENKOWSKI BRIDGE FIRE IN WARSAW – STRUCTURAL DAMAGE AND RESTORATION METHOD

H. ZOBEL<sup>1</sup>, W. KARWOWSKI<sup>2</sup>, M. WRÓBEL<sup>3</sup>, P. MOSSAKOWSKI<sup>4</sup>

On the 14th of February, 2015, a huge fire broke out on Łazienkowski Bridge; a five span bridge, 423 m long and 28 m wide, built in the years 1972-74. It was a fully steel structure with four plate girders and orthotropic deck. The fire started under the first span during the replacement of wooden service decks. The next day, the Department of Bridges of the Warsaw University of Technology was designated to conduct an expertise material investigation, geometrical verification, and FEM model analysis. The subject of this paper concentrates on geometrical issues. The main difficulty of this task was the lack of full reference data regarding the bridge's original structure. The old design was incomplete and there was no actual surveying results for the undamaged structure. As a conclusion, some remarks focused on surveying measurements and on the final decision regarding this bridge are given. It was eventually exchanged into a brand new one and put into public use on the 28th of October, 2015.

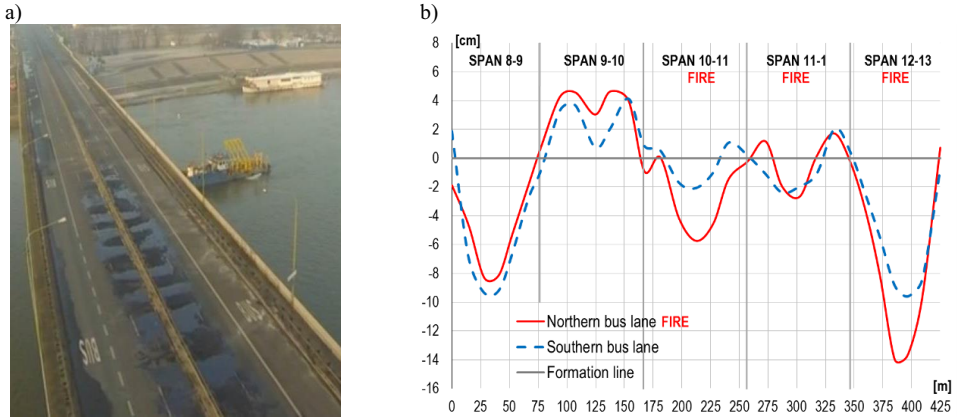
First, there was enormous noticeable damage to the deck; extensive, deep bulges of the plate of the orthotropic deck in the central part of the traffic lanes (Fig. 3 a). In the span 12-13, values of local differences were up to 30 cm, mostly around 15-20 cm. From the bottom view of the deck there was a visible loss of stability of the longitudinal ribs. This kind of damage was observed in the area of the deep bulges of the orthotropic deck as well as in the area without those bulges. The plate on the bus lanes was locally flat and no damage of insulation and asphalt pavement was observed. Only upon further surveying the measurements showed that this part of the structure was also deformed as noted by the shape of the strong deflected girders (Fig. 3 b).

Fig. 3. First view of the damaged structure: a) top view of destroyed central part of traffic lanes and deceptively undestroyed bus lanes [www.gazeta.pl], b) comparison of the bus lane formation lines

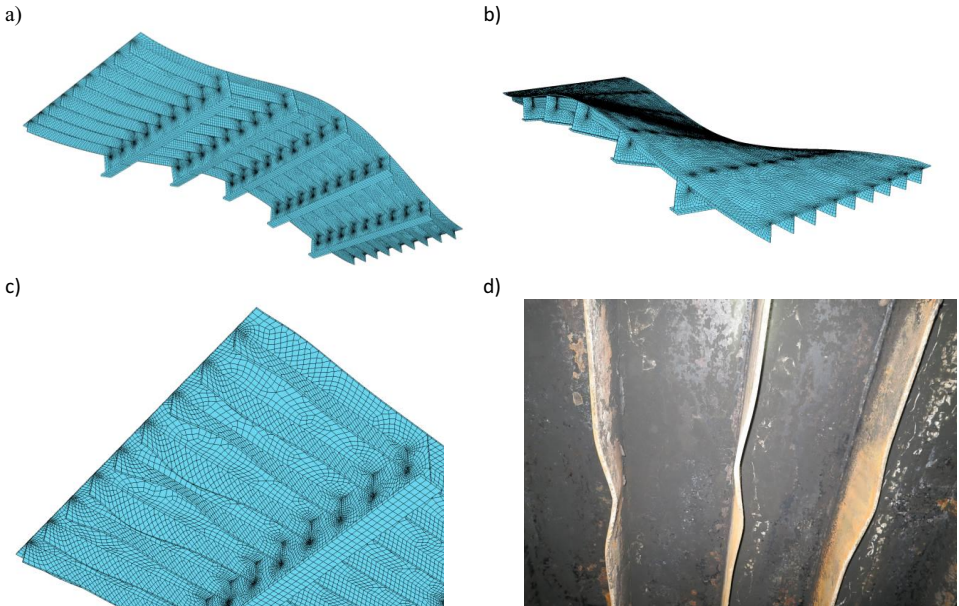
FEM analysis (with simplified boundary conditions – only local actions) was done to determine the internal forces which could cause observed displacements. The results showed different forms of local failure (Fig. 5 a, b c), which could be found on the real structure (Fig. 5 d).

Deformations of the plate and of the longitudinal ribs of the orthotropic plate „pulled” the cross-beams alternately; first one up, and the next one down.

Fig. 4. Loss of stability of the orthotropic deck: a) FEM analysis in temperature 100°C-115°C – bending form of loss of stability, b) FEM analysis in temperature 115°C-125°C – bending-torsion form of loss of stability, c) FEM analysis in temperature 150°C-175°C – warping of longitudinal ribs, d) real warping of longitudinal ribs of bus lane part

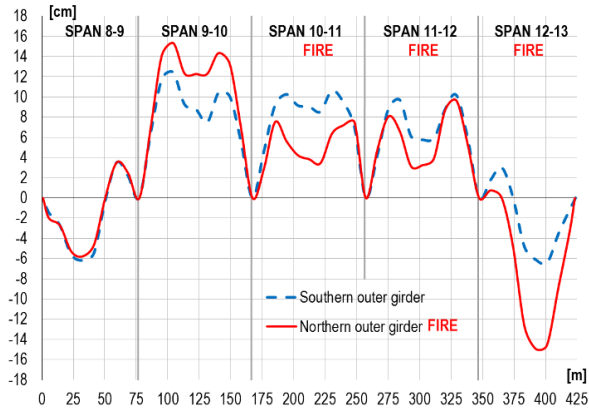
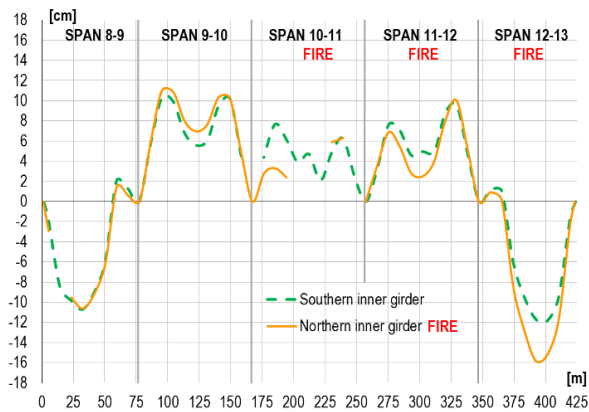
Excessive deflection of the two northern girders was observed. The northern external girder was lower comparing to the southern one by 58 mm, 32 mm, and 81 mm, for spans 10-11, 11-12, and 12-13, respectively (Fig. 5 a). The northern internal girder was lower comparing to the southern one by 46 mm, 22 mm, and 33 mm for spans 10-11, 11-12, and 12-13, respectively (Fig. 5 b).

Fig. 5. Comparison of girders deflection: a) external , b) internal (some data was impossible to collect because of impeded visibility of bottom flange)

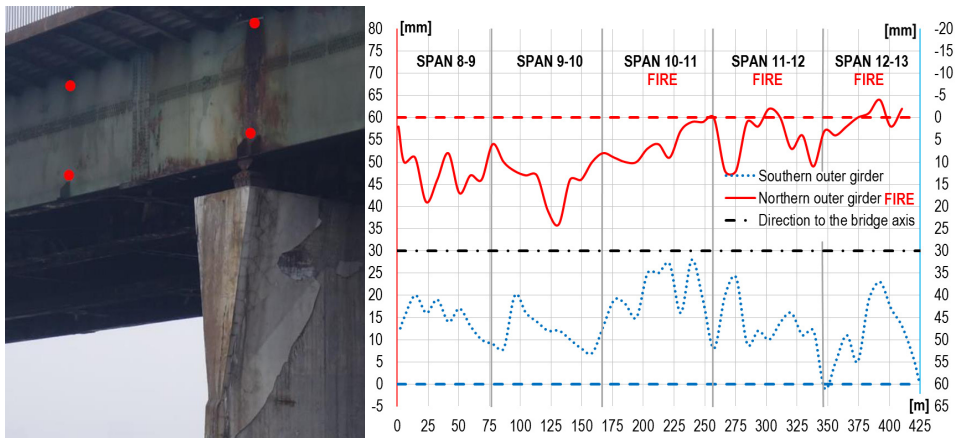
As a result of the fire there was a torsional deformation of the whole cross section of the bridge in spans 10-11, 11-12, and 12-13, a result of the shrinkage of the total steel structure in the transverse direction, and deflections or bulges of particular elements of the orthotropic deck. The initial shape of the cross-section was symmetrical, and both pairs of girders were slightly inclined to the longitudinal axis of the bridge (which showed the shape of two undamaged spans) after years of work. Surveying after the fire showed that the southern girders rotated in the direction toward the longitudinal axis of the bridge, and the northern girders rotated in the direction opposite to the longitudinal axis of the bridge. Finally, the northern girders in all three spans affected by the fire remained straight, with the southern more inclined (Fig. 6). The total cross-section of the bridge was asymmetrical – “skewed” in the northern direction – and as a consequence the loss of stability of the whole structure was very possible.

Fig. 6. Verticality checking of outer girders: a) example of the measurements points, b) results for the whole structure

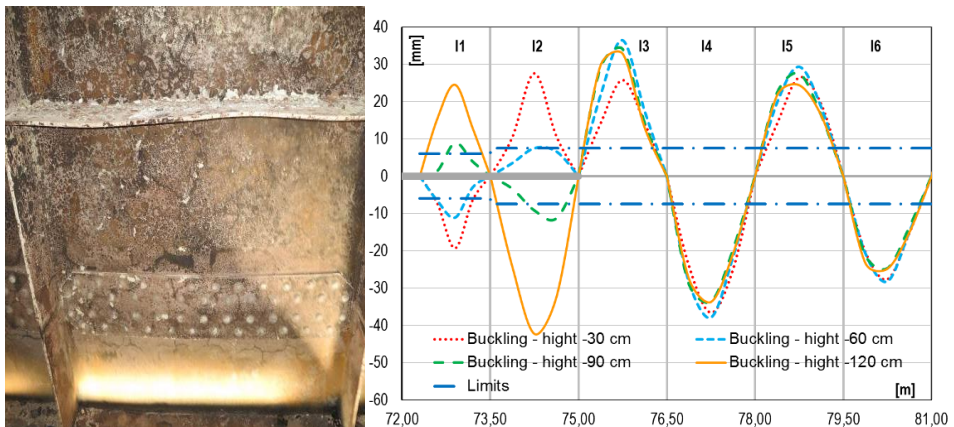
More serious damage to the girders was discovered when it was possible to go under the deck in the close proximity of the girder web. Extensive local bulges of the webs in the internal girders were noticed and later measured. For the northern one (which was most exposed to fire), the curvature was bigger than 40 mm at a distance of 1500 mm (Fig. 7 b). The maximal measured bulges of the northern internal girder were 43,1 mm at span 10-11 and 41,2 mm at span 11-12.

longitudinal ribs was also not linear. The web of the girder lost stability for more than 1500 mm of distance. A comparison of values of standard permissible deformations against measured ones showed that the steel structure was in a state of emergency. Large deformations („waving”) of horizontal ribs stiffening in the upper part of the webs of the internal girders (Fig. 7 a) were also observed.

Horizontal and vertical ribs did not prevent a change of the geometry of the web. High temperatures caused „waving”, thereby losing stability. The damage was much more extensive in the northern girder. An adjacent cold water pipeline secured the southern girder, consuming quite an amount of heat generated by the fire.

Fig. 7. Failure mode of the girders webs: a) picture of local bulges of the web and deformations of the horizontal ribs, b) local bulges of the 9 m long part of the girder 10-11 – values for level of measurements 30/60/90/120 cm below the deck

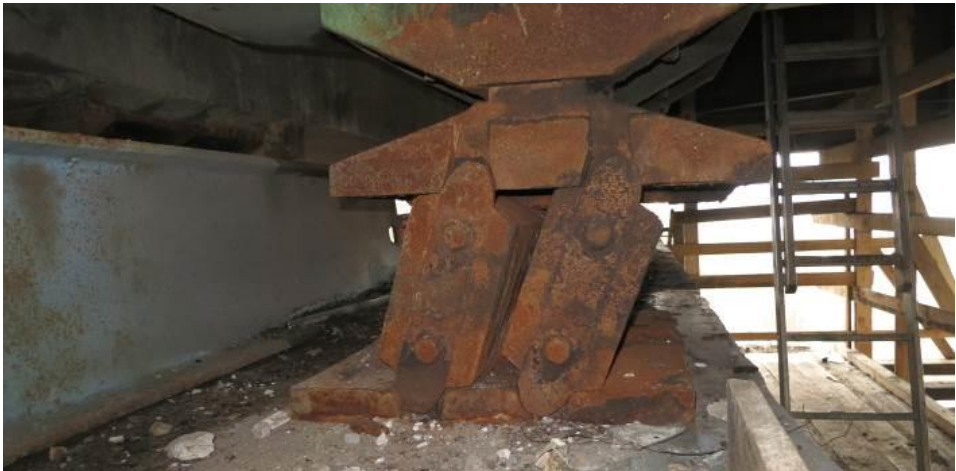
Serious damage was observed with bearings as well; there had been excessive rotation of bearings on three piers (11, 12, and 13).

The bearings on pier 13 reached the maximal permissible angle of rotation (Fig. 8) caused by elevated temperatures, which changed the geometry of the steel superstructure. In the case of extreme low temperatures, there was a risk that span 12-13 could fall down. It was winter and the probability of occurrence of temperatures of  $-25^{\circ}\text{C}$  is high.

Fig. 8. Maximum permissible rotation of the bearing on the pier 13

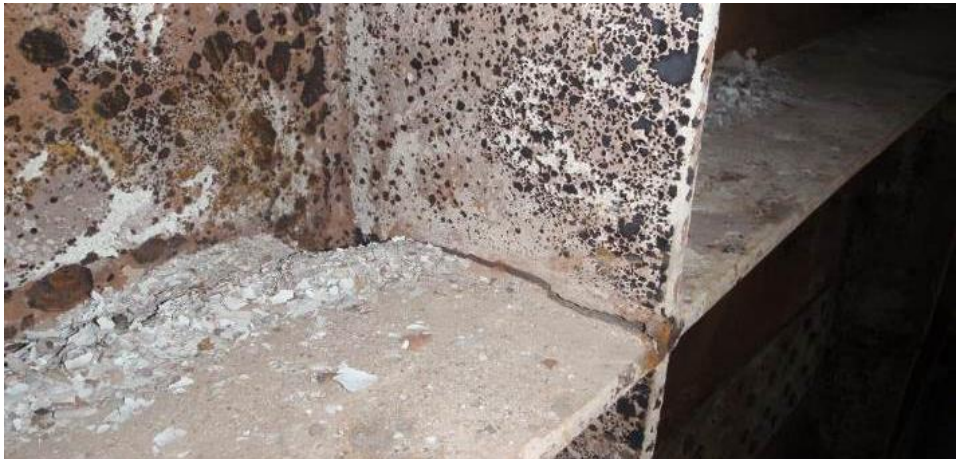
There was a lot of other damage observed, mostly damage of equipment. But there was also very local structural damage such as cracks of welds or shearing of rivets. For example, the investigation found several cracks of welds connected to the vertical ribs with cross-beams of the orthotropic deck (Fig. 9) and with the horizontal rib stiffening web of the internal girders. Many of the rivets were sheared in assembly joints between the cross-beams and the internal girders and in the joints of secondary elements in all three spans. Inventorying all this damage was impossible in reasonable time. Fortunately it would be necessary only in the case of maintenance, which was finally rejected.

Fig. 9. Typical crack of weld
