The analysis of temperature disintegration on the body of fuel injector during research on test bench

Key words: *infrared camera, Common Rail system injector, injection and return dosages, fuel high pressure pump, CI engines*

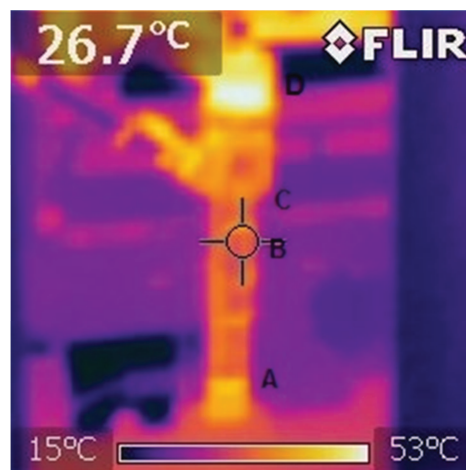
Figure 2 presents electromagnetic Bosch fuel injector researched infrared camera during test bench. There has been marked on the figure precision element on injector needle (A), fuel injector steering valve (B), valve sealer (C) and fuel injector coil (D). It is noticeable that higher temperature is on precision elements due to leaks and in the solenoid.

Fig. 2. Electromagnetic Bosch fuel injector on the infrared camera picture during test

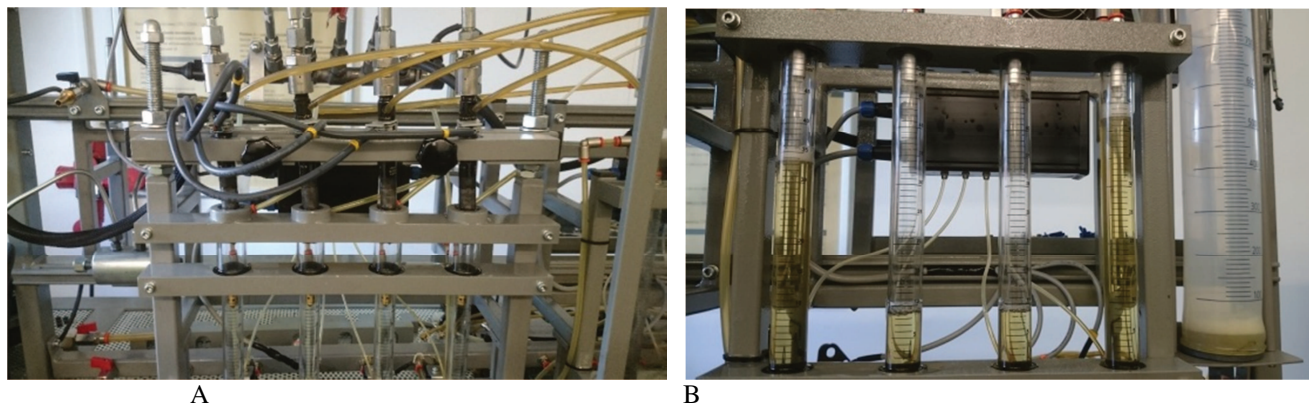
Table 1 shows standard test of researched fuel injectors. There is noticeable that injectors 1 and 4 are damage. There are huge return dosages what influence on theirs parameters. Figure 7 presents test bench STPiW 3 with researched Delphi injectors and magnitude of return dosage test. There was taken two injectors third and fourth during researches with infrared camera. Studies has been taken into consideration two areas of injectors body nozzle (Fig. 8, 9) and steering valve with coil (fig. 10, 11). Tests have been made with 50, 80, 110 and 140 MPa system pressures. Figure 12 presents measured return dosage by pressure 140 MPa for faulty and good working injectors. There is noticeable in all instances considerable difference temperatures between injectors. Figures 13 and 14 present damage fuel injector precision elements: needle and steering valve.

Fig. 7. A – researched fuel injectors on test bench STPiW 3, B – the magnitudes of return dosages researched fuel injectors

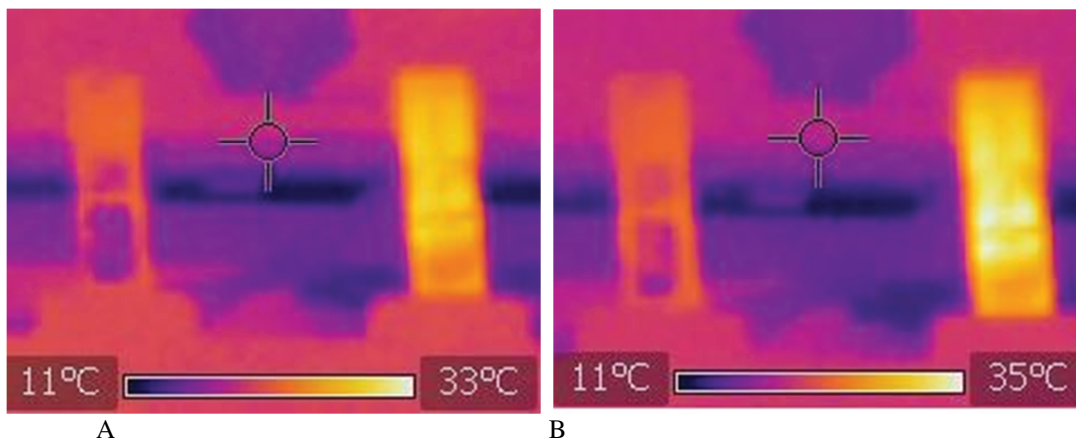
Fig. 8. Pictures of nozzle areas from infrared camera for third and fourth injectors: A – fuel pressure 50 MPa, B – fuel pressure 80 MPa

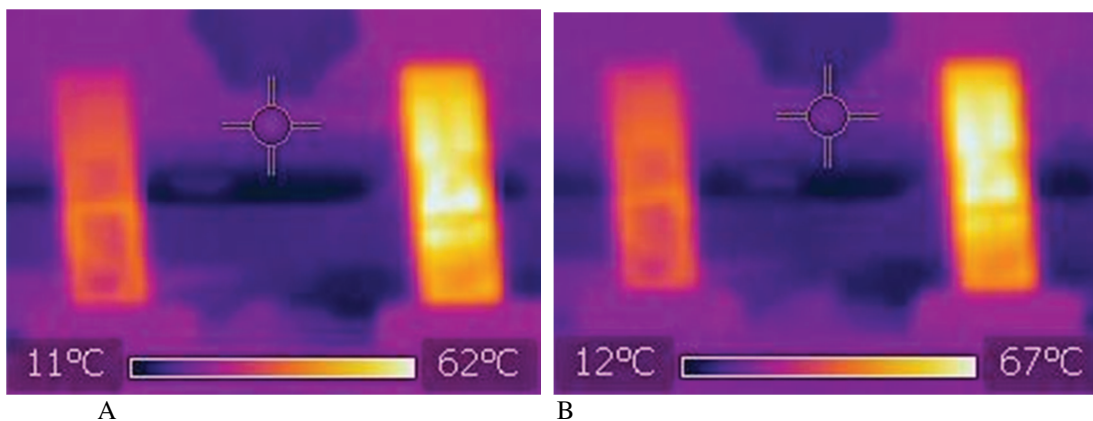
Fig. 9. Pictures of nozzle areas from infrared camera for third and fourth injectors: A – fuel pressure 110 MPa, B – fuel pressure 150 MPa

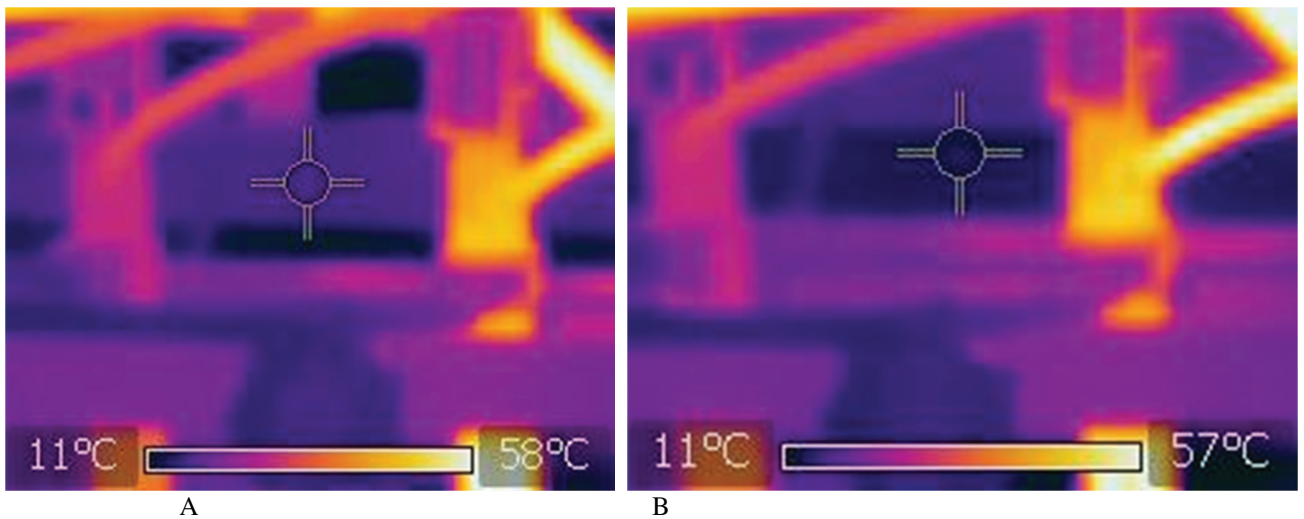
Fig. 10. Pictures of steering valve and electromagnetic coil areas from infrared camera for third and fourth injectors: A – fuel pressure 50 MPa, B – fuel pressure 80 MPa

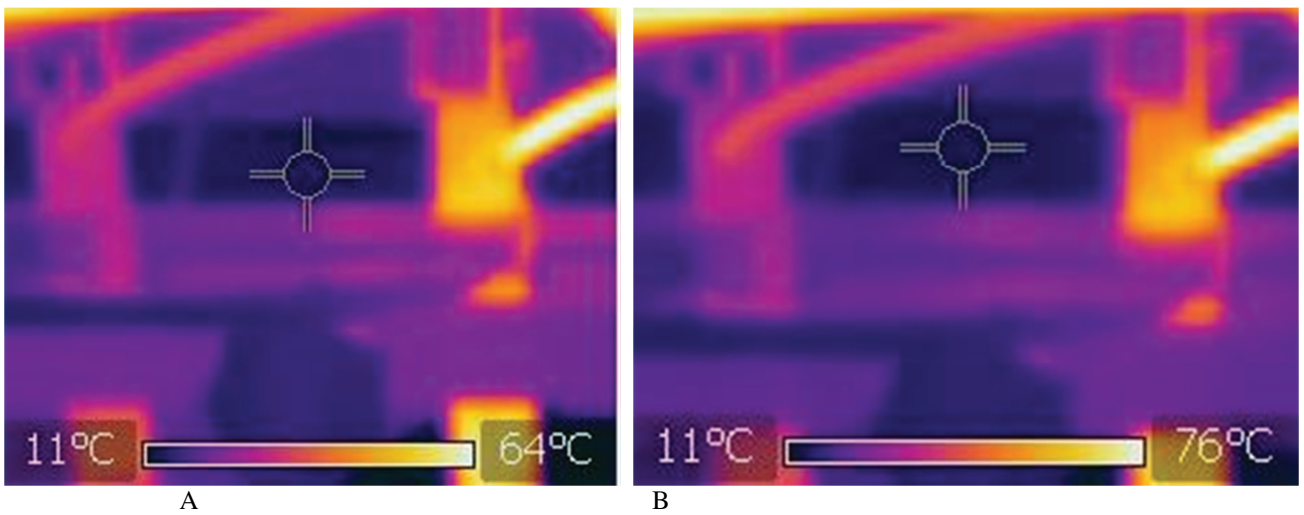
Fig. 11. Pictures of steering valve and electromagnetic coil areas from infrared camera for third and fourth injectors: A – fuel pressure 110 MPa, B – fuel pressure 140 MPa

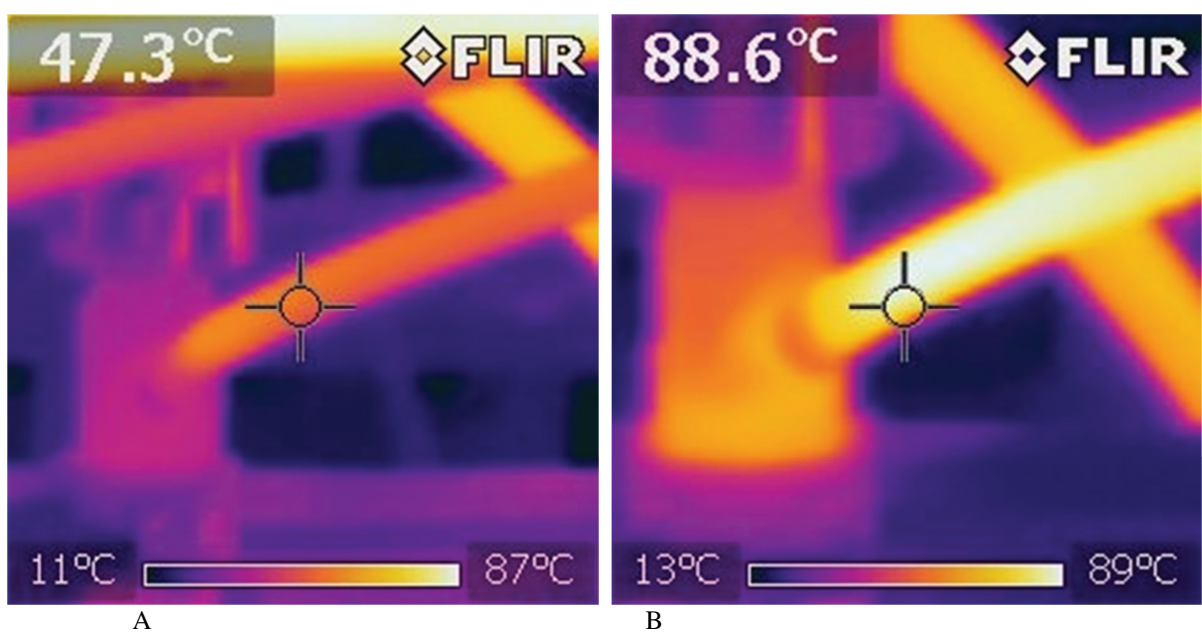
Fig. 12. Temperature of return dosage: A – correct fuel injector, B – faulty fuel injector

It is possible to state during analysis of research results that infrared camera could be useful during researches fuel injectors on the test bench. There happen very often that fuel injector is researched and the standard test shows its damage but engineer don't know where it occur. Fuel injector has few areas: nozzle with needle, steering valve with sealer and coil. When return dosage is too high it is hard to determine where the fault occurs. There is possibility to disassemble injector and use microscope to check precision elements but sometimes it is hard to find where the leaks are. It is easy to change all elements but then repair costs increase. Using infrared camera is very effective method without invasion of diagnostic during researches. There have been researched two areas of injectors during test. The first area was injector nozzle area. If the precision element on the injector needle is damaged it will increase leaks. Temperature would be higher there (Fig. 8, 9). Infrared camera registers it. The same situation is with steering valve. Figure 12 presents the temperature difference between good working and faulty injectors. Return dosages amount $119.40 \text{ mm}^3/\text{H}$ for faulty fuel injector and $38.26 \text{ mm}^3/\text{H}$ for good working by 160 MPa test pressure. This difference is visible on infrared camera because the faulty injector has temperature of returning fuel 88°C (361 K) and

good working 47°C (320 K). This is the result of internal leaks caused damages precision elements. The return dosage temperature increased about 87% by system pressure 160 MPa. For lower pressures 80 MPa temperature increased about 40%.

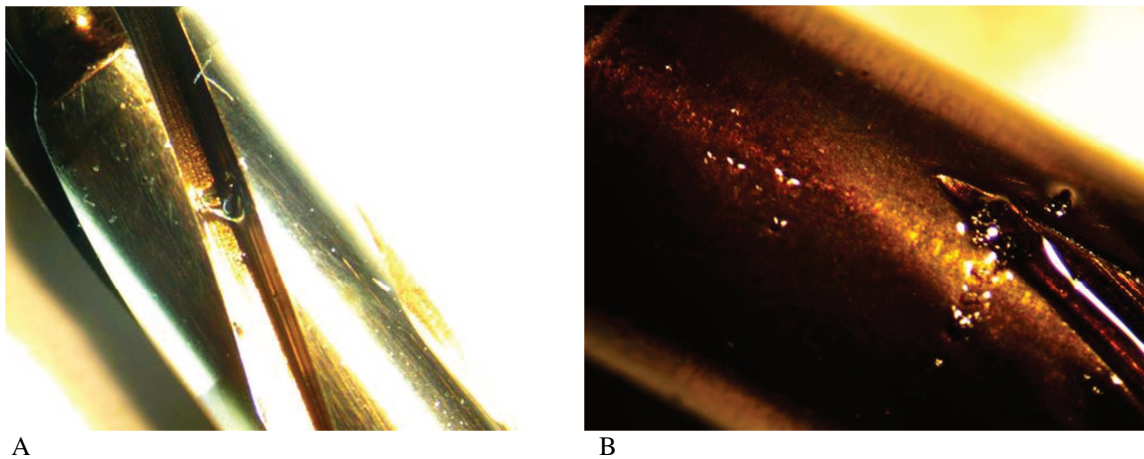
Fig. 13. A, B Precision elements on damage injector needle

Figure 13 and 14 show damages precision elements. There are noticeable a lot of pollutants, metal filings, corrosion, temperature damages and pieces of fuel filter. Metal fillings come from fuel injection pump. In this case diagnostic process was very easy. Everything were visible. But sometimes there are instances where theoretical all elements are in norms but injector leaks. Using infrared camera to find this area is very helpful. There were researched injection fuel temperature on the test bench and fuel return dosages temperature for good working and faulty injectors. Injection temperatures were similar for both but return various due to leaks. The measurements have been carried starting through 40°C intake fuel to injectors. Then has been made one fuel injectors standard test to stabilize the temperature inside. After the test is it possible to make researches by using infrared camera. There is possibility to use this method to all modern fuel injectors. Every electromagnetic and piezoelectric fuel injectors start to heat during inner leaks.

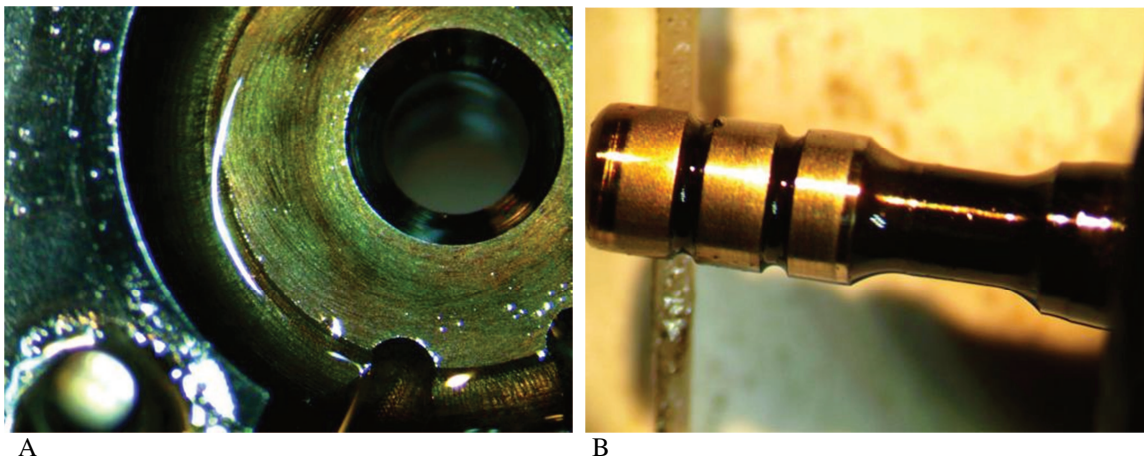
Fig. 14. Damage injector steering valve A – valve section, B – piston
