## THERMAL FATIGUE PROBLEMS OF TURBINE CASING

Lucjan Witek

### **Abstract**

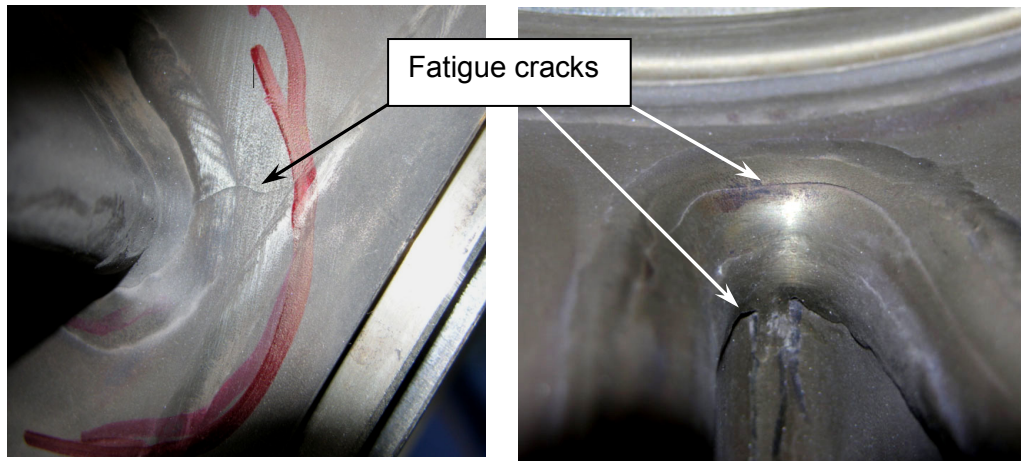
This paper describes a case of premature fatigue failure of turbine casing of the aero-engine used for drive of PZL-W3 “Sokol” helicopter. In this engine, some problems related with cracks appearance and premature fatigue fracture of the connection between deflectors and outer cylindrical casing were occurred (Fig. 2-4) [4]. Explanation of this problem is not easy on the experimental way. An answer on the question about fracture of casing can give numerical stress analysis.

Fig. 2. Fatigue cracks detected under obligatory inspection of engine [4].

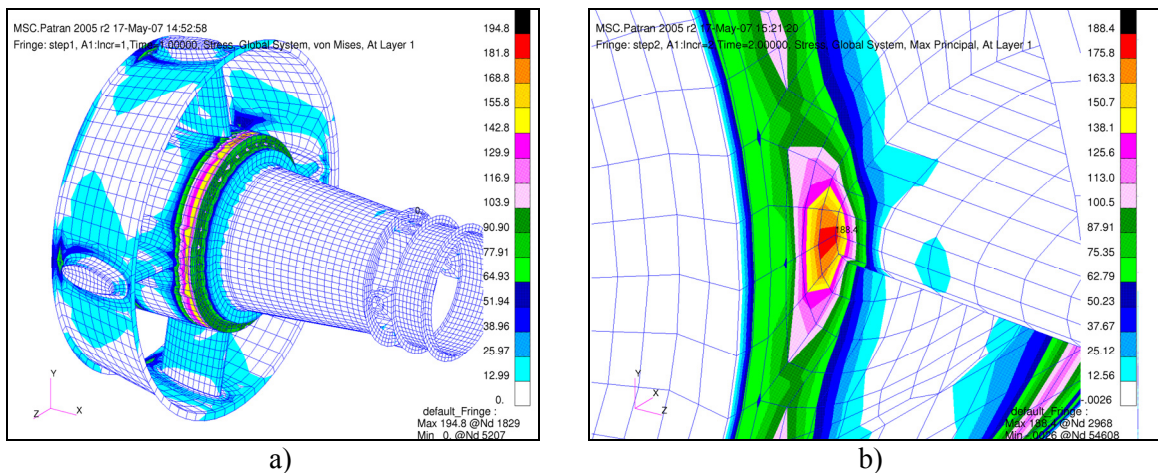
Fig. 7 shows, that the tensile stress in the critical region where the cracks appeared (connection between deflectors and outer cylindrical casing), achieves 188 MPa (Fig. 7). Under loading, the outer cylindrical part of casing is strongly distorted (Fig. 8). By specify two load components it was possible to estimate which load has more impact on the premature fatigue failure of casing. As seen in Fig. 9 and 10, the thermal stresses observed in the model are about two times larger than the mechanical stresses.

Fig. 7. Von Mises stress distribution for the casing (a) and maximum principal stress values in the critical region of component (b).

- The stress in the critical zone where the first fatigue crack occurs (Fig. 7) was at about 180-190 MPa. This value is close to the yield stress of the material (220 MPa for temperature 200°C). The cyclic variation of stress in this critical zone was reason for fatigue crack arising.
- The thermal stresses observed in the model were about two times larger than the mechanical stresses (Fig. 9 and 10). Based on this information, the next conclusion is that low cycle thermal fatigue (LCTF) was the reason for premature fatigue failure.
- It can also be concluded that the additional stresses as a result of vibrations of the engine were reason for decreasing the fatigue life of the casing. However, the dynamic analysis was not performed in this work.

- a) Increasing the radius between the deflector and the casing surfaces in the critical region.
- b) Weld residual stress may occur under welding. Different heat treatment method can be used in order to reduce the residual stress.
- c) The material used in the critical component could be changed. The alloy 1H18N10TA used for this part has a yield stress of 240 MPa (for 0°C). It was proposed that the 1H18N10TA alloy can be replaced by Inconel 625 alloy, which has a much higher yield stress (414 MPa) and is often used in aerospace applications.

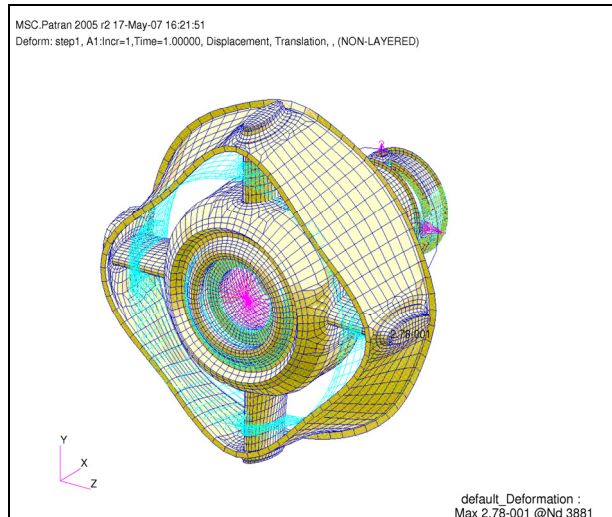
**Fig.8. Visualization of the casing deformation (front view, scale of deformation 150:1).**

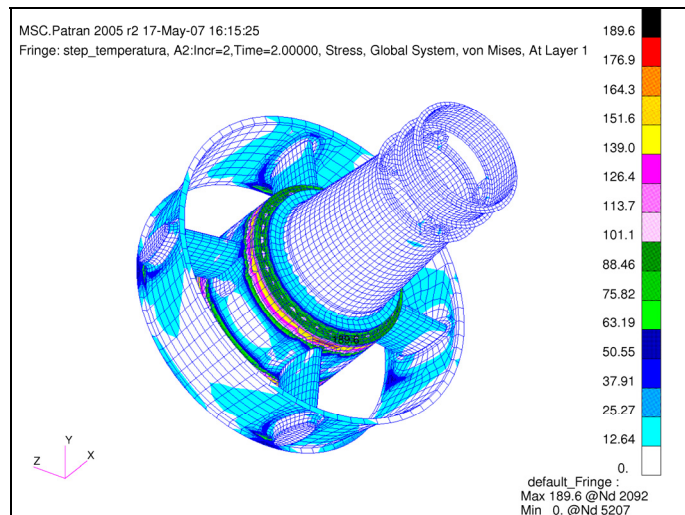
**Fig. 9. Von Mises stress resulting from thermal load.**

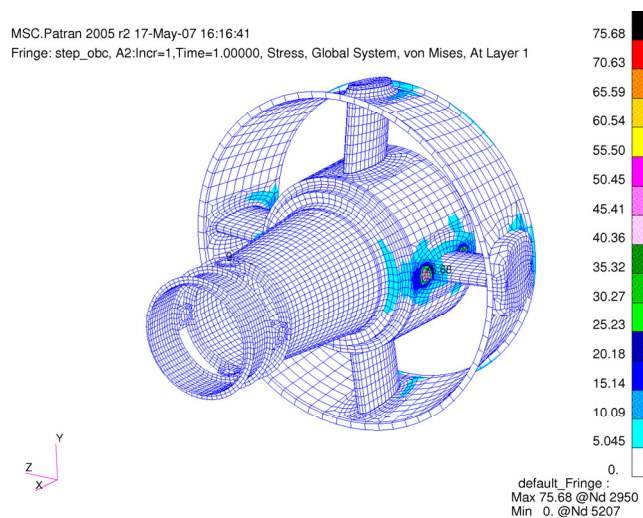
**Fig. 10. Von Mises stress as a result of the mechanical load.**
