Investigation and Restoration of the Black House on Rynok Square in Lviv

The stone townhouse at 4 Rynok Square in Lviv is an architectural monument of national importance (protection number 326/3). It is located on the territory of the complex of the historic center of Lviv, placed on the list of UNESCO World Heritage Sites in 1998 (865 bis). In 2016, the Lviv Historical Museum received a grant as a part of the “Big Project” competition of the US Embassy for Cultural Preservation (AFCP) for the restoration of the Black House. The project coordinators were Petro Slobodyan, the head of the department of the Museum of Science and Technology, and Ruslan Koshiv, the head of the department of scientific and educational work and promotion of the same institution. Restoration work on the monument took place in the years 2016–2019.

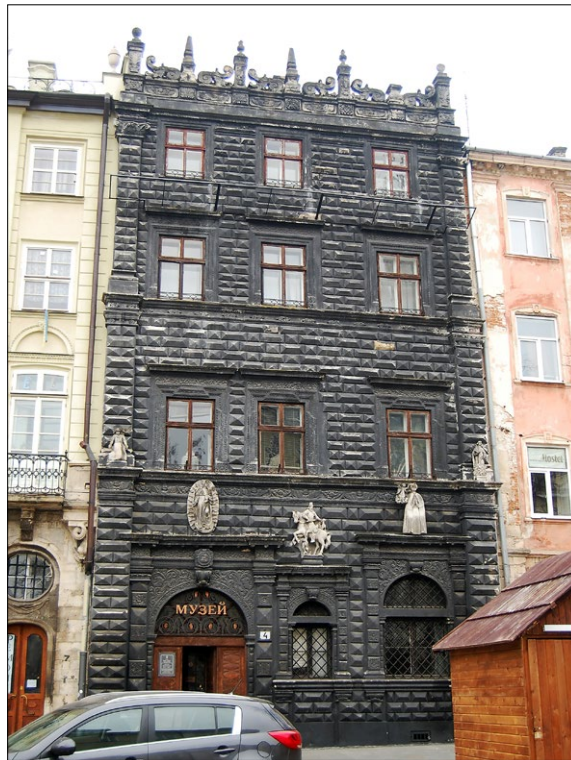
Prior to the start of the works, the monument was in an unsatisfactory condition: the lower part of the walls was very damp, the decorative carved details of the facade had a significant number of missing fragments, the attic and roof structures were in an alarming

Fig. 1. Black House on Rynek Square in Lviv, view before the restoration, 2015; photo by O. Rybchynskiy.
 Рys. 1. Czarny Dom przy placu Rynkowym we Lwowie, widok przed renowacją, 2015; fot. O. Rybchynskiy.

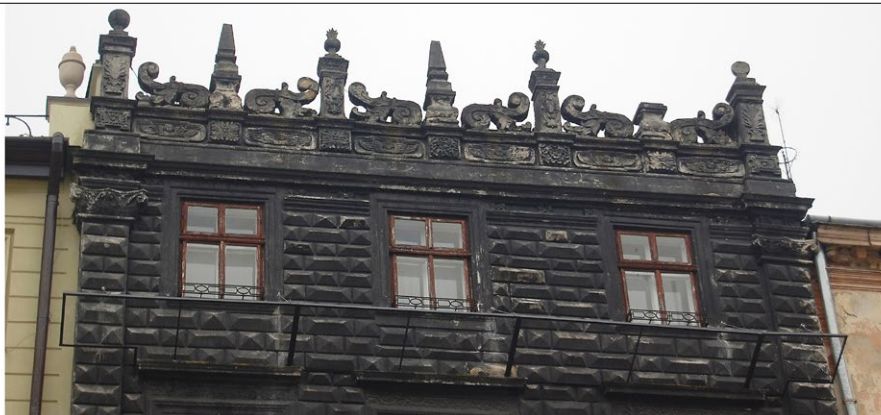
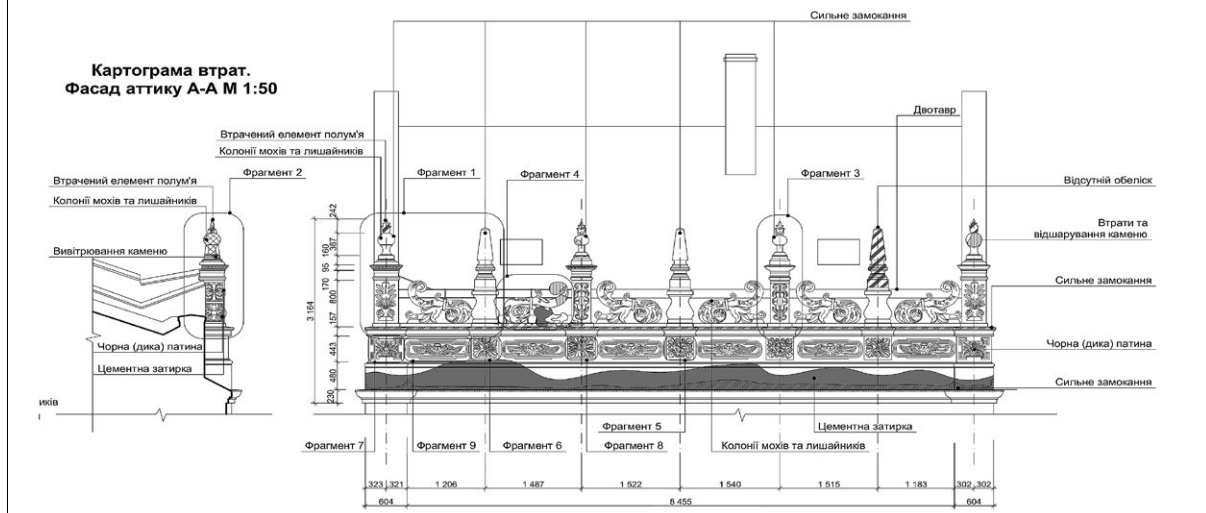
Картограма втрат. Фасад аттику М 1:50

Fig. 2. Black House on Rynek Square in Lviv, attic before the restoration, damage cartogram, 2016; by O. Rybchynskiy and M. Hohon.
 Рys. 2. Czarny Dom przy placu Rynkowym we Lwowie, attyka przed renowacją, kartogram ubytków, 2016; opr. O. Rybchynskiy i M. Hohon.

An investigation of the attic showed that the iron anchors that attached the white stone volutes to the parapet were heavily damaged because the mounting sockets were filled with sulfur.

The technology of restoration of the main facade consisted of the following parts: Attic. 1. Cleaning the surface of carved stone figures from dust, dirt, cement additives, traces of biological damage and paint coating. 2. Temporary dismantling of four attic volutes, their restoration on scaffolding was aimed at: cleaning the surface from dust, dirt, cement additives, biological damage and paint coating, the dismantling of parts in poor condition; replacement of leaking anchors; execution of a new anchoring from a stainless steel wire; bonding of cracked parts of the attic with epoxy glue and additional anchoring with stainless steel wire. 3. Removal of black patina from the stone using Remmers Fassadenreiniger-Paste gel and steam cleaning. 4. Removal of acrylic paint from stone with AGE gel and steam cleaning. 5. Coating of metal anchors with a rust converter, cleaning and preservation using a 10% solution of Paraloid72. 6. Injection of cracks with carbonate solution. 7. Clearing stone figures from destructed stone. 8. Structural fixing of the surface of stone figures with the Remmers KSE 100 and 300 strengthener on a silicic acid ester base. 9. Reproduction of lost parts of stone carving by the method of adding restoration carbonate mixtures. 10. Antiseptic treatment of stone figures with a solution of Remmers Adolit M flussig. 11. Structural strengthening of the attic by the Remmers KSE 300 strengthener on a silicic acid ester base. 12. Hydrophobic protection of the surface of the attic stone (Remmers Fungosil FC Hydrophobic liquid). 13. Replacement of metal clamps for the fastening of attic figures with stainless steel analogues.

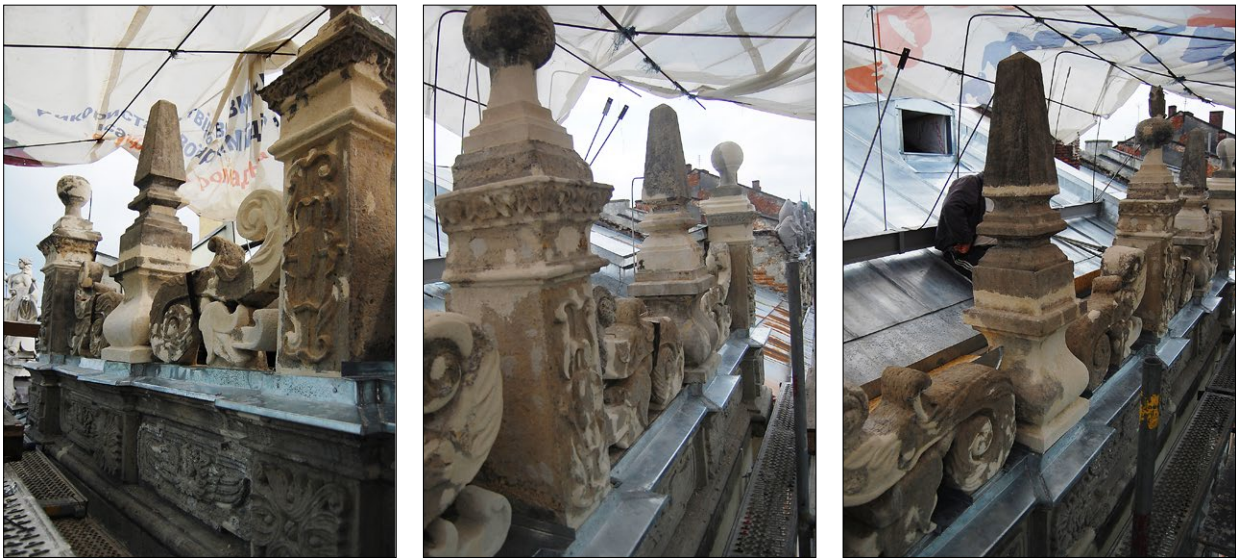
Fig. 3. Black House on Rynok Square in Lviv, attic after reproduction of losses, 2018; photo by O. Rybchynskiy.
Ryc. 3. Czarny Dom przy placu Rynkowym we Lwowie, attyka przed uzupełnieniem ubytków, 2018; fot. O. Rybchynskiy.

At the beginning of the restoration work in May 2018, the white stone decoration of the main facade of the building at 4 Rynok Square was in a gradually deteriorating state. The roof was repaired first, as its unsatisfactory technical condition caused damage to the attic. From May to July 2018, the surface of the carved stone figures on the attic were cleaned from cement additions, biological damage, black patina and paint coating; the four volutes of the attic were dismantled and restored; those parts that risked to fall out were dismantled and glued; the rusted metal anchors of the fastening were replaced; new anchoring was made of stainless steel wire; cracks were injected with a carbonate solution; the reconstruction of decorative visual elements was performed using natural and artificial stone; the surface of the stone figures was fixed with a strengthener on a silicic acid ester base (Fig. 3). In May 2019, antiseptic stone treatment was performed, hydrophobic surface proofing was applied and new stainless steel attic fasteners were installed.

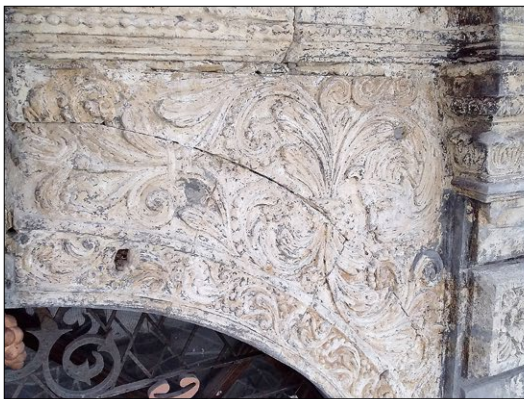
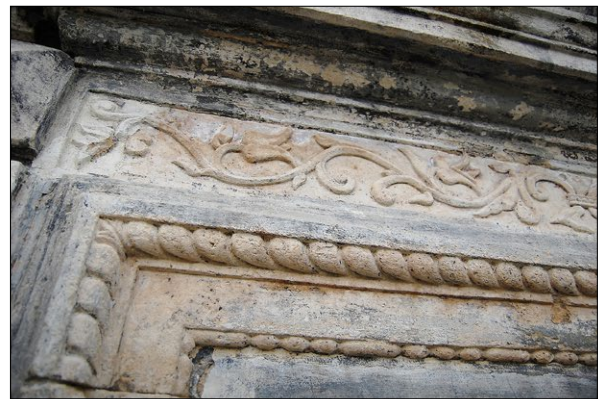
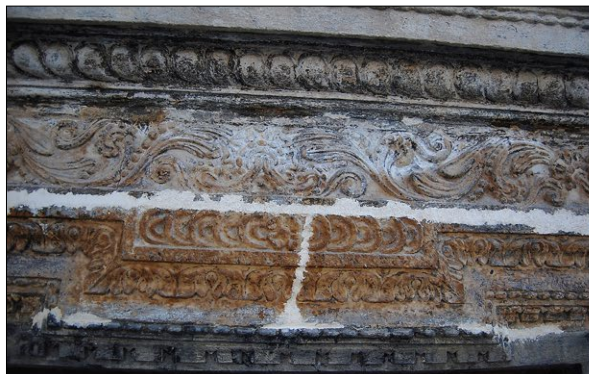
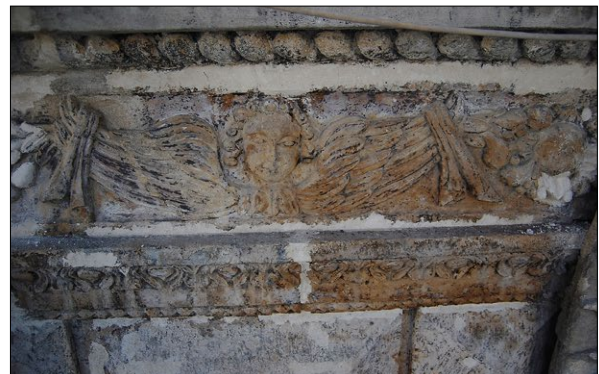
Fig. 4. Black House on Rynok Square in Lviv, filling in of cracks and crevices, 2018; photo by O. Rybchynskiy.
Ryc. 4. Czarny Dom przy placu Rynkowym we Lwowie, uzupełnianie zarysowań i pęknięć, 2018; fot. O. Rybchynskiy.

the diamond rust was cleared from destructed areas of stone; cracks and crevices were filled in with injected material; additions were made of natural and artificial stone; stainless steel anchors were placed in the places of additions; the surface of the stone décor was fixed with a strengthener on a silicic acid ester base, antiseptic treatment of the stone and hydrophobic proofing were applied. Given the exceptional artistic value of the carved décor of window frames, they were cleaned using scalpels, plastic and brass brushes, and vapor generators. (Fig. 4)

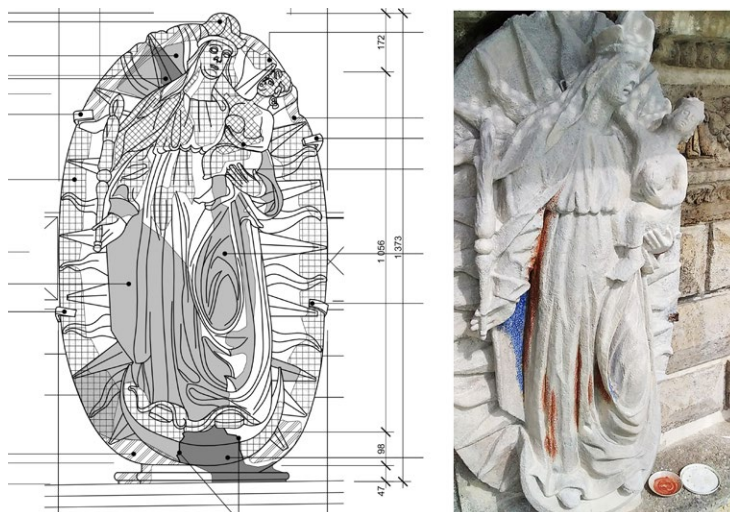
Fig. 5. Black House on Rynok Square in Lviv, sculpture of the Virgin and Jesus, damage cartogram, 2019; by O. Rybchynskiy and M. Hohon, photo by O. Rybchynskiy.

From June to August 2019, conservation work was carried out on three large sculptures on the first floor. The areas of limestone stratification were structurally strengthened on the sculpture of the Virgin and Jesus; cracks were filled with injected material; the crowns,

the face of Jesus, fragments of draperies and rays were recreated. Cement additions were removed from the sculpture of St. Martin, cracks were filled with injected material, the head, arms, fragments of the cloak and horse harness were recreated out of artificial stone. The sculpture of St. Stanislaus was dismantled because a through-transverse crack in the figure could have caused it to fall (Fig. 5–7). Then it was found that there was a secondarily used carved block in the wall behind the sculpture, the composition of which was similar to the window sandrics of the second floor (Fig. 8). The sculpture of St. Stanislaus was cleared of black patina and cement grout, glued and arranged in its original place. Structural strengthening was carried out and the colors were touched up to ensure integrity.

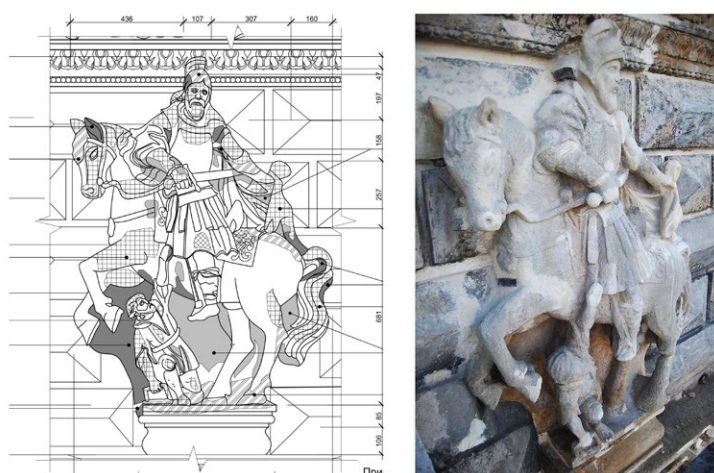
Fig. 6. Black House on Rynok Square in Lviv, sculpture of St. Martin, damage cartogram, 2019; by O. Rybchynskiy and M. Hohon, photo by O. Rybchynskiy.

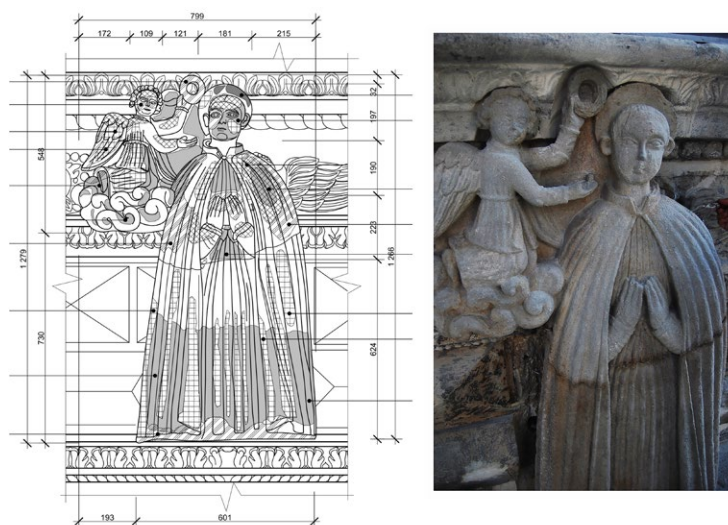
Fig. 7. Black House on Rynok Square in Lviv, sculpture of St. Stanislaus, damage cartogram of losses by O. Rybchynskiy and M. Hohon, 2019; photo by O. Rybchynskiy.

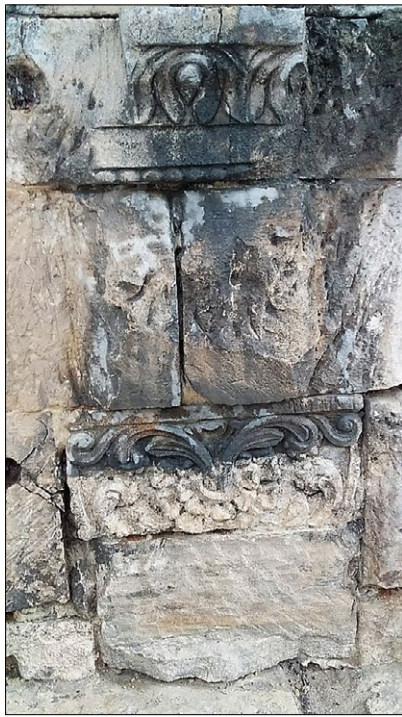
Fig. 8. Black House on Rynok Square in Lviv, carved block in the wall behind the sculpture of St. Stanislaus, 2019; photo by O. Rybchynskiy.
Ryc. 8. Czarny Dom przy placu Rynkowym we Lwowie, kuty blok w ścianie za rzeźbą św. Stanisława, 2019; fot. O. Rybchynskiy.

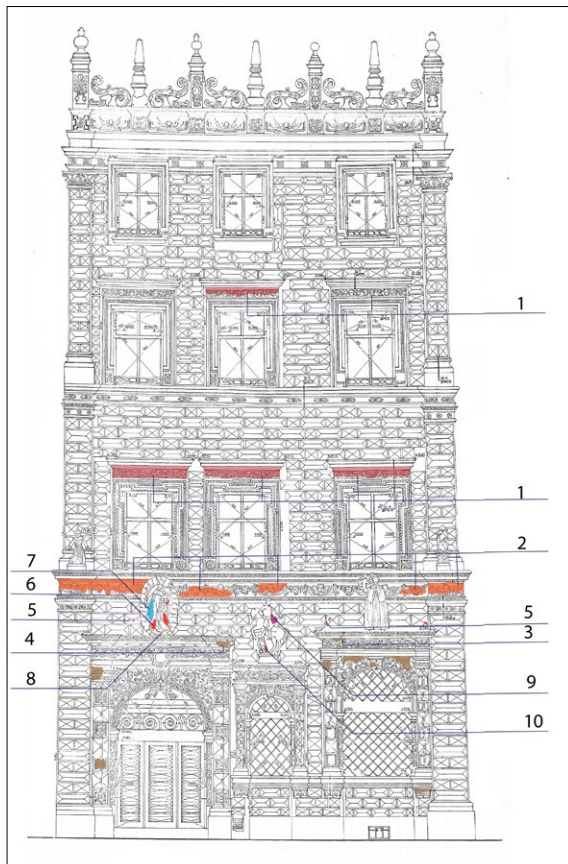
Fig. 9. Black House on Rynok Square in Lviv, discovery sites and small fragments of ancient polychromy, 2019; processing and photo by O. Rybchynskiy.
Ryc. 9. Czarny Dom przy placu Rynkowym we Lwowie, miejsca dokonania znalezisk, w tym drobnych fragmentów zabytkowej polichromii, 2019; fot. i obr. O. Rybchynskiy.

During the restoration works on the main facade we were lucky to find areas and small fragments of ancient polychromy. The sandrics of three windows on the second floor and of the middle window on the third floors were brown. Areas of dark burgundy color, probably remnants of polymer, were found on the frieze with cherubs. Thus, we can assume that in the seventeenth century the reliefs of cherubs and garlands were covered with dry gold. Small fragments of red color were found on several diamond rusts on the first floor after clearing. Terracotta color was found in several places on the carved *mavreskas*, brackets and capitals of the ground floor pilasters, and the rosettes were of brown color.

The red color of the dress, the ultramarine color of the omophorion and the areas of preserved dry gold on the rays were discovered on the sculpture of Odigitria. Probably in the past, the crowns on the Virgin and Jesus were also gilded. Red areas on the cloak and brown area on the beggar's trousers were found on the figure of St. Martin (Fig. 9). After many meetings, the methodical council decided to cover the facade of the building with black glaze paint (Fig. 10).

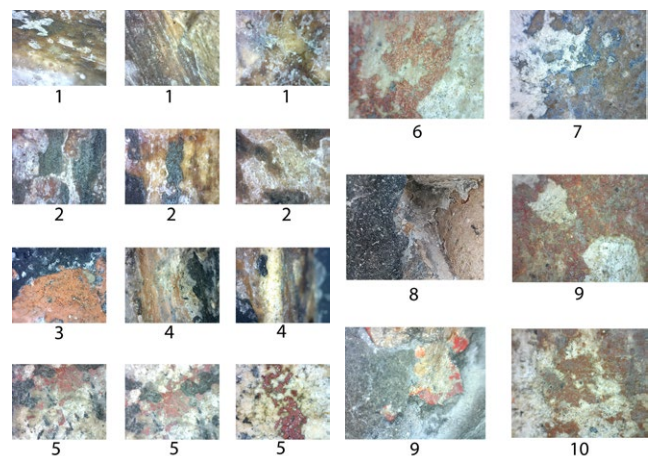
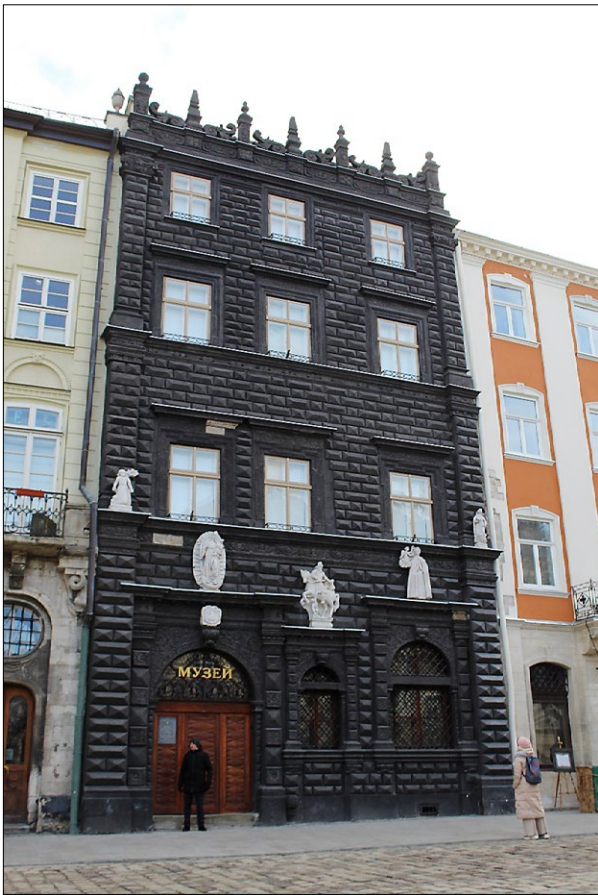
Fig. 10. Black House on Rynok Square in Lviv, view after restoration, 2021; photo by O. Rybchynskiy.
Ryc. 10. Czarny Dom przy placu Rynkowym we Lwowie, widok po renowacji, 2021; fot. O. Rybchynskiy.
