Michał BEMBENEK*, Janusz KRAWCZYK**, Krzysztof ZAGÓRSKI***,
Jan PAWLIK****

ON THE WEAR MECHANISM OF HIGH-CHROMIUM GYRATORY CRUSHER MANTLE LINING IN TERMS OF THE ASSESSMENT OF THE USED MATERIAL

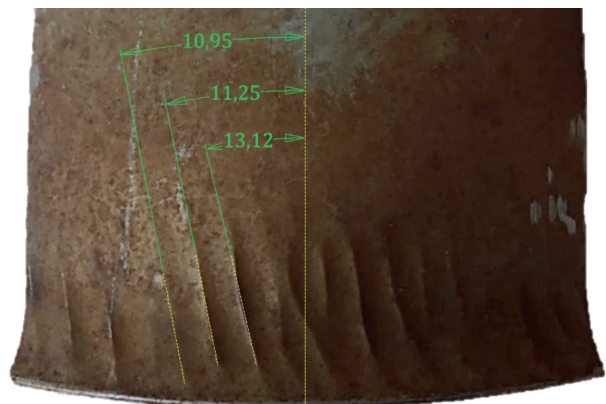
The mantle lining presents a volumetric loss in the expected area at the bottom of the lining cone. On the working surface area subjected to the highest loads, one can notice the vertical wear marks. The

motion, fulfilled by the mantle is gyratory; thus, the grooves are slightly inclined towards the main axis of the mantle shaft (**Fig. 4**). The measured angle of inclination varies between 10.95° and 13.12°

Fig. 4. Close-up macroscopic picture of the vertically inclined grooves resulting from wear

The uncommon, inclined wear ploughs are a possible result of the eccentric and rotational motion of the mantle.

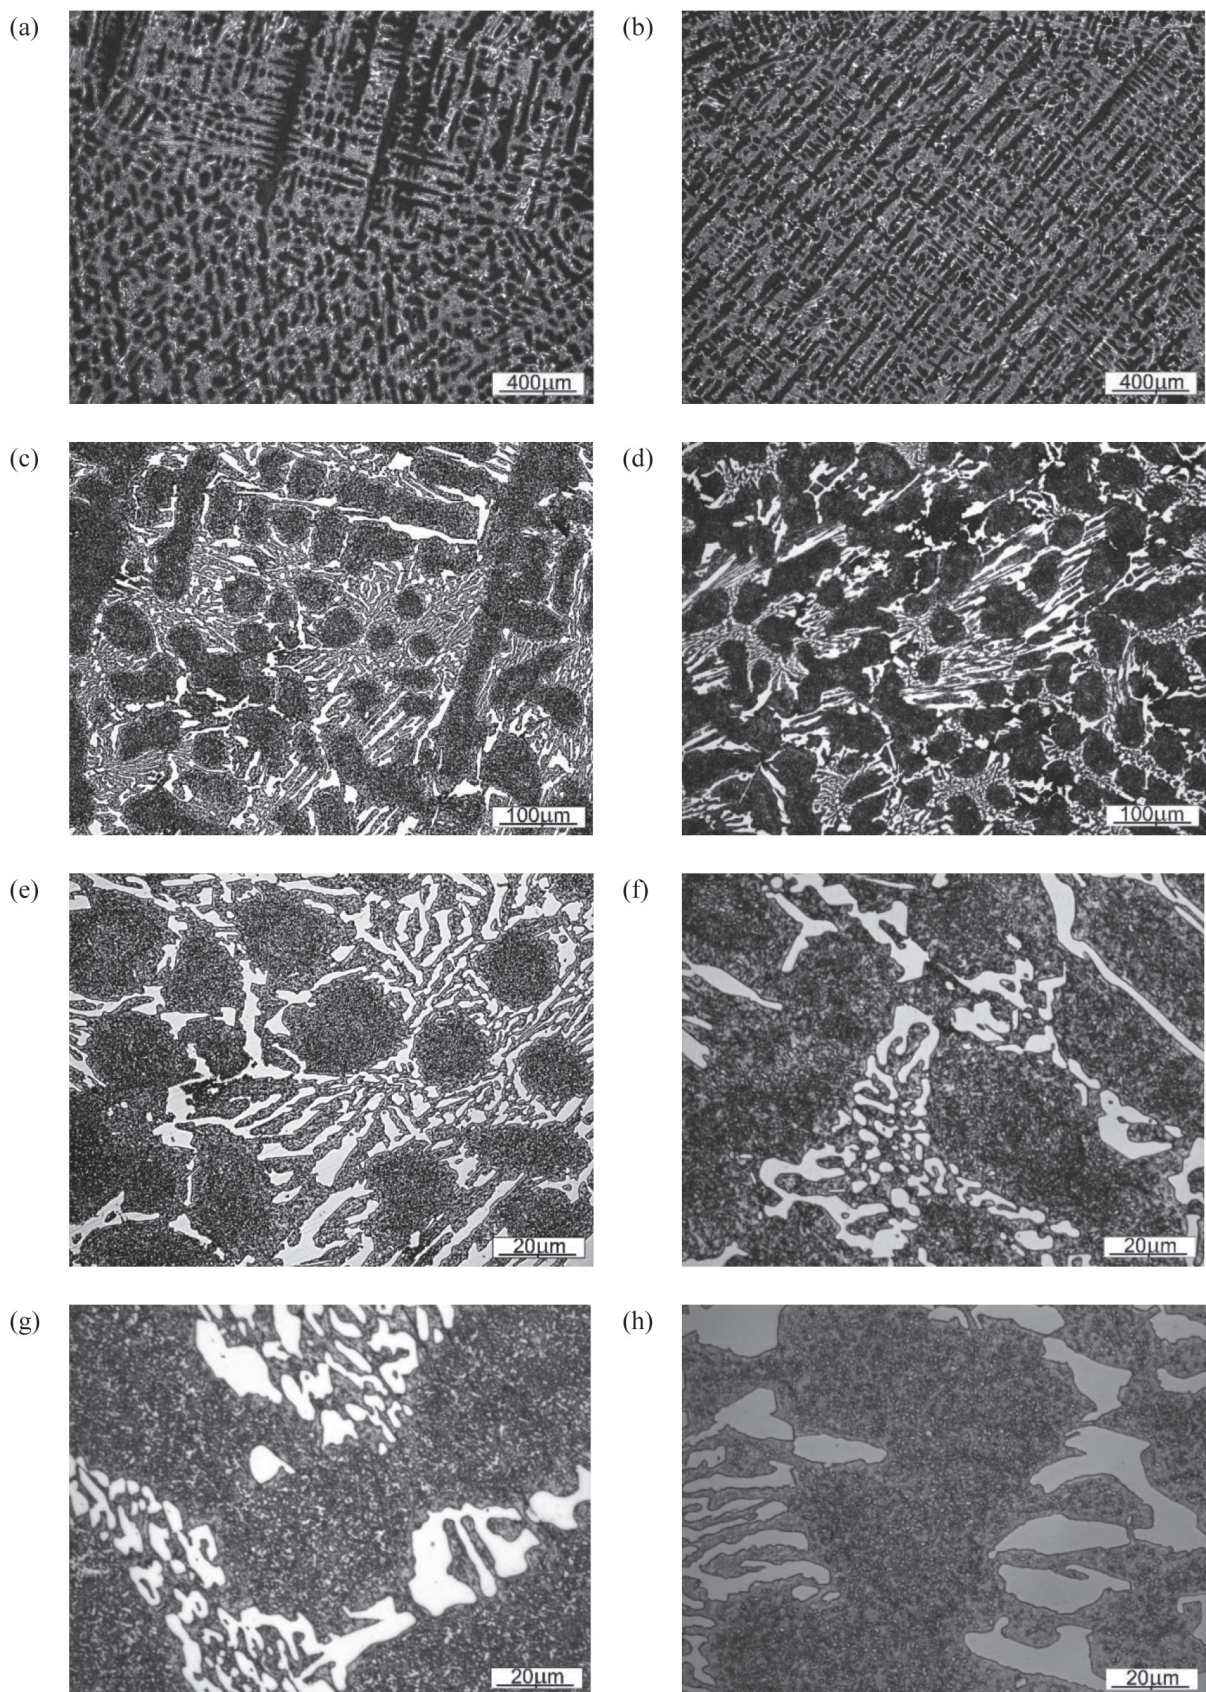
The material consists of areas of differently oriented sets of dendrites, where those sets will be further referred to as crystallites. **Figure 5a** (sample A5) shows the crystallite boundaries. The area of particular crystallite corresponds with the austenite, solidifying from the liquidus phase, as seen in **Figure 5c**. The eutectic phase, made out

primarily of austenite and primary carbides, was identified in the inter-dendritic space. In the process of further cooling, secondary carbides emerged, and the result can be seen in **Figure 5e**. Further heat treatment resulted in a martensite structure present, which is visible. During austenite cooling, some of the secondary carbides have been attached to the primary carbides, especially in the areas of former eutectic. Due to more intensive etching, the authors could observe the effects of martensite tempering in sample A7 (**Fig. 5b, d, f**). It is presented in the, especially in subfigures (f). Specific etching of sample A1 enabled the authors to observe acicular (**Fig. 5 g**). The average length of the occurring dendrites was calculated to be approximately 623 μm. Also, in **Figure 5h**, lamellar and acicular eutectic morphology can be distinguished. Some lamellae are arranged radially, while others are organised parallelly.

Fig. 5. Microstructure of the sample: A5 (a), (c) and (e) with different magnifications, A7 (b), (d), and (f) with different magnifications, A1 (g) and A3 (h)

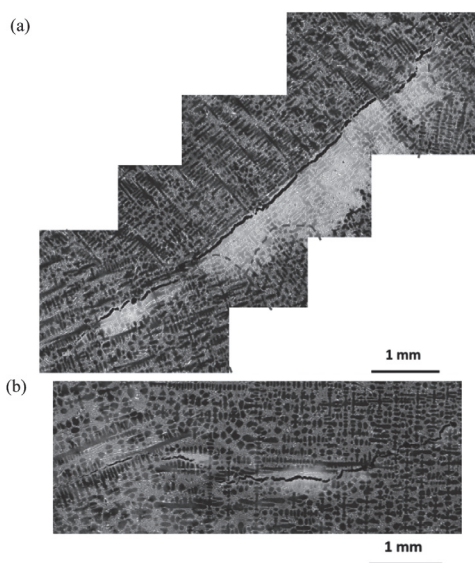
When sample A5 was inspected, a few cracks were captured, which are visible in **Figures 6 a** and **b**. After stitching the singular microscopic images and drawing perimeters of the crystallites (**Fig. 6a** – blue, dashed line), the cracks' geometry appeared to run along the crystallite boundaries. It is a highly undesirable occurrence since whether the crack is initiated on the surface of the mantle lining, it can easily propagate deep into the part.

Fig. 6. Cracks were observed during the inspection of sample A5: (a) shows crack propagation along the crystalline boundaries, and (b) shows the change of the crack's path due to differently oriented dendrites

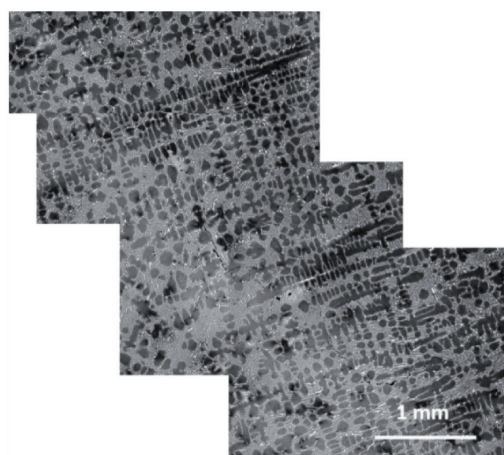
Another possible reason behind decreasing the wear resistance of the studied part may be the occurring porosity. The pores are visible in **Fig. 7**. They probably emerged during the rapid cooling of the freshly-cast part, when the crystallising material reduced its volume, causing internal shrinkage, cracks and discontinuities. Another possible reason for the existence of the pores is the quenching stress, where the temperature difference along the part cross-section was too high (or the cooling process was carried out too fast). In order to prevent inter-dendritic porosity near the surface, longer cooling periods could be introduced. Supposing the pores occur in the internal parts of the lining, they should not affect the operational parameters of the part negatively since by the time the wear-sensitive volume is reached, the geometry of the cone will require replacing, nevertheless.

Fig. 7. The porosity of sample A5 is due to casting shrinkage or quenching stresses

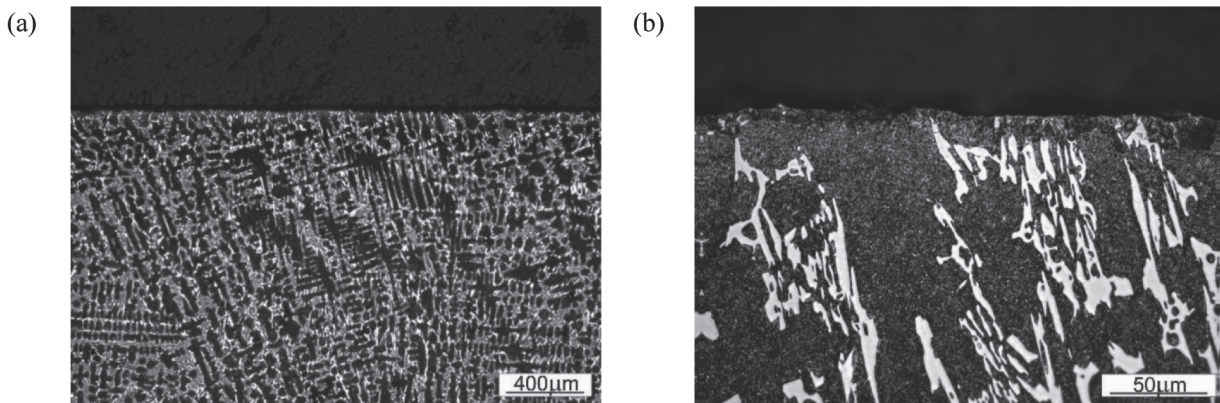
Considering the non-working surface, no areas of columnar phase were observed. Some noticed contamination and unevenness are probably a result of issues with the roughness of the casting mould. **Figure 9** depicts the described microstructural properties.

Fig. 9. Microstructure of the superficial layer of the not-exploited surface of the mantle lining (a) the general view, (b) depicts the surface roughness, being a consequence of ceramic casting form

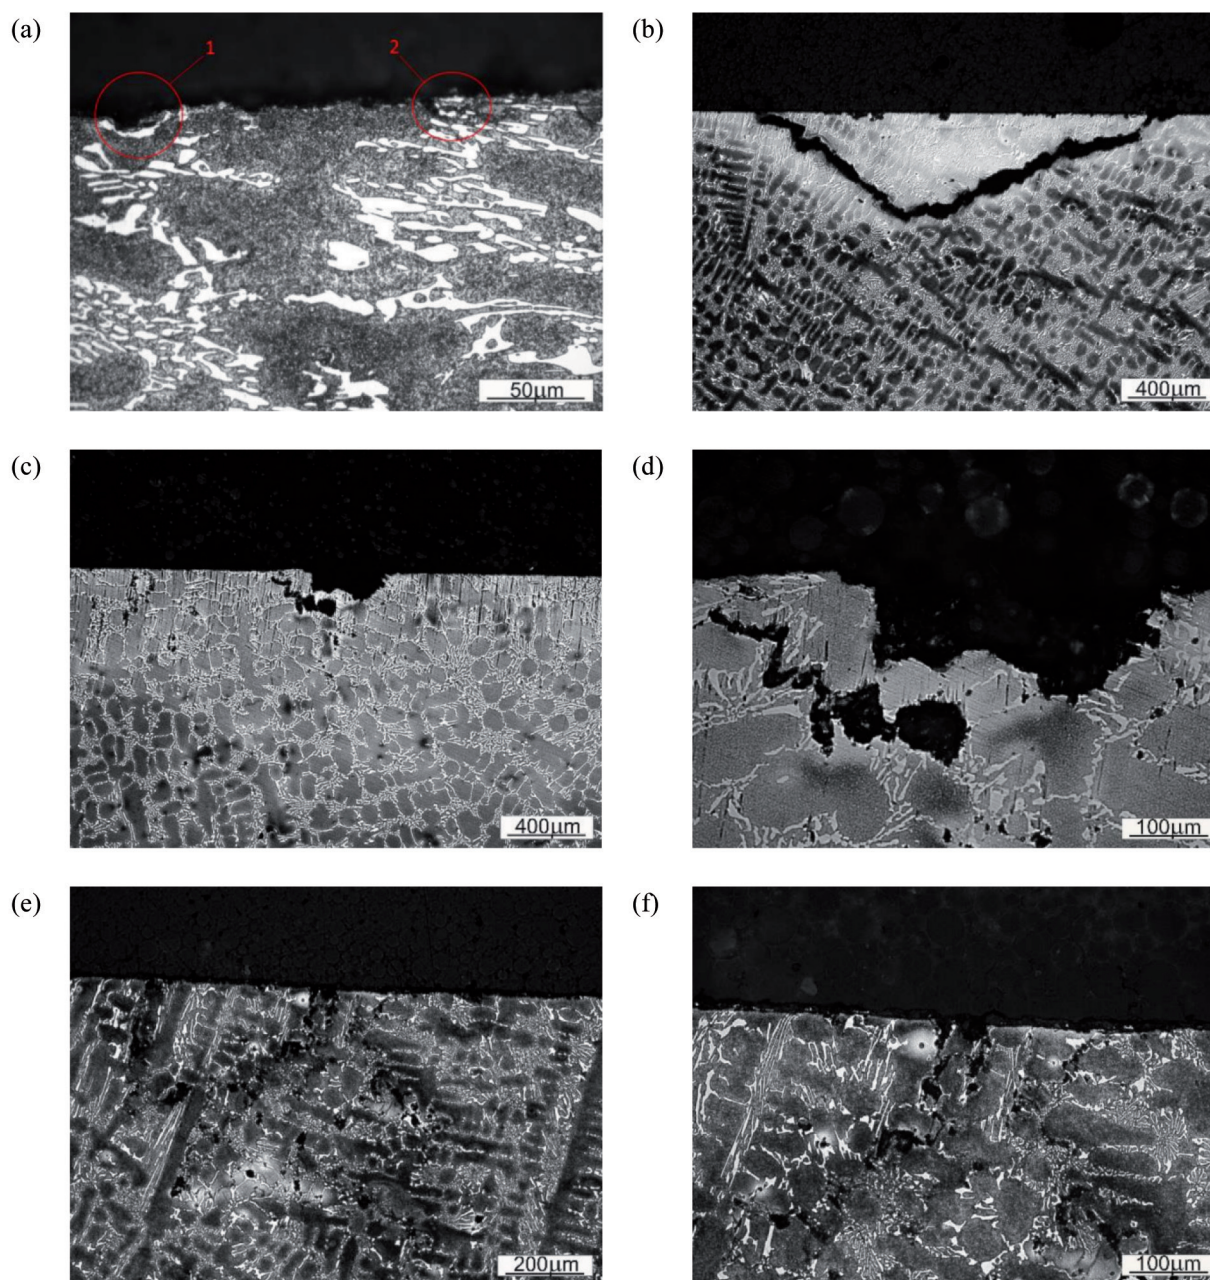
During the observations of the exploited surface, a binary role of the primary carbides was noticed. On the one hand, it is visible that the primary carbides diminish the abrasive wear (**Fig. 10a**, area 1), yet on the other hand, the observed cracks are propagating along the carbide lattice (**Fig. 10a**, area 2). A similar crack propagation mechanism is also visible in **Figures 10c** and **d** (which presents the same area but with different magnification). The outcome of superficial mechanical impact also depends on the dendrites' arrangement, where **Figure 10b** is one of the best examples found. The porosity, seen in **Figures 10e** and **f**, is another possible factor that sets the upper limit for wear resistance.

Fig. 10. Microstructure of the exploited surface of the studied part: (a)-(c) cracks propagating along the carbide lattice, (d) crack propagating along the dendrites, (e), (f) depicts porosity

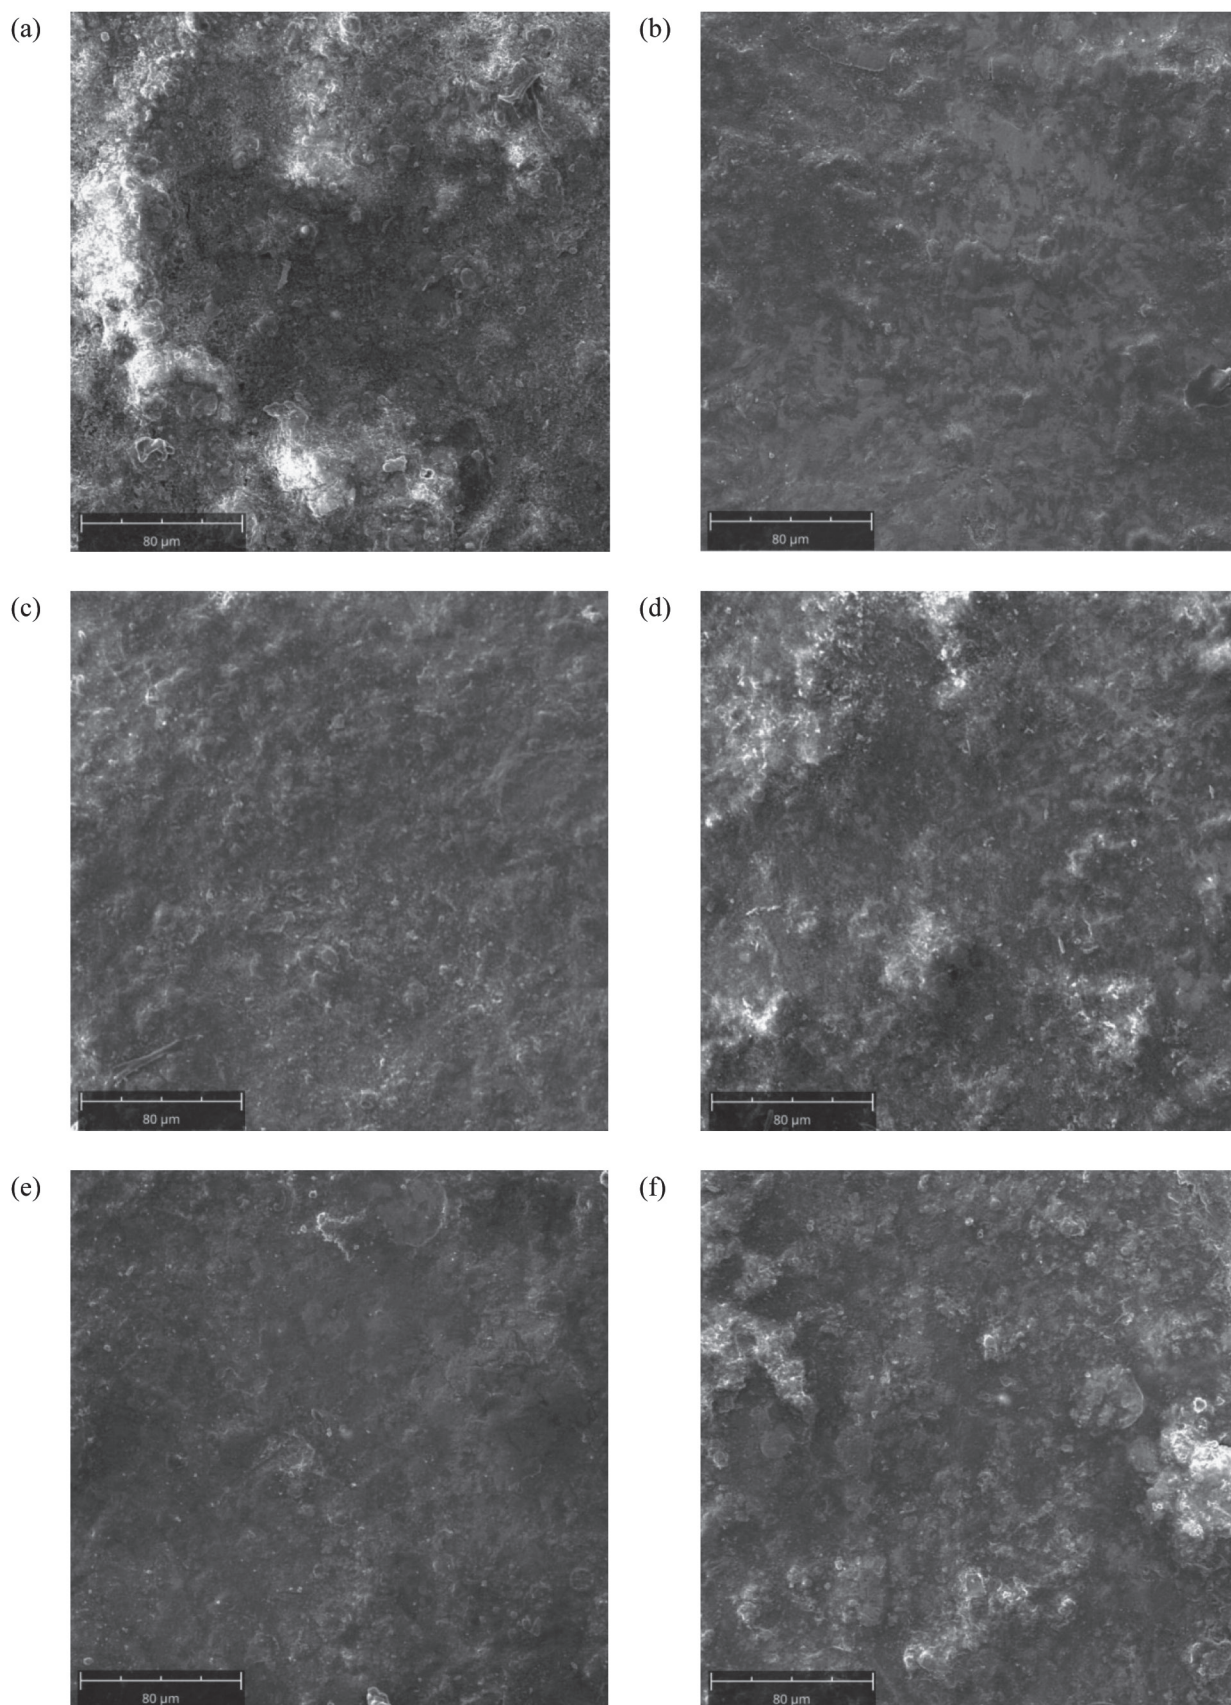
behaviour causes; nonetheless, the authors also wanted to perform an areological analysis. The captured images in **Figure 11** confirm the previously found worn material defects. In subfigures (a)-(f), one can observe the divergent reaction to abrasion of the particular material phases, subfigures (a), (b) and (d) show the occurrence of cracks and subfigure (e) depict craters.

Fig. 11. Areological analysis of the material surface: (a) Sample B1-B, (b) B2-B, (c) B2-B, (d) B3, (e) B6-A and (f) B6-B
Rys. 11. Analiza areologiczna powierzchni materiału (a) próbki B1-B, (b) B2-B, (c) B2-B, (d) B3, (e) B6-A i (f) B6-B

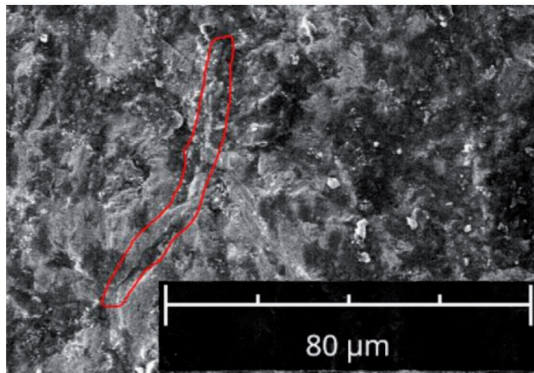
Some micro-cracks were observed on the material surface, as seen in **Figure 12**. The cracks tend to propagate along the crystallite boundaries.

Fig. 12. Exemplary image of a crack propagating along the dendrite boundaries

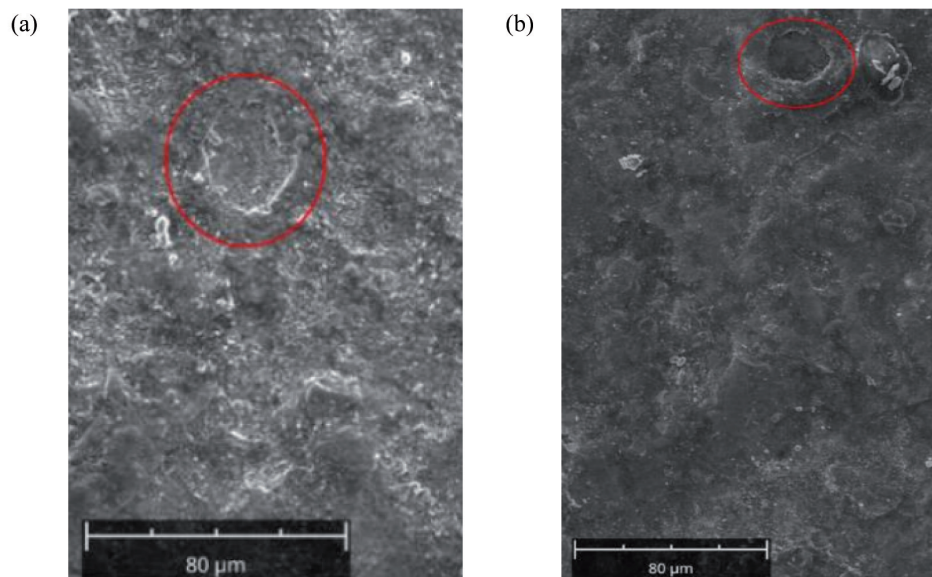
During the operation of the machine, the mantle lining was periodically eroded. The cavities collected the products of erosion, and some build-ups started to occur. The process continued with build-up ripping, resulting in visible craters. Some exemplary craters are presented in **Figure 13**, marked with red circles.

Fig. 13. Exemplary images of craters being a result of build-up ripping: (a) sample B4, (b) sample B5-B

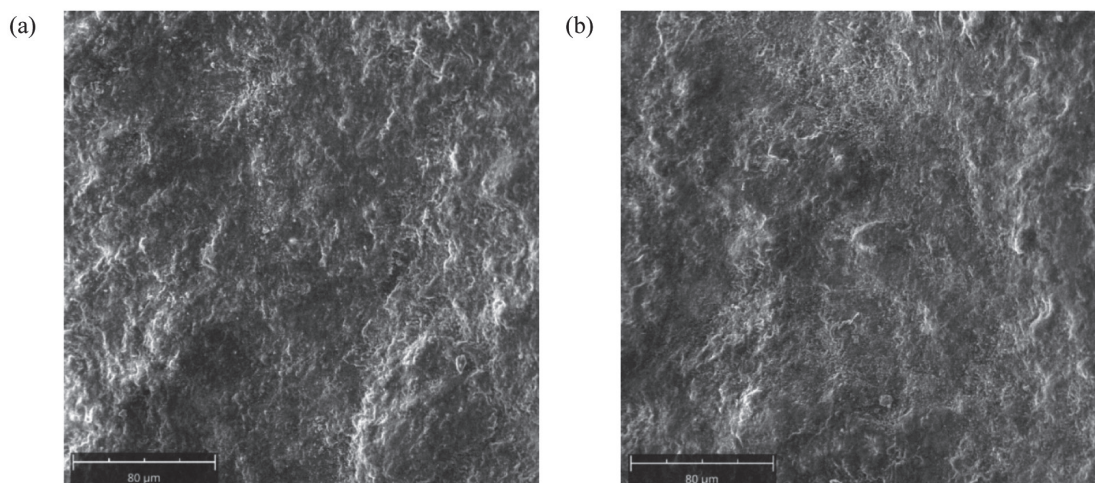
The images collected in **Figure 14** were captured at an angle to the surface in order to highlight the ploughs and scratches occurring on the B7-A and B7-B samples. Those samples belong to the mantle lining region exposed to fine-grained, crushed abrasive material. In the areas with smaller hardness values, the abrasive wear occurs more rapidly, which afterwards leads to deep creases. The

crease partially acts as a funnel, which concentrates the crushed material, further leading to more intensive wear in the particular creased region.

Fig. 14. Exemplary images of worn surface topography

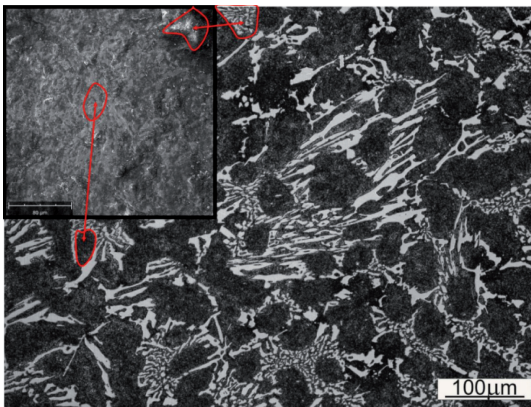
In order to confirm the assumed wear mechanism, the Authors compared microscopic and SEM images of the carefully located same regions of samples. Inspecting the analogue regions of sample B1-A (**Fig. 15**), one can notice that the most

intensive wear is aligned along the dendrites. The harder phases (primary carbides) tend to aggregate in the inter-dendritic regions; hence the wear is observably lower.

Fig. 15. Comparison of the same regions captured with SEM and metallographic microscope. The red areas with arrows represent the analogic regions of the studied sample

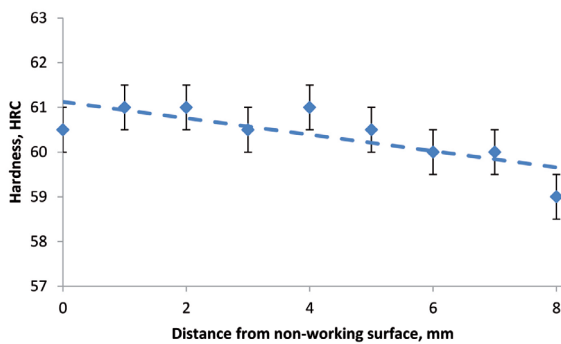
The hardness measurement is shown in **Figure 16**. The hardness appeared to vary between 59 and 61 HRC with a tendency to decrease away from the surface, which is another confirmation of applied heat treatment. It can also be stated that due to the nature of the hardness curve, the wear may be more intensive with the passage of time.

Fig. 16. Graph showing the decrease in hardness along the distance from non-working (thus not exploited) surface
