B. PAWŁOWSKI*, P. BAŁA*, T. TOKARSKI*, J. KRAWCZYK*

PREMATURE CRACKING OF DIES FOR ALUMINIUM ALLOY DIE-CASTING

Keywords: die failure; die-casting; hot-work tool steel; heat treatment

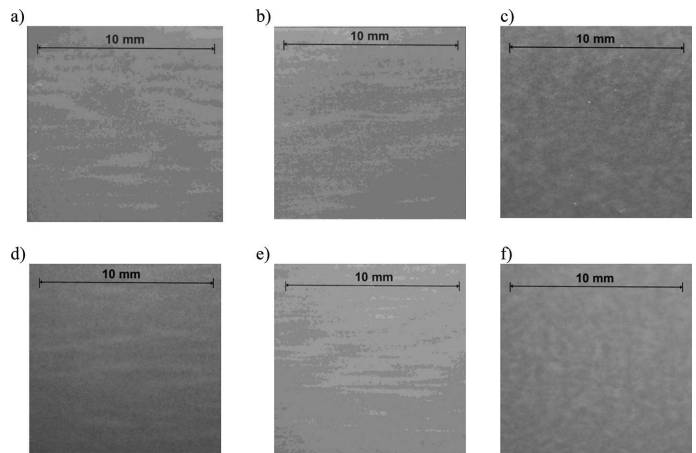
The chemical composition of the investigated steel (die A, in wt. %) was 0.32% C, 0.22% Si, 0.44% Mn, 4.71% Cr, 2.17% Mo and 0.58% V and meets the Dievar steel manufacturer requirements [11]. The microstructural banding orientation of the investigated dies can be seen in the macroscopic images of etched metallographic specimens for the XY, XZ and YZ planes (see Fig. 4), which are presented in Fig. 5. The appearance of the microstructural banding (fibrous microstructure of steel) is caused by the segregation of substitutional alloying elements during the dendritic solidification and is affected by subsequent plastic deformation. As shown in Fig. 5, for both dies, the microstructural banding direction is parallel to the X-axis of the coordinate system used, which is also the direction of surface crack propagation. A banding structure of the dies was also observed at higher magnification during the microscopic examination. The results of these observations are shown in Fig. 6. As all observed surface cracks (for both dies) were parallel to the X-axis, it is clear that such a geometrical orientation of the dies with respect to the microstructural banding promotes crack propagation. However, such microstructural banding, as presented in Fig. 5 and Fig. 6, is acceptable according to the North American Die Casting Association industry standard [12] but the banding direction does not meet the requirements of the manufacturer’s design assumptions.

Fig. 5. Macroscopic images of etched metallographic specimens, etched with 2% nital, a) die A XY plane, b) die A XZ plane, c) die A YZ plane, d) die B XY plane, e) die B XZ plane, f) die B YZ plane

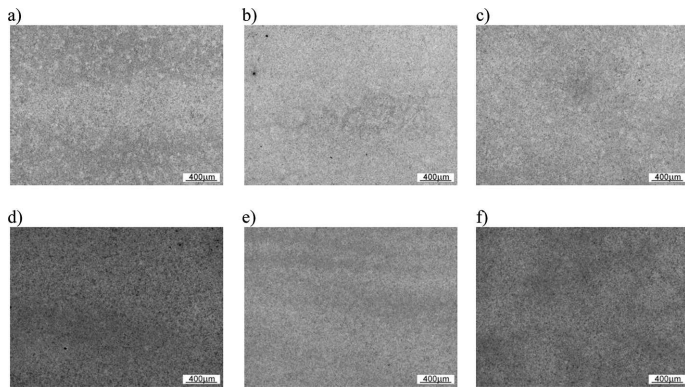
Fig. 6. Microscopic evidence of microstructural banding, etched with 2% nital, a) die A XY plane, b) die A XZ plane, c) die A YZ plane, d) die B XY plane, e) die B XZ plane, f) die B YZ plane

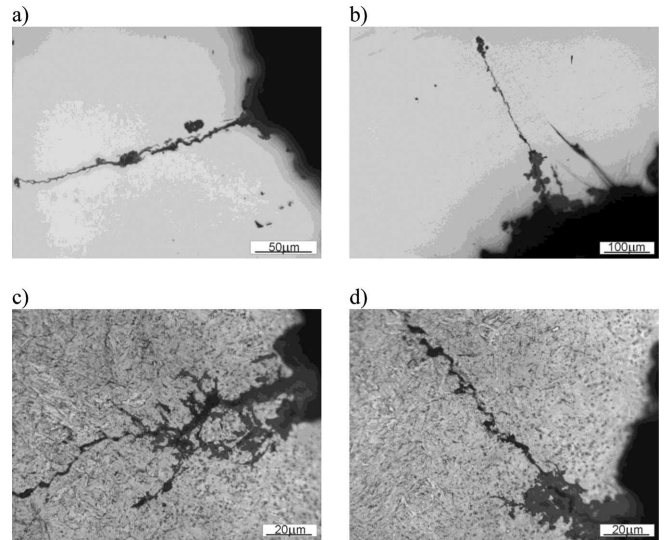
Macroscopic observation of the cooling hole cross section (Fig. 7) revealed that around the edge of the hole, many fine cracks had started. Microscopic images of some of these are presented in Fig. 8.

Fig. 8. Microscopic images of cracks nucleated at the edge of cooling hole: a), b) – not etched, c), d) – etched with 2% nital

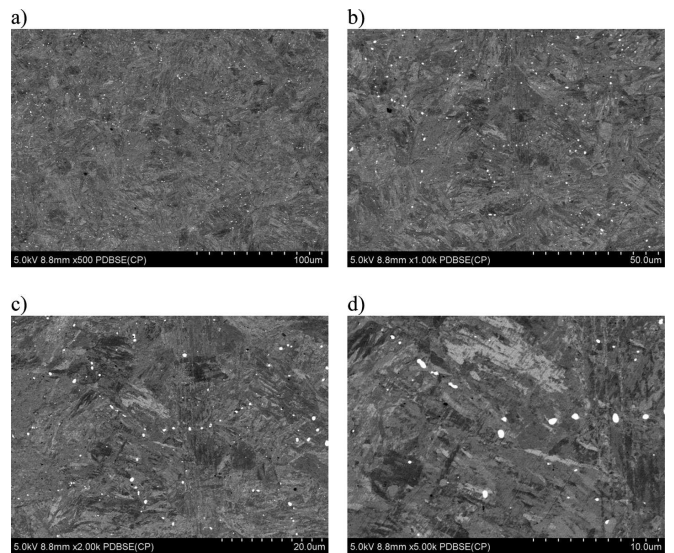
The die microstructure is typical for Dievar steel after quenching and tempering. Light microscopy studies did not confirm the presence of surface decarburisation or wear traces. It was confirmed that the surface and bulk microstructures are similar. SEM studies revealed carbides precipitated along the prior austenite grain boundaries, as shown in Fig. 9. The use of the higher accelerating voltage allowed observation of another type of carbides, precipitated inside the prior austenite grains – transgranular carbides (Fig. 10).

Fig. 9. SEM images of tempered martensite microstructure of investigated steel, accelerating voltage 5 kV

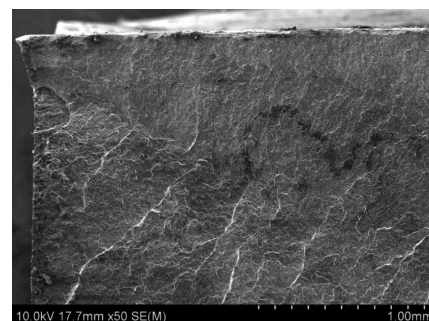
SEM observations were also made for the fracture surface at the origin of the crack presented in Fig. 7. The results of this investigation are shown in Fig. 14 and Fig. 15. As can be observed, the crack initiation occurred at the edge of the cooling hole and further crack propagation took place in stages, probably corresponding to the die-casting cycles (the so-called “shots”). Fig. 16 shows a transgranular fracture mode of the above-mentioned stages, separated by a dimple fracture area (Fig. 16a) with friction traces (Fig. 16b).

Fig. 14. SEM image of fracture surface of crack presented in Fig. 7, close to the cooling hole (crack origin)

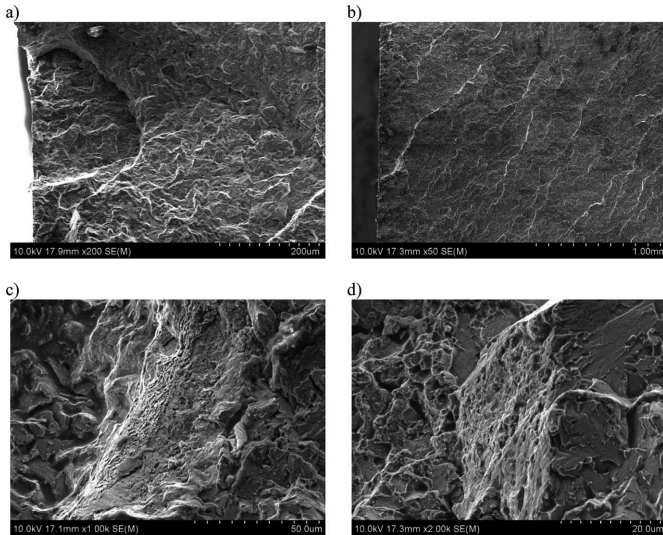
Fig. 15. SEM images of transgranular fracture mode separated by dimple fracture area, a) general view, b) crack origin, c-d) transition region
