DANIEL WAŁACH\*, PIOTR DYBEŁ\*, MAREK CAŁA\*, JUSTYNA JASKOWSKA-LEMAŃSKA\*

**EVALUATION OF LOAD CAPACITY OF SHAFT COLLAR SUBJECT TO UNINTENDED  
EXCEPTIONAL LOADS****OCENA NOŚNOŚCI GŁOWICY SZYBOWEJ PODDANEJ NIEZAMIERZONYM  
OBCIĄŻENIOM WYJĄTKOWYM**

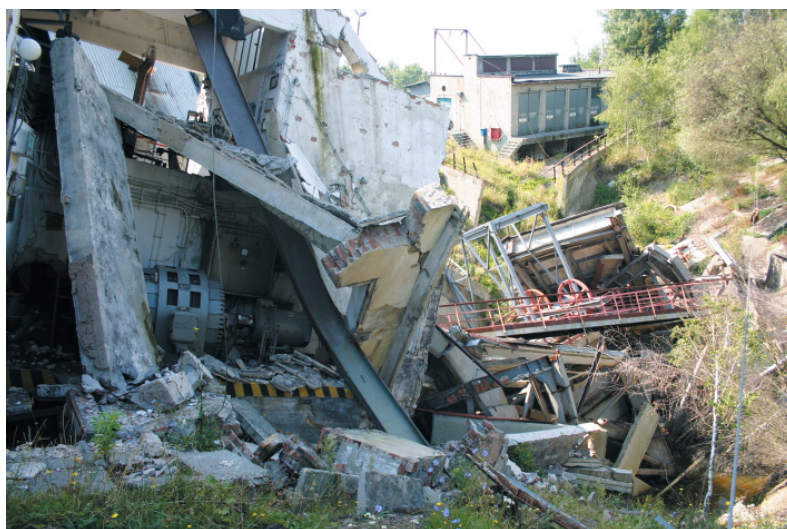
Fig. 1. Construction failure on a shaft object caused by the lack of corrective action

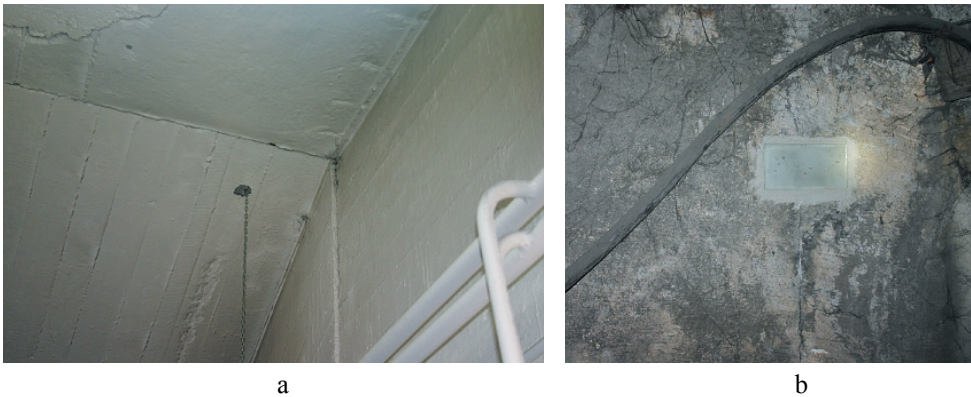
- slight displacement of the rotating part of the L-2 ventilation drift noticeable on expansion joints – Fig. 3a,
- vertical cracks on the expansion joints and of individual parts of the ventilation drift,
- lack of progress on the delamination of expansion joints on the basis of installed seals – Fig. 3b,
- displacement of the vertical part of the L-1 ventilation drift relative to the shaft collar – Fig. 4,
- no damage to the shaft collar in the breakout location under the ventilation telescope,
- loosening of wall elements in shaft top undermining the new ground beam,
- damage to the shaft top corner of the wall of the building.

Fig. 3. Recorded damage a) displacement of ventilation head, b) view of the installed seal

On the basis of observation carried out it was found that the resulting damage could have been caused by uncontrolled displacement and rotation of the individual parts of the ventilation drift. The placed seals allowed for constant monitoring of the possible increase in the rate of delamination of the registered cracks and damage. On the basis of the analysis of damage it was assumed that factors triggering the displacement of individual elements of the ventilation duct stabilized, which was confirmed by the lack of damage to the seals. Additional confirmation of the stabilization of possible effects causing displacement of the ventilation duct were the results of periodic surveying of shaft deflection guides and hoist tower. Table 1 lists the results of measurements of a given year, which clearly shows the lack of effects causing further displacement of the rock mass in this area or that this phenomena is of a relatively small range. The obtained results of the guide shaft deflection and hoist tower are within the limits of the margin of error.

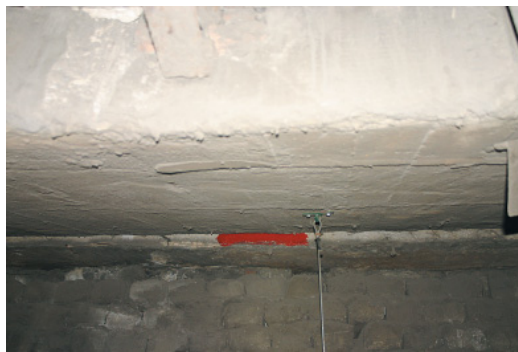
Fig. 4. Registered displacement of ventilation drift relative to the shaft support structure

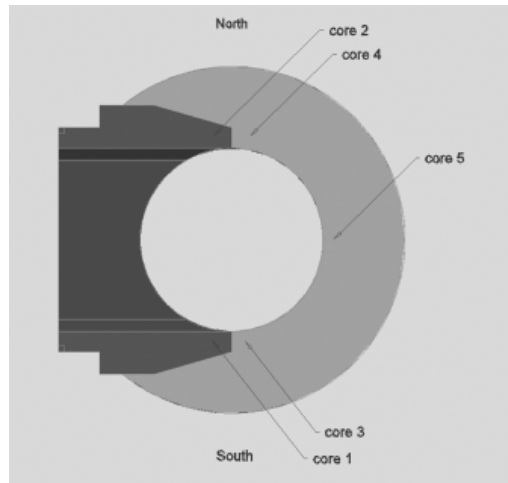
Five core samples were taken from the shaft collar support structure and ventilation drift, the location of which is marked in Fig. 5. A total of eleven samples were cut from the cores and subsequently tested for durability in a hydraulic press. The results obtained are shown in Table 2.

Fig. 5. Location of core drilling taken

Based on the results of laboratory tests, it was stated that the material parameters of the ventilation duct are substantially worse than the resistance properties of the material of the shaft support structure. Average compression and tension resistance of the ventilation duct material amounted to 12.07 MPa and 2.23 MPa, respectively. In contrast, the average compression and tension strength of the shaft support structure material amounted to 25.42 MPa and 2.28 MPa.

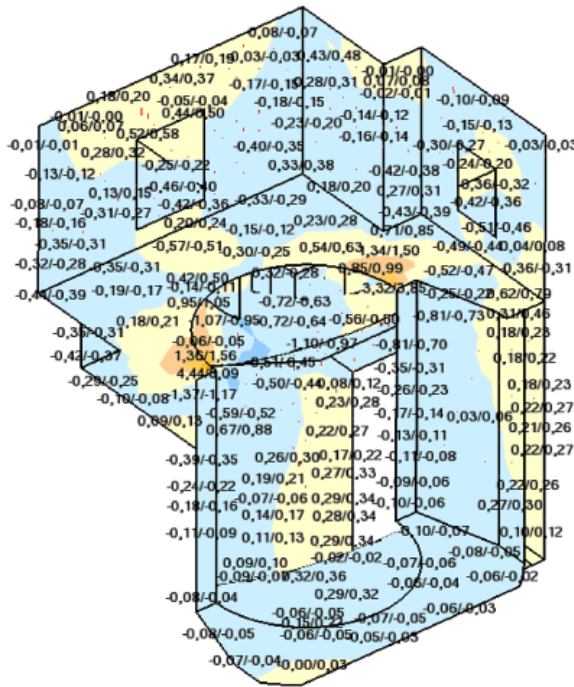
On the basis of calculations, it was ascertained that the maximum value of the reduced compressive stress in the shaft collar does not exceed 1.35 MPa and that the reduced value of the maximum tensile stress is 3.21 MPa. The tensile stress of this value occurs only locally at the place of support of the ventilation channel on the shaft collar.

Fig. 7. Map of the reduced normal stress [MPa] occurring in the collar – a view from the side of the shaft

3. The maximum value of compressive stress in the reduced shaft collar has been determined on the basis of numerical calculations and did not exceed 1.35 MPa and occur locally at

the base of the shaft collar of the shaft support structure. The maximum value of reduced tensile stress in the analyzed element is 3.21 MPa and occurs only locally at the site of the ventilation channel on the back of the shaft collar. It should be noted that the shaft collar was made as a reinforced concrete structure and the location where tensile stress was applied and steel inserts have been used – in the form of a reinforced concrete bar.

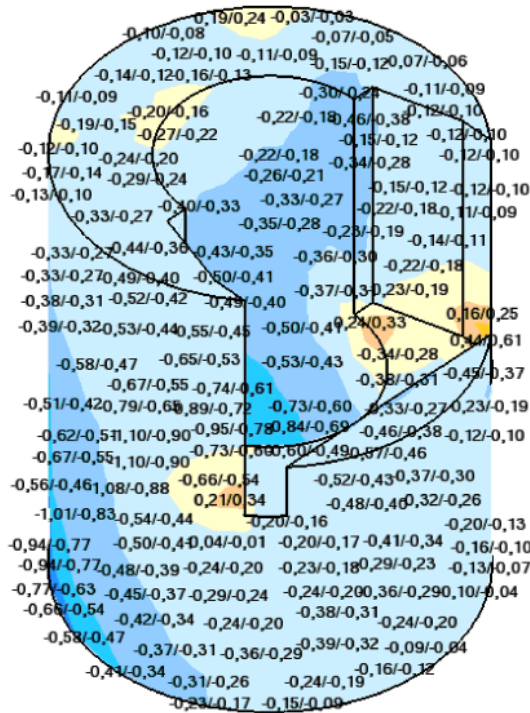
In the case of the shaft support structure the maximum value of the reduced compressive stress is 1.1 MPa. In turn, the reduced tensile stress values do not exceed 0.61 MPa. It should be emphasized that the values obtained for both the reduced compressive stress and the tensile stress do not exceed the strength of the material from which the shaft support structure is made.

Fig. 8. Map of the reduced normal stress [MPa] occurring in the shaft support structure  
– view from the canal shaft

4. Based on the results of numerical calculations it can be concluded that the critical stress in the shaft support structure is compressive stresses with a maximum value of 1.1 MPa. In turn, the reduced tensile stress value of the shaft in the support structure does not exceed 0.61 MPa. The obtained values of reduced stress, both compressive and tensile loads do not exceed the strength of the material from which the shaft support structure is made.

5. On the basis of the analysis carried out it can be concluded that both the collar and shaft support structure are able to transfer the additional load coming from the ventilation duct. It is necessary to carry out continuous monitoring of the displacement of individual elements of the ventilation duct installed by observing seals and the analysis of the results of surveys of the guide shaft deflection and hoist tower. It is also recommended to carry out constant monitoring of ground deformation by using special measures, which are described, amongst others, in the work of Gustkiewicz et al. (2004).
