M. HAWRYLUK^{*#}, Z. GRONOSTAJSKI*, M. KASZUBA*, J. KRAWCZYK*,
P. WIDOMSKI*, J. ZIEMBA*, M. ZWIERZCHOWSKI*, M. JANIK^{**}

WEAR MECHANISMS ANALYSIS OF DIES USED IN THE PROCESS OF HOT FORGING A VALVE MADE OF HIGH NICKEL STEEL

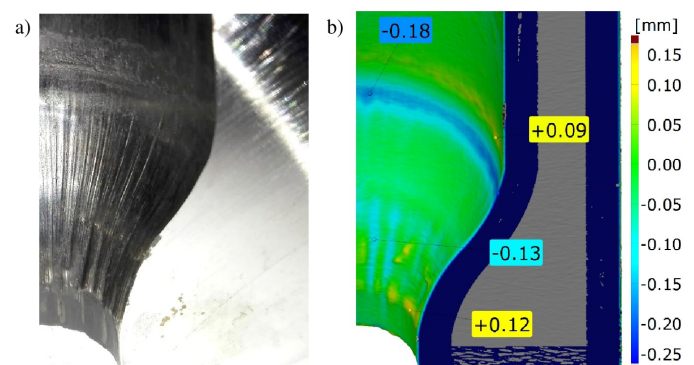
Fig. 3. The tool surface after 900 working cycles: a) macro view, b) comparison of laser scan image with CAD model

grooves, about 0,1 mm deep, formed along the direction of the forging material shift on the tool surface (area II). The biggest loss (-0.18 mm) is observed in the area of the tool's contact with the sharp edge of the charge material cut from bars (area II, point 1).

Also, we can observe locally present material allowances reaching 0.12 mm, which probably represent the areas of plastically deformed tool surface. The allowances may also mean the high nickel steel charge material being stuck to the die surface.

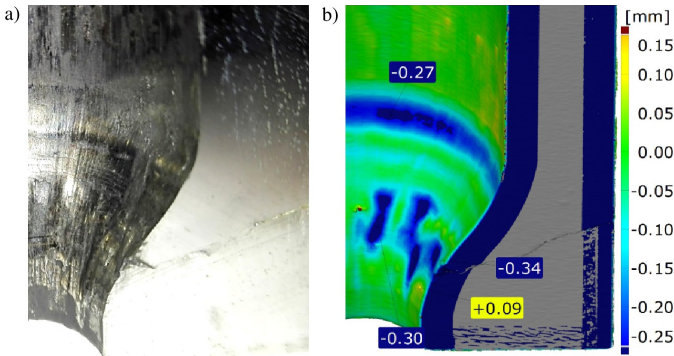
Fig. 4. The tool surface after 1900 working cycles: a) macro view, b) comparison of laser scan image with CAD model

The highest wear was observed on the surface of the tool which worked through the biggest number of forging cycles, i.e. 1900 (Fig. 4). The material losses reach 0.30-0.34 mm and are extensive. On the surface, we can also notice cracks and traces of plastic deformation in the surface layer, visible on the surface in the form of deformed cracks as well as protruding fragments constituting the allowance whose values reach over 0.15 mm.

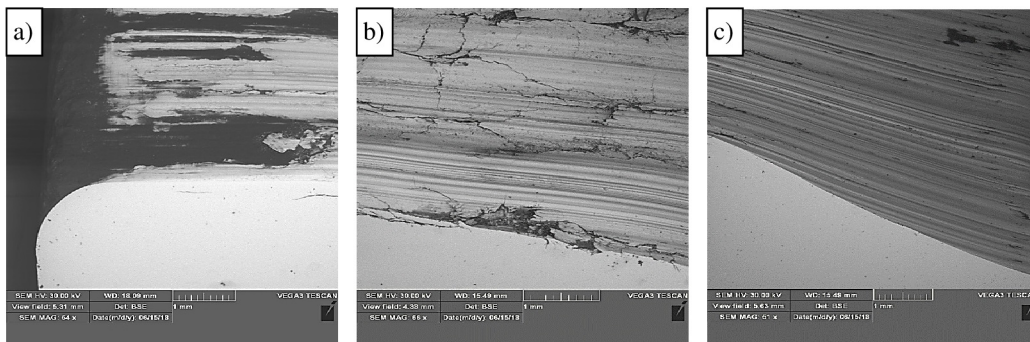
On the tool's surface (Fig. 11), after it has produced 900 forgings, we can observe oxide layers in the area of the radius and the throat (Fig. 11a-b). Layers of this type characterize in a different shade of grey during the analysis performed with the use of a BSE detector on a scanning electron microscope. In Figures 11a-b, they are visible as the darker zones in the areas between the thermal fatigue crack networks. It is also possible to notice production impurities on the surface (in the crack area). Fig. 11b shows deep grooves originating from abrasion wear. The direction of the grooves is in accordance with the direction of the forging material flow. Grooves of the same direction are visible in the other analyzed areas (Fig. 11c). Fig. 12 shows the results of the SEM analysis for 3 main selected tool areas for the first operation of forging an engine valve, after 1900 forgings.

Fig. 11. View of the analyzed die surfaces after producing 900 forgings: a) zone I, b) zone II, c) zone III

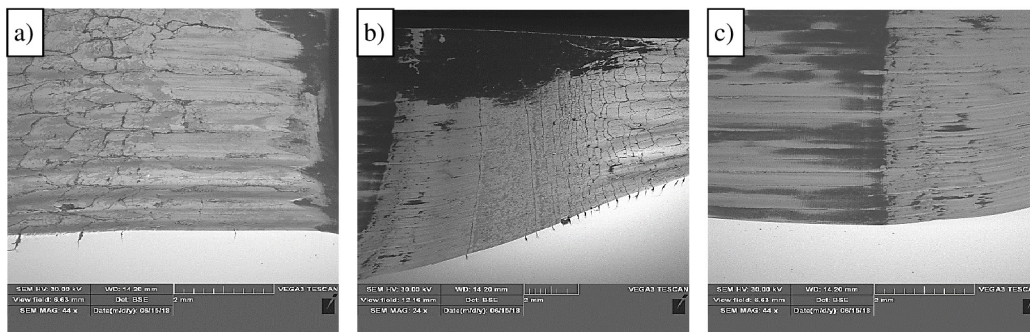
For the analyzed die, which produced 1900 forgings, we can observe the presence of a small layer of oxides in the area of the radius and the throat (Fig. 12a-b) – there are some darker areas visible during the tests with the use of a BSE detector. The EDS analysis confirmed those areas to contain iron oxides. What is more, Fig. 12a and Fig. 12b show deep grooves originating from abrasion wear. The direction of the grooves is in accordance with the direction of the forging material flow. In this area, we can observe a large number of cracks originating from thermal fatigue, which, in some areas, are plastically deformed. This may prove a loss of stability of the surface layer and its tempering. A result of this phenomenon is a drop of hardness in this area. Grooves of the same direction are visible in the other analyzed

Fig. 12. View of the analyzed die surfaces after producing 1900 forgings: a) zone I, b) zone II, c) zone III

areas (Fig. 12c), while, in this zone, it is possible to observe an almost complete removal of the surface layer (scale and worn tool material), which was not observed for the die after 900 forgings.

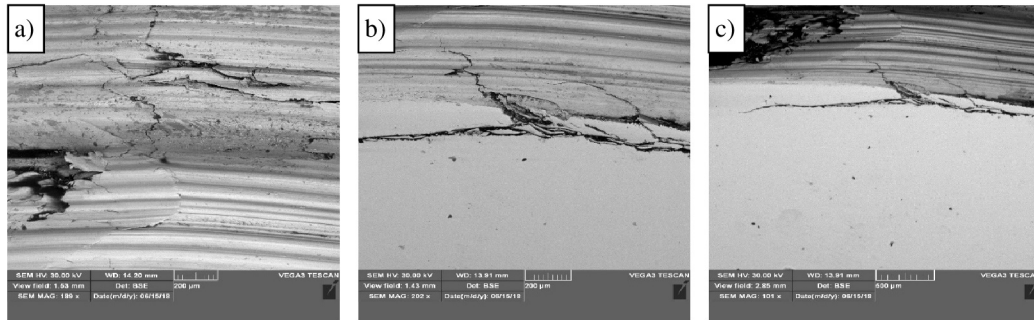
The analyzed area (Fig. 13) contains numerous grooves and scratches. In the groove pits, we can see impurities and, in some of them, a small amount of oxides. In the groove area, we can also see plastic deformations. In the thermal fatigue crack areas,

it is possible to notice zones of tool material plastic deformation as well as subsurface cracks at the depth of about 150 μm.

Fig. 13. Analysis of zone I for a tool which produced 900 forgings

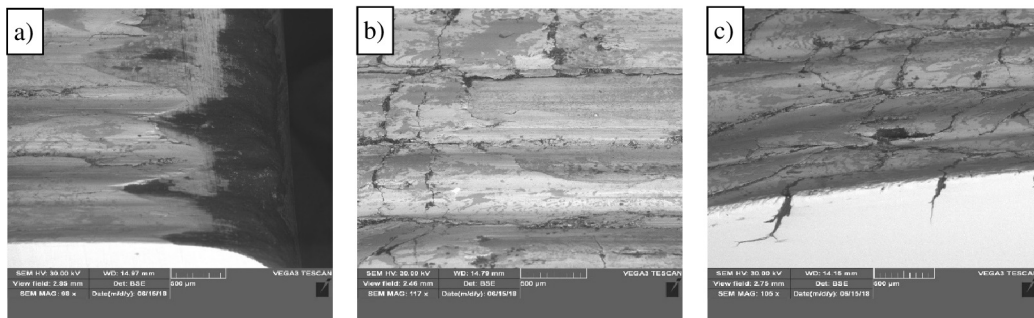
The analyzed area (Fig. 14) contains numerous grooves and scratches. In the groove pits, it is possible to see impurities and iron oxides (which was confirmed by the EDX analysis – Fig. 14c). In the groove areas, we can notice plastic deformations, numerous cracks and tool material spillings (Fig. 14b).

In the thermal fatigue crack areas, tool material plastic deformation areas are visible (Fig. 14c) as well as subsurface cracks at the depth of about 500 μm. In the deformed material areas, we can see the presence of an additional material (Fig. 14b), which probably comes from the material of the forging. Fig. 15 shows another microstructural image, for which, additionally, the chemical composition was provided.

Fig. 14. Analysis of zone I for a tool which has produced 1900 forgings

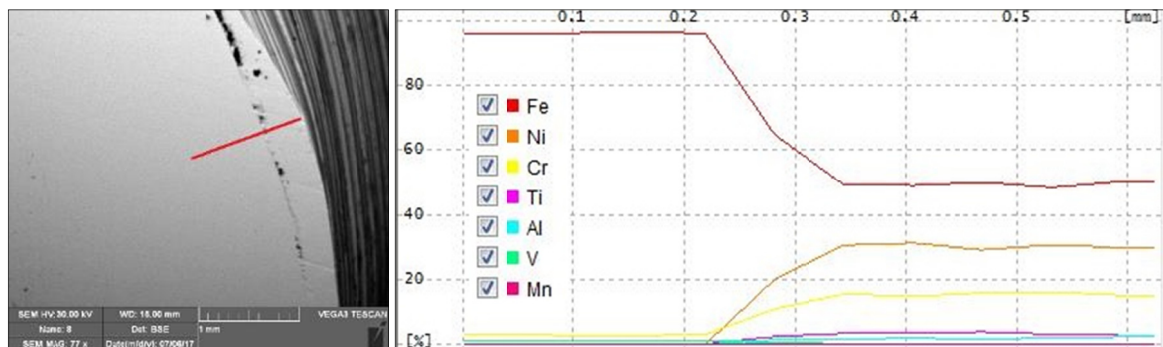
The analysis presented demonstrated a varying element content along the vector marked in yellow in Fig. 15. While in the diagram, the values on the left correspond to the chemical content of the tool steel for hot operations, which, beside cast

Fig. 15. Results of the chemical composition tests in the forging section for a tool which has produced 1900 forgings in zone I

steel, also contains alloy additions, such as Cr, V, Mn. A clear change in the chemical composition signifies the beginning of the forging material area, which adheres to the die surface. This material characterizes in the following contents: about 30% nickel, 15% chromium and 2% titanium in an iron matrix. This result is in accordance with the assumed chemical composition of tool steel W360 ISOBLOC and the composition of the forging material – high nickel steel. The obtained results (Fig. 15) confirm the previous observations of the forging material being stuck to the tool surface in the analyzed area. An additional material is distributed on the surface, forming a layer of a varying thickness, reaching even 0.5 mm, which forms a new working surface. An effect of the sticking (adhesion) of the shaped material to the tool is a change in the geometry of the tool section through the narrowing of the die opening, a low quality of the forging surface, excessive friction of the shaped material with the formed layer, as well as blocking of the forging during the process of its extrusion.

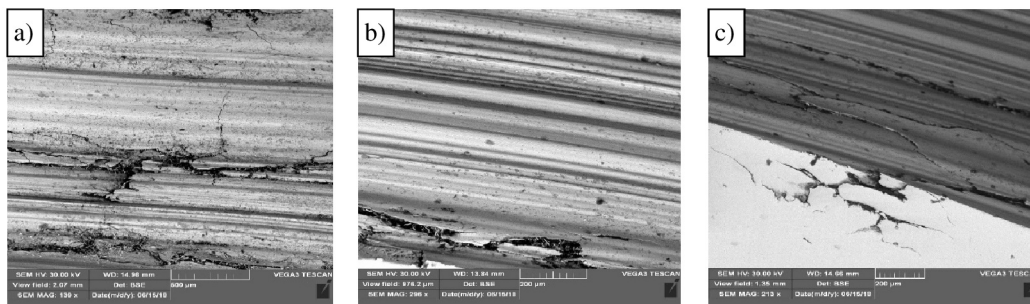
The analyzed area (Fig. 16) contains numerous grooves of different widths 25-100 μm and depths 5-25 μm . We can also notice cracks originating from thermal fatigue. The cracks propagate to the depth of about 300 μm from the surface. On the surface, it is possible to see sticking of the plastically deformed material (Fig. 16c).

Fig. 16. Analysis of selected areas in zone II for a tool which has produced 900 forgings

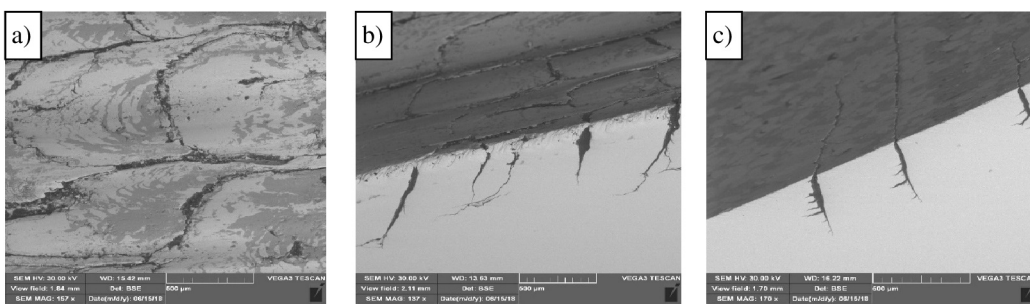
Fig. 17. Analysis of zone II for a tool which has produced 1900 forgings

The analyzed area (Fig. 17) contains numerous grooves of different widths 500-750 μm and depths 25-50 μm . We can also notice cracks originating from thermal fatigue. The cracks propagate to the depth of about 500 μm from the surface. On the surface, it is possible to see sticking of the plastically deformed material (Fig. 17a-b). In the groove and crack areas, we can observe a material in the form of oxides and impurities from the production process. The cracks filled with iron oxides originating from the tool material were confirmed by the EDX analysis. In the area of transition into the arc section, cracks without plastic deformation are visible (Fig. 17c). Their depth is about 350-500 μm . They are also filled with iron oxides coming from the tool material. This proves a relatively high temperature of the tool in these areas.

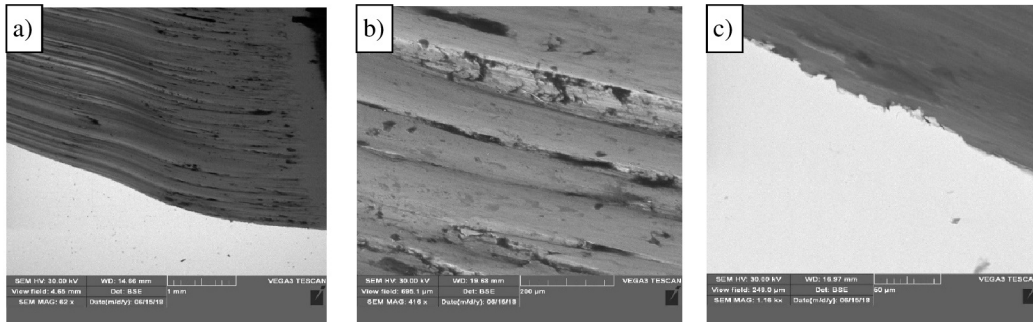
The analyzed area (Fig. 18) contains numerous grooves in the radial area, which fade in the further section of the tool. In the groove areas, we can see the lack of material cohesion (Fig. 18b). In the radial area (Fig. 18a), no thermal fatigue cracks were detected. Beyond the radius, no wear was observed, as well as no grooves, fatigue cracks or other traces of wear.

Fig. 18. Analysis of zone III for a tool which has produced 900 forgings

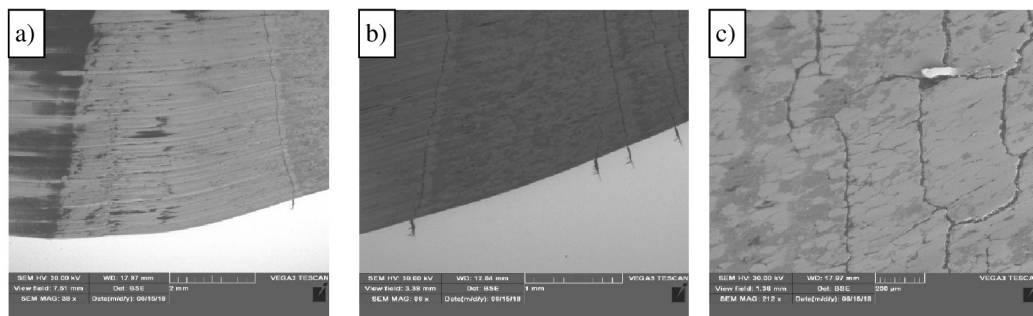
The analyzed area (Fig. 19) contains numerous grooves in the radial area, which fade in the further section of the tool (Fig. 19a). In the transition zone, we can notice material cracks originating from thermal fatigue (Fig. 19b). Cracks of this type

Fig. 19. Analysis of zone III for a tool which has produced 1900 forgings

were not visible for the tool which had produced 900 forgings. Also, it is possible to notice a network of primary and secondary cracks (Fig. 19c) in the transition area, covered with a small amount of oxides.

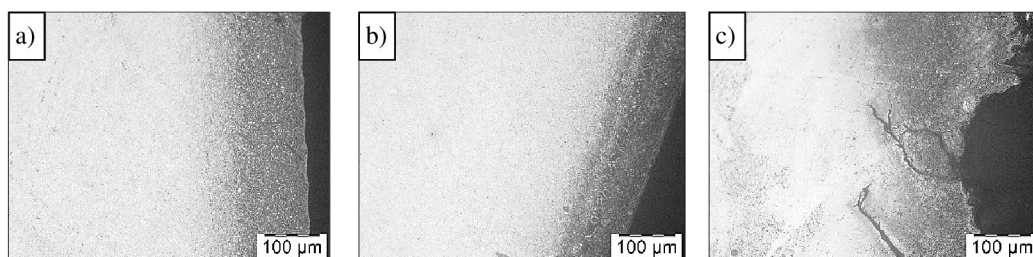
The performed light microscopic tests confirm the fact that the tool which has produced 1900 forgings exhibits a much higher degree of wear. The previously presented SEM investigations for the tool which has produced 900 forgings point to the presence of only a few deep cracks.

Fig. 20. Exemplary microstructural images with a visible nitrided layer and a few cracks. The tool has produced 900 forgings: a) in zone I, b) in zone II, c) in zone III

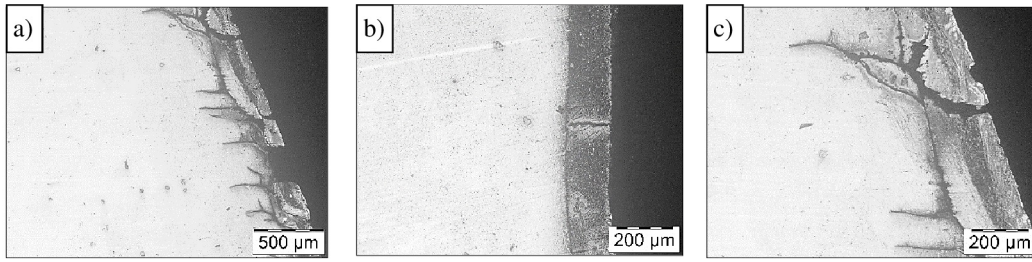
For the tools after a larger number of forgings, the cracks are much deeper; also, as it can be observed in Fig. 21a and

Fig. 21c, material losses as well as a strongly deformed material in the surface layer are present. We can also notice a tendency for spalling of the diffusive nitrided layer for the tools which have produced a larger number of forgings.

Fig. 21. Exemplary microstructural images with a visible nitrided layer and numerous cracks. The tool has produced 1900 forgings: a) in zone I, b) in zone II, c) in zone III

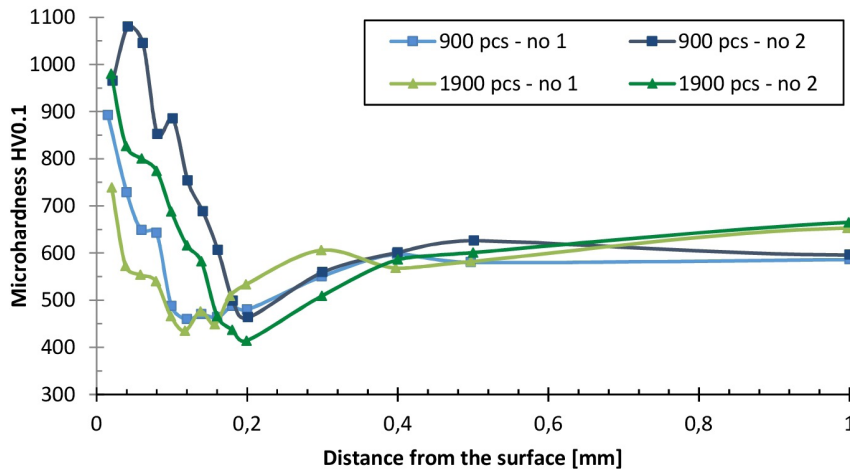
layer, the hardness is lowered to about 900 HV at the surface after 900 forging cycles and to about 740 HV after 1900 forging cycles. This proves a gradual removal of the nitrided surface layer in the surface of the die. At the same time, the hardness analysis in point 2 (Fig. 2) showed that the tool, through the whole operation time, remains in this area without a loss of its mechanical properties. This is confirmed by the lack of abrasive loss in this region and the presence of only a few fatigue cracks on its surface. The performed analysis confirms that the stability of the nitrided layer in this area is still high.

Fig. 22 shows visible effects of a loss of stability of the nitrided layers of the tools to the depth of about 0,2 mm after

900 forging cycles and to about 0.4 mm after 1900 forging cycles. This may prove the presence of high temperatures in the vicinity of point no. 4, caused by the highest deformation of the forging material and the highest pressures. The tempering and plastic deformation of the tool in the region are confirmed by the light microscopic analysis – Fig. 23, where one can see deformed cracks down to the depth of about 0.5 mm from the surface.

Fig. 22. Microhardness measurement results in point no. 1 and no. 2

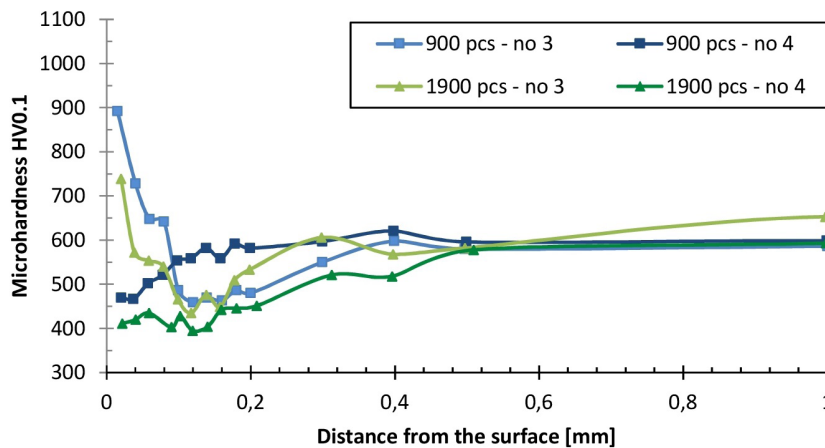
The presented results prove the occurrence of local overheating of the shaping tools' surface layer, which results in their total tempering in such a short operation time. As it has been discussed above, the large number of losses and cracks, their

Fig. 23. Microhardness test results in points no. 3 and no. 4
