An Analysis of the Demolition of the Cereal Elevator Building within a Conservation Protection Zone: Considerations of Technical, Functional-Utility, and Economic Factors

Maciej NIEDOSTATKIEWICZ *¹ and Tomasz MAJEWSKI¹

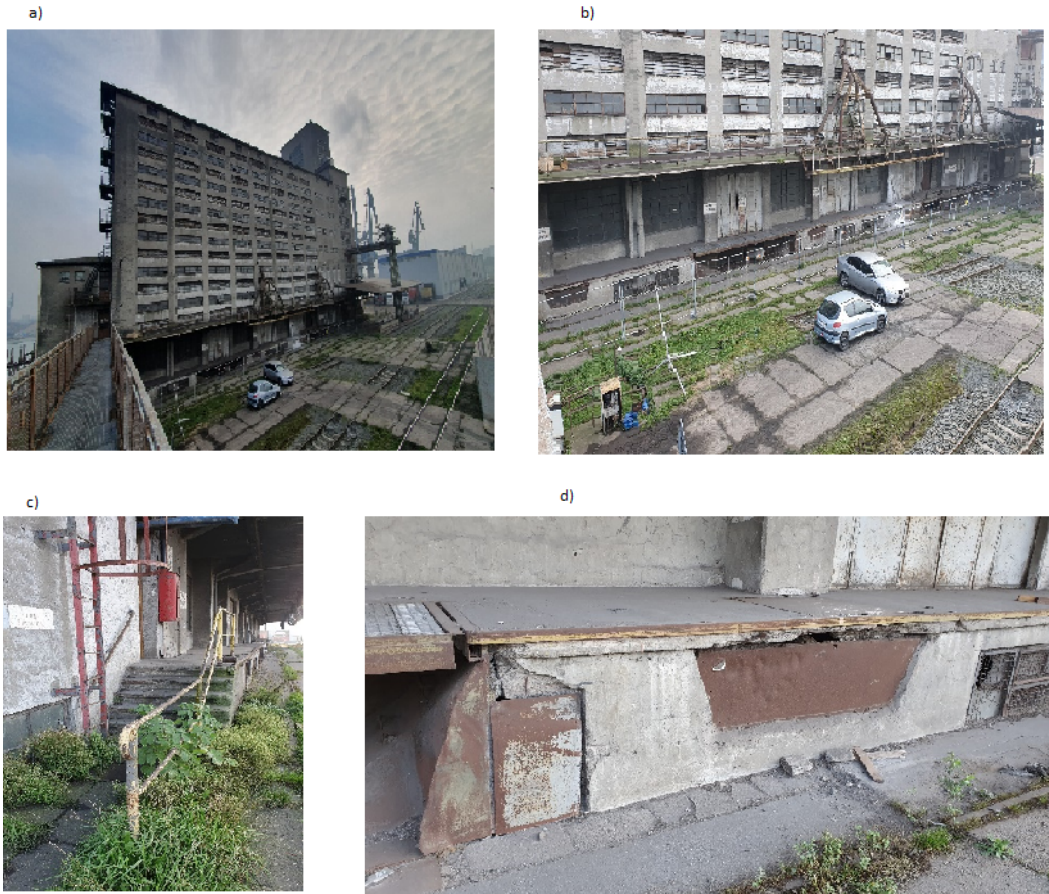
Figure 1. Grain Elevator building - elevation from the land side: a) general view, b) close-up, unloading ramp at the ground floor level: c) general view, d) damage in close-up

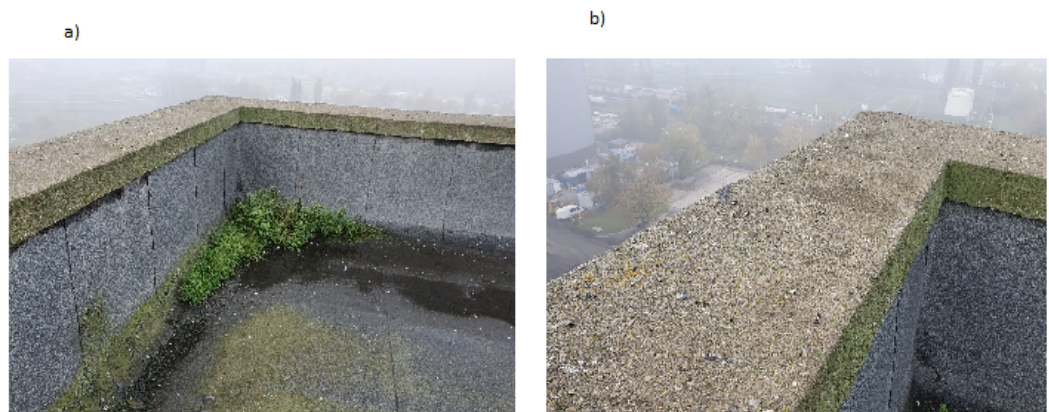
Figure 2. Grain Elevator building - roof level: decapitalization of: a) roofing felt (blistering and unevenness), b) cornice elements (carbonation)

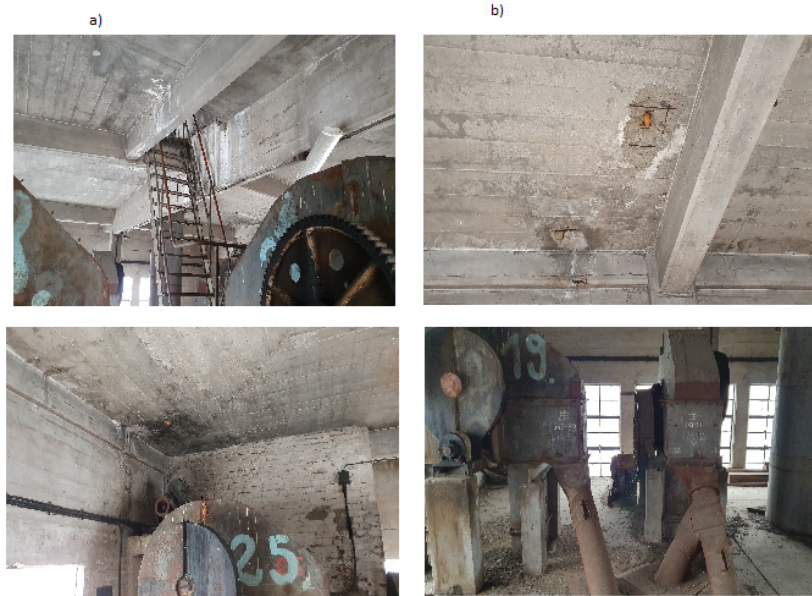
Figure 3. Grain Elevator building - level +10: a) mechanical damage to structural elements, b) defective and incomplete equipment for transporting loose materials

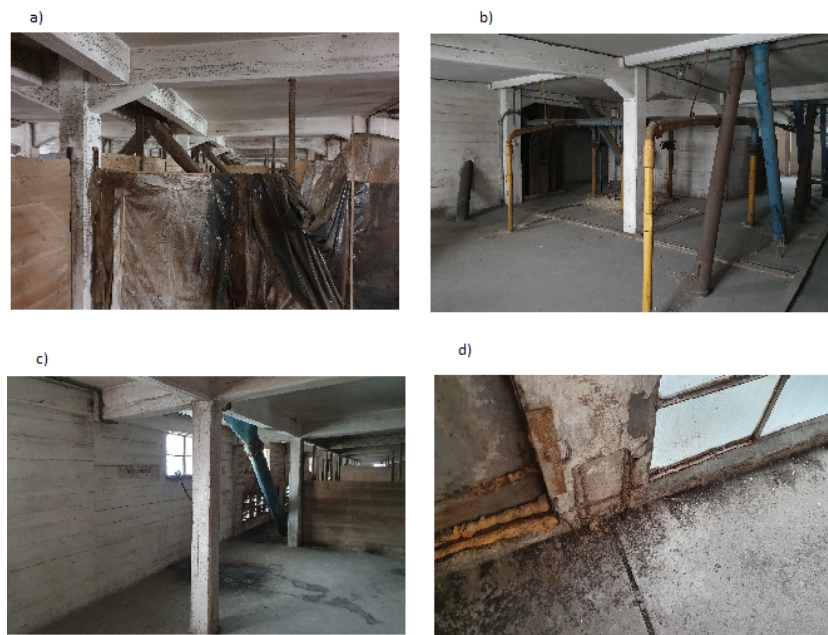
Figure 4. Grain Elevator building - level +7: a), b), c) division of the usable area with wooden partitions, d) falling off the concrete cover in the floor zone

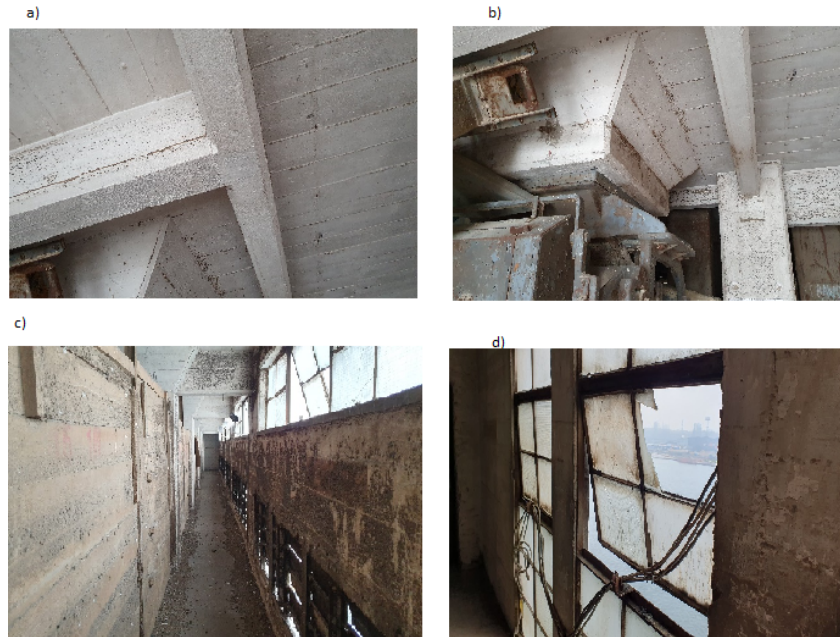
Figure 5. Grain Elevator building - level +5: a) mechanical damage to structural elements, b) equipment for transporting loose materials left inoperative and incomplete, decapitalization of: c) ventilation shutters, d) window joinery

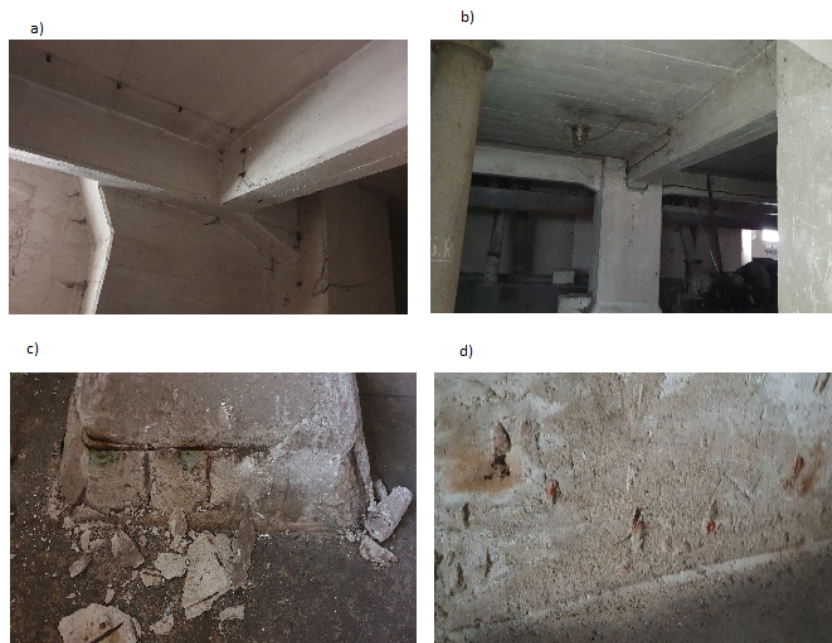
Figure 6. Grain Elevator building - level -1: a) mechanical damage to structural elements, floor zone: c) concrete cover falls off the column heads at the level of the foundation slab, d) moisture in the outer wall
