A COMPARISON OF COMPOSITE SPECIMENS DAMAGE AREA MEASUREMENTS PERFORMED USING PULSED THERMOGRAPHY AND ULTRASONIC NDT METHODS

Air Force Institute of Technology, Księcia Bolesława 6, 01-494 Warsaw, Poland

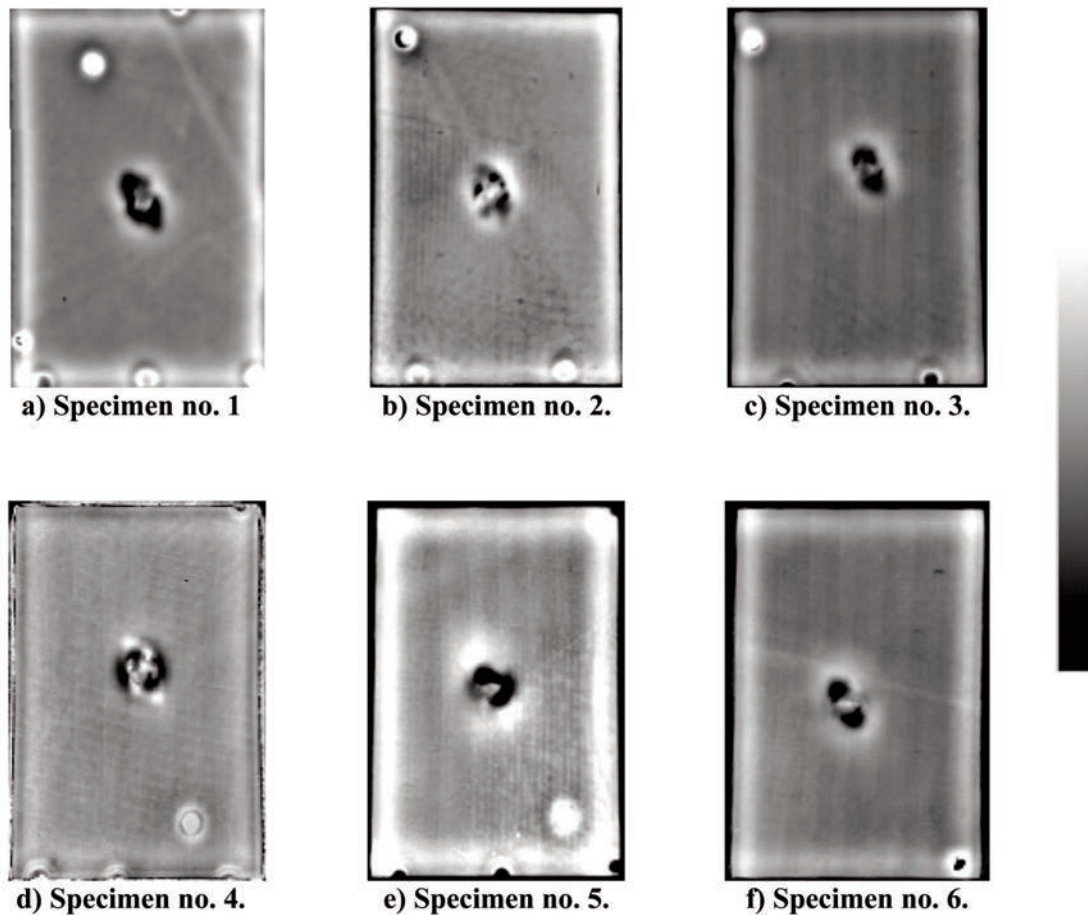
The results obtained with the thermography method are presented in Figure 2. For each measurement, one image in grayscale is shown. Different shades of gray represent different values of temperature's first derivative. The damage is visible in the central area of each specimen, as shaded areas clearly differ from the surrounding material.

The metal rivets remaining in the structure are visible close to the specimens' edges.

Figure 2. Outside surface. Thermographic inspection result.

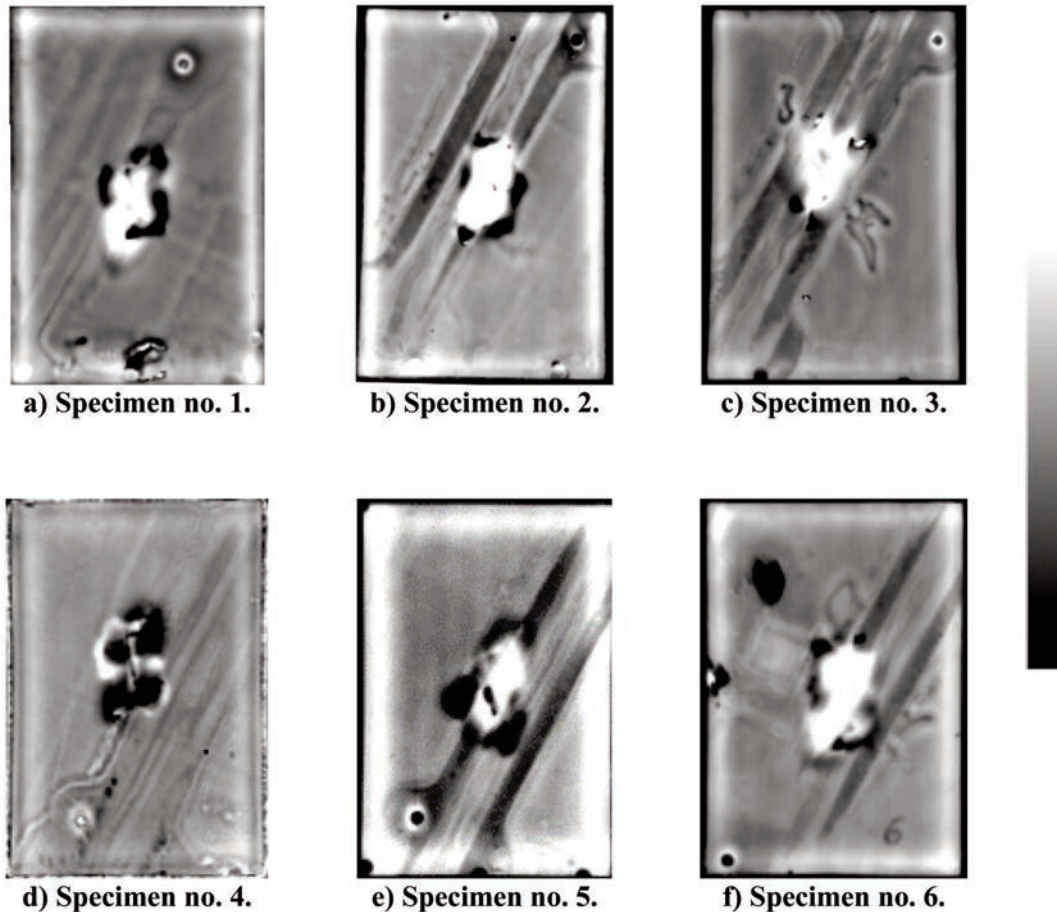
Below, in Figure 3 (a-f), the thermographic results of the specimens' inside surfaces are shown. For each specimen, the damage area visible on the inside surface is clearly larger than the one visible on the outside surface. Besides the rivets, the remnants of composite stringers, located at an angle to specimens' edges, and the irregular shapes of the remaining adhesive can be seen.

Figure 3. Inside surface. Thermographic inspection result.

Differences between the results obtained with thermographic inspection for inside and outside surfaces of the specimens are significant and caused by the damage geometry- the largest areas of fiber layers' separation are located near the inside surface (3.5 ÷ 4.2 mm deep), and can remain undetected during inspection of the outside surface. The presence of a paint layer can also be a factor. The irregular shape of the damage also affects the precision of determining its size.

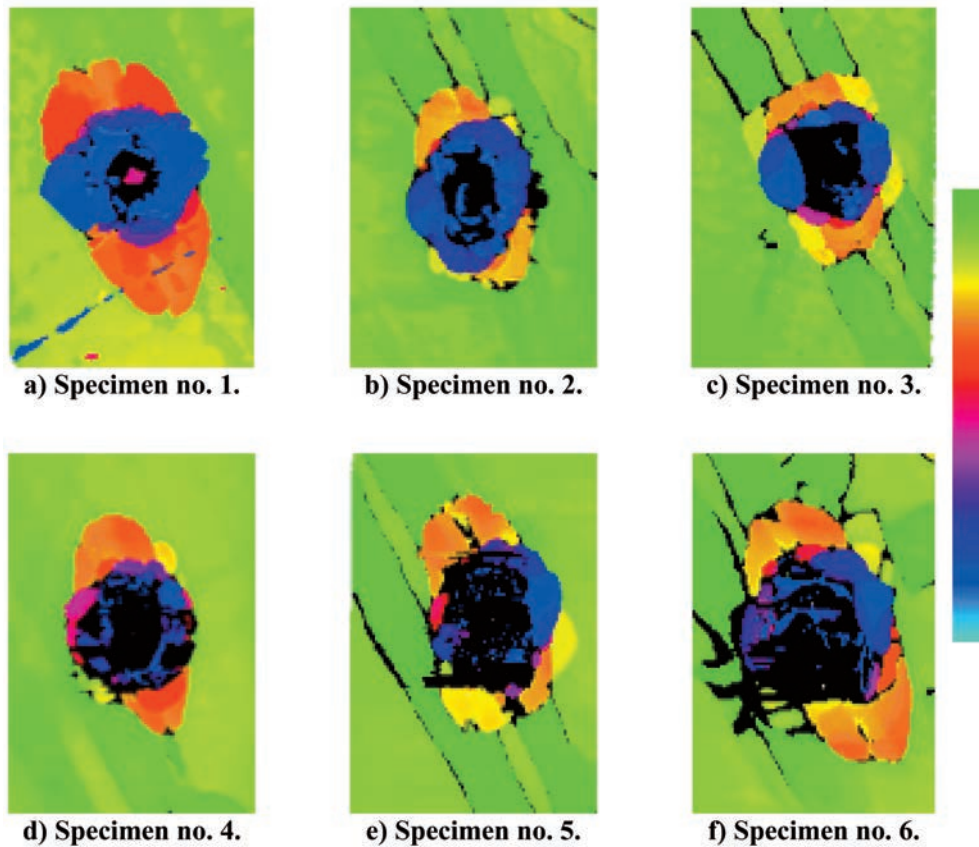
The ultrasonic inspection results are presented in Figure 4 (a-f) in the form of a C-scan mode as 2D color maps. Each color represents a different depth of detected surface. Black color marks areas with increased signal attenuation, where no reflected signal was registered, or it was too attenuated to be registered. Inspection of a single specimen took approximately 10 minutes.

Figure 4. Ultrasonic inspection result.

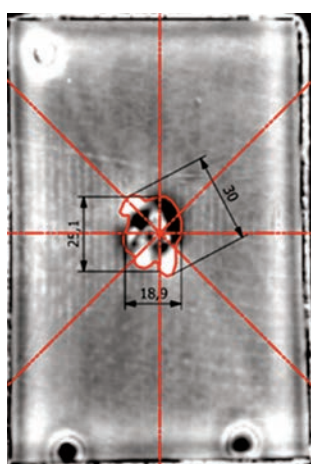
Figure 5. An example of damage dimensioning-thermographic method, outside surface.

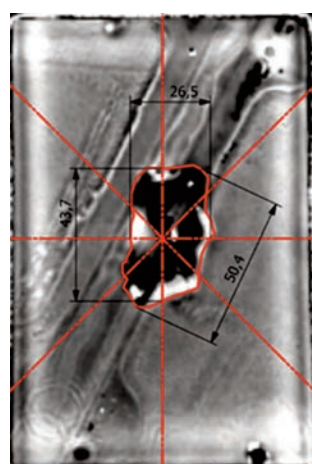
Figure 6. An example of damage dimensioning-thermographic method, inside surface.

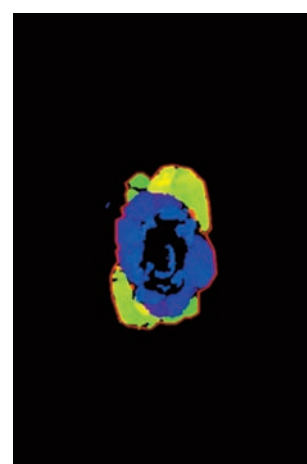
Figure 7. An example of damage dimensioning-ultrasonic method.
