Renovation works in buildings in the area of former defensive fortifications

Abstract

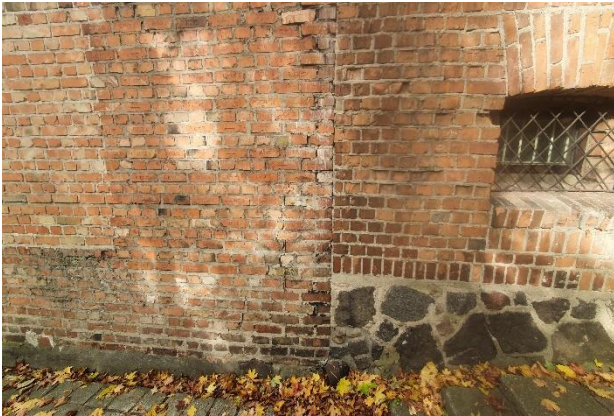
Photo. 2: No masonry bond at the junction of the former office spaces (A) with the former staff apartment (B), part of which are the rooms of the Southern Guardhouse

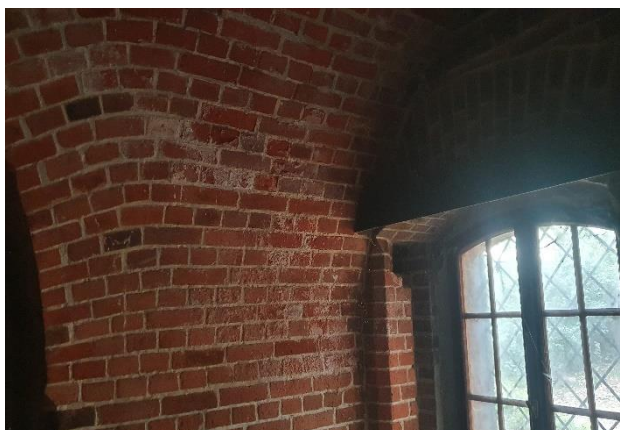
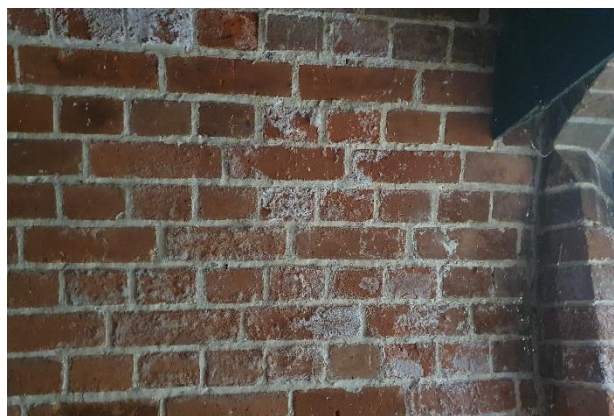
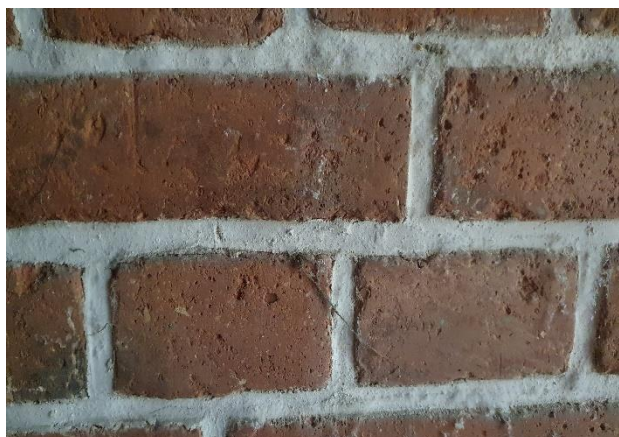
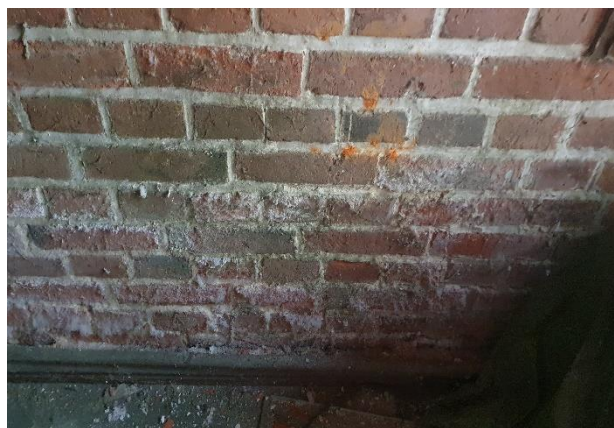
In the rooms of the former service apartment (B), local traces of dampness were visible, both in the floor area and at the height of the wall. In the historical part of the South Guardhouse, cracks and scratches in the plaster on the fillings under the brick arches were visible. Salination was visible on the surface of the walls inside the rooms of the Southern Guardhouse (Photo 6a and 6b), particularly intense on the surface of bricks, on fragments of walls that were subjected to renovation works in the past period. The porous lime-sand mortar was replaced with a sealed cement or cement-lime mortar (Photo 6c and Photo 6d).

In the rooms of the Southern Guardhouse, on the walls, especially in the floor zone, salt efflorescence and brick discoloration were visible on the surface of the brick wall - this situation was caused by the capillary rise of moisture resulting from the lack or technically inefficient anti-moisture insulation of the vertical and horizontal parts of the walls sunk in the ground. Similar faults and damages also occurred locally on keystones and runoffs of brick vaults and were a consequence of moisture seepage from the roof side as a result of local leaks in the roofing as well as due to the lack of proper thermal insulation of the roof over part (B) of the Building Complex. .

Photo. 6: Salting the walls inside the rooms of the former service apartment (B)

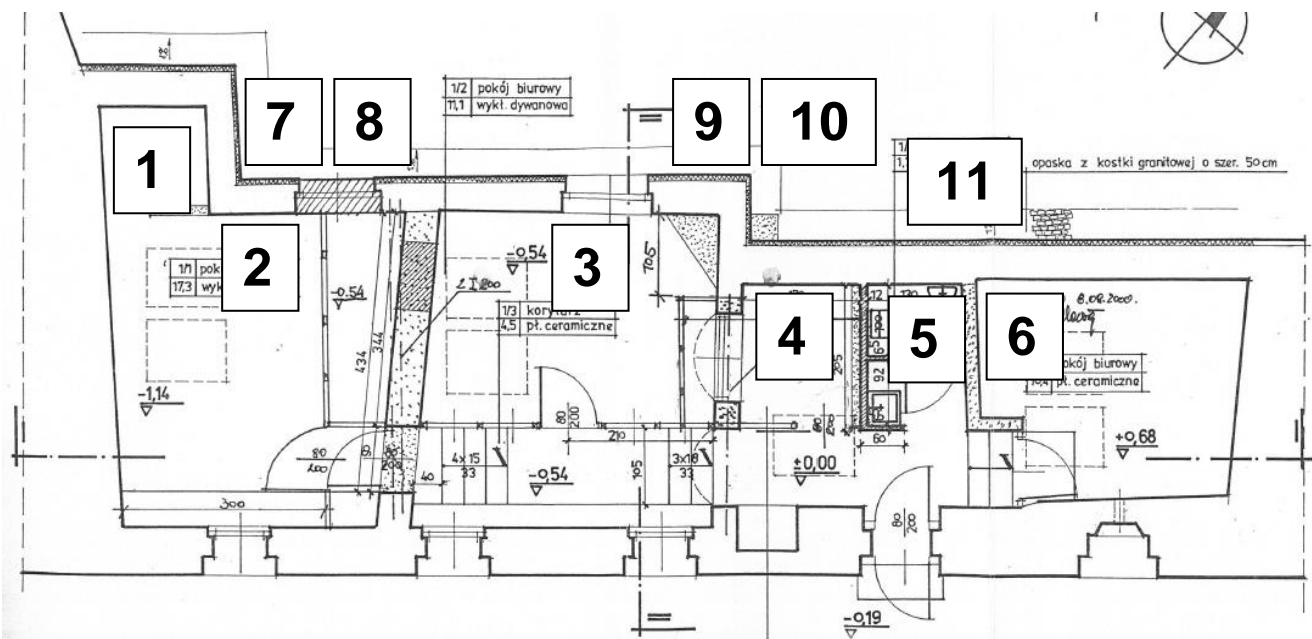
In order to estimate the method of constructing the wall from the side of the slope in the area of the former office premises (A), excavations were made, both from the outside and the inside of the building (Fig. 2). Thanks to the excavations made, it was checked whether the historical, brick reinforcements of the escarpment were used during the construction of the rear wall. Based on the excavations made, it was found:

Fig. 2: Location of opencasts in the external wall (on the slope side) of the former office rooms (A): 1, 2, 3 ... - number of the opencast

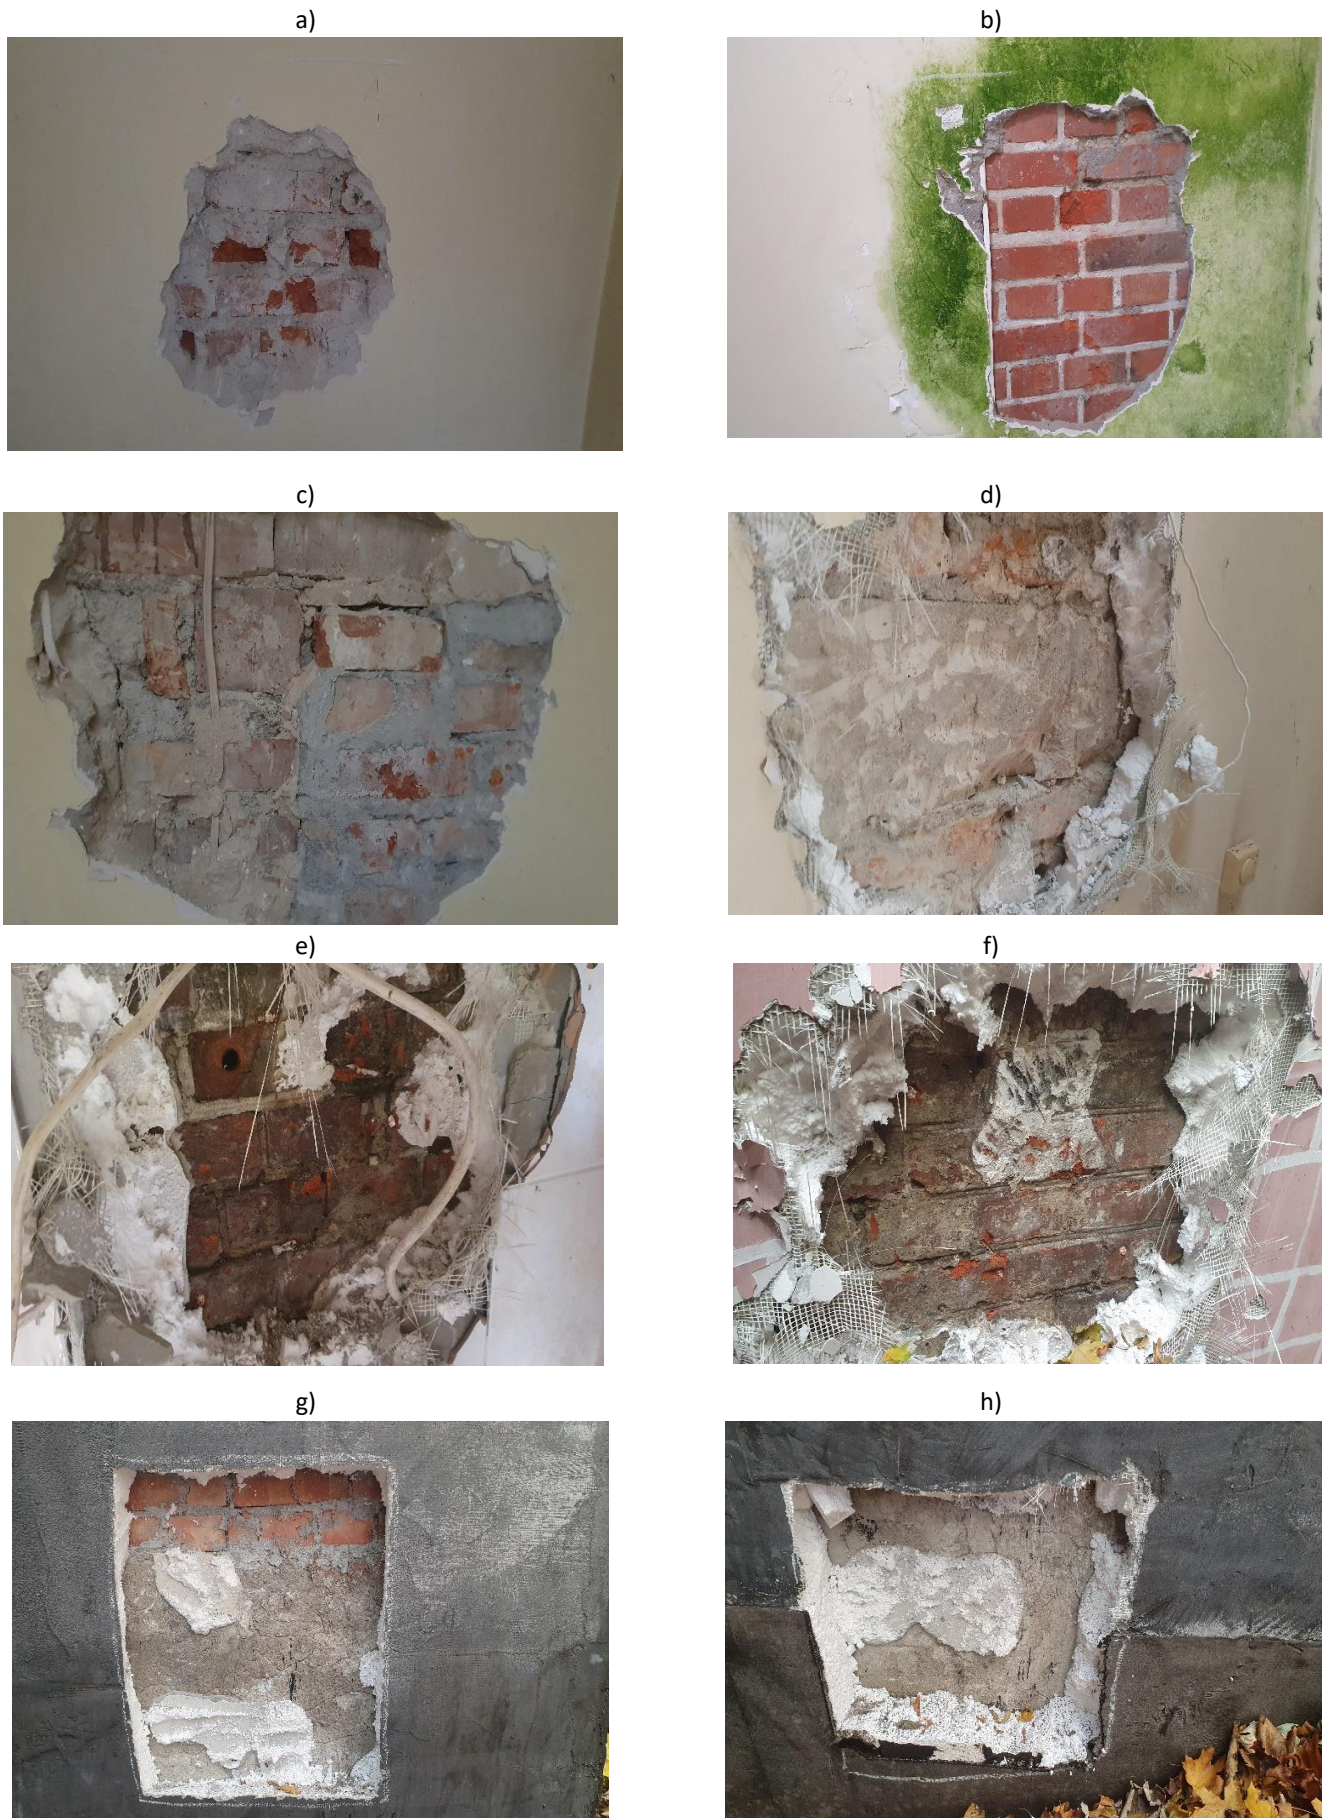
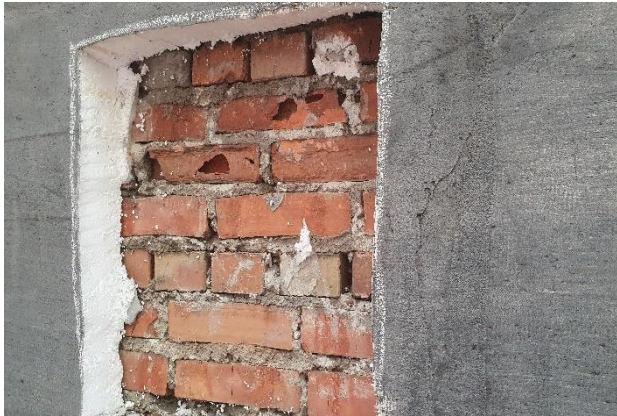
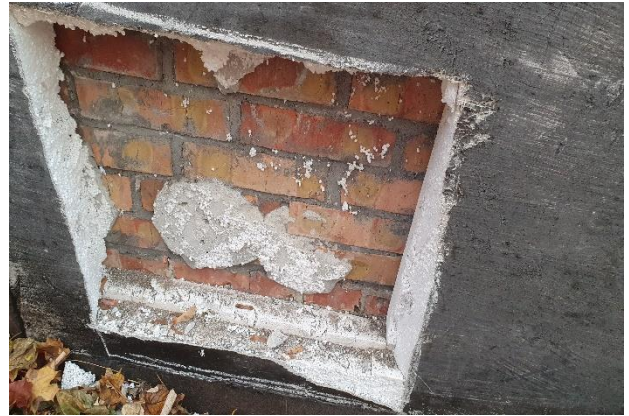
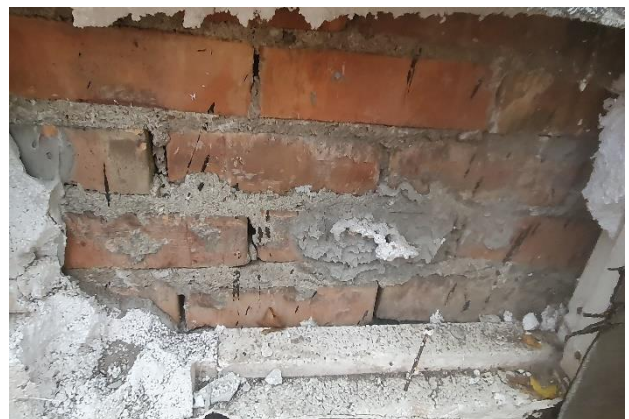
- inner outcrop (inside the building) O1: contemporary brick wall + cement-lime plaster from the inside (Photo 9a),
- inner outcrop (inside the building) O2: contemporary brick wall + cement-lime plaster from the inside (Photo 9b),

- inner outcrop (inside the building) O3: local redevelopment of a modern brick wall with a fragment of a modern wall built later (with high probability in the place of a bricked-up window opening) + cement-lime plaster from the inside (Photo 9c),

- inner outcrop (inside the building) O4: contemporary fragment - brick wall with redevelopment made of cellular concrete (aerated concrete) + 4 cm polystyrene insulation with a protective layer (elevation mesh) and gypsum plaster from the inside (Photo 9d),

- inner outcrop (inside the building) O5: probably an old (historical) brick wall + 4 cm polystyrene insulation with a protective layer (elevation mesh) and glazed tiles on the inside (Photo 9e),

- inner outcrop (inside the building) O6: probably an old (historical) brick wall + 4 cm polystyrene insulation with a protective layer (elevation mesh) and gypsum finish from the inside (Photo 9f),

contemporary brick wall + 10 cm polystyrene insulation with a protective layer (elevation mesh) (Photo 9g),

- external outcrop (outside the building) O8:
contemporary brick wall with a protective layer of plaster + 10 cm polystyrene insulation with a protective layer (elevation mesh) (Photo 9h),
- outdoor outcrop (outside the building) O9:
contemporary brick wall + 10 cm polystyrene insulation with a protective layer (elevation mesh) (Photo 9i),
- outdoor outcrop (outside the building) O10:
contemporary brick wall + 10 cm polystyrene insulation with a protective layer (elevation mesh) (Photo 9j),
- outdoor outcrop (outside the building) O11:
contemporary brick wall + 10 cm polystyrene insulation with a protective layer (elevation mesh) (Photo 9k).

Photo. 9: View of the outer wall (from the escarpment side) of the former office rooms (A): a) O1, b) O2, c) O3, d) O4, e) O5, f) O6, g) O7, h) O8, i) O9, j) O10, k) O11
