OPERATIONAL TESTS OF THE TECHNICAL CONDITION OF TRUCK TIRES

Piotr Cieślak, Daniel Pieniak, Leszek Gil, Artur Dmowski, Andrzej Niewczas

Cieślak P., Pieniak D., Gil L., Dmowski A., Niewczas A., Operational tests of the technical condition of truck tires. *Motor Transport* 66 (2), 17-34

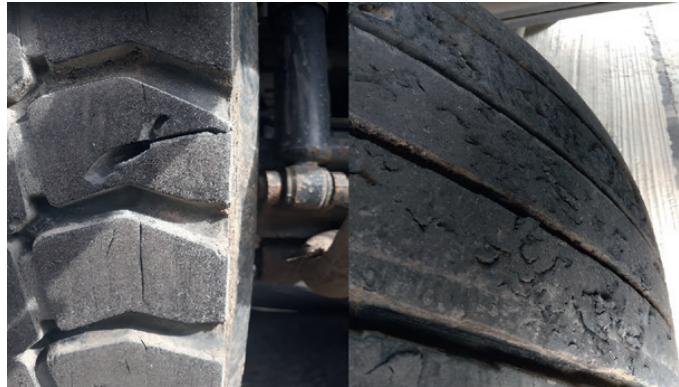
Fig. 16. Examples of tread block cuts

Figures 16 and 17 show examples of cuts to the blocks and tread ribs caused by the use of tires on a stony surface or hitting a sharp object.

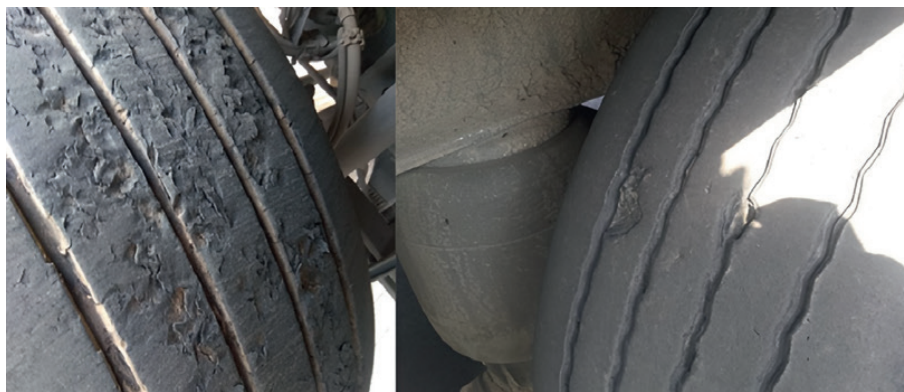
Fig. 17. Examples of cuts to the tread ribs

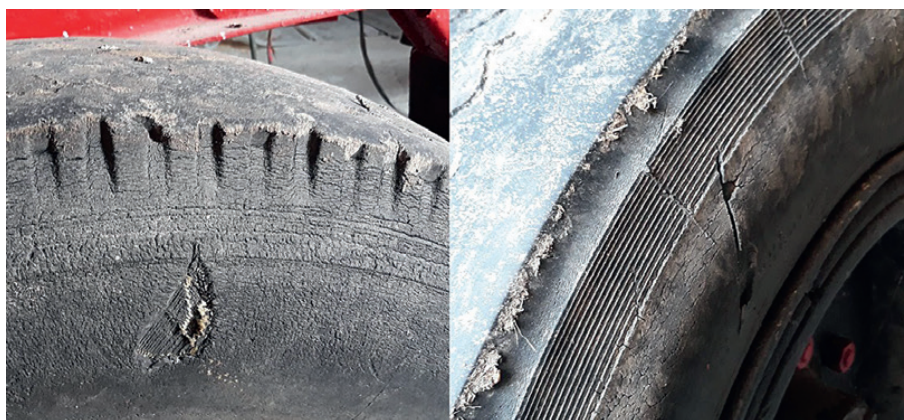
Figure 18 shows examples of tire sidewall damage caused by sharp edges of random objects on the road or by contact with elements of road infrastructure (kerbs).

Fig. 18. Examples of tire sidewall damage

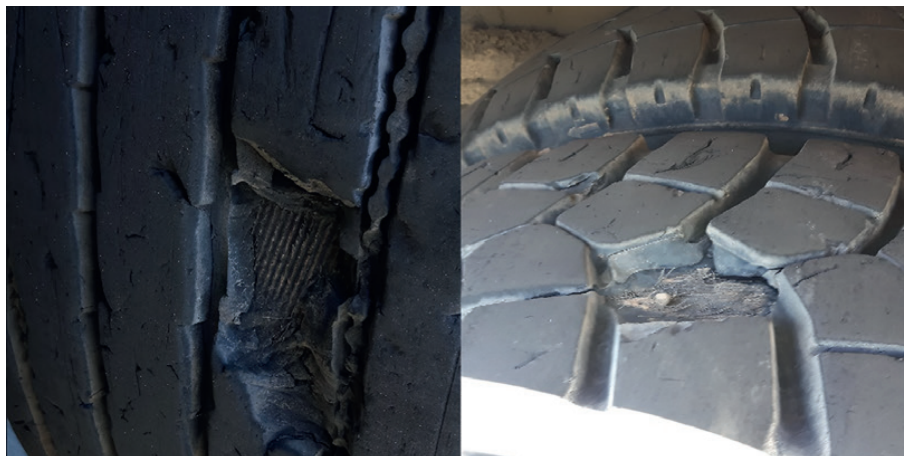
Figure 19 shows the places of the torn off tread fragments. They are probably the result of rapid starts and accelerations of a loaded vehicle leading to wheel slipping against the road surface.

Fig. 19. An example of tearing off a tread fragment

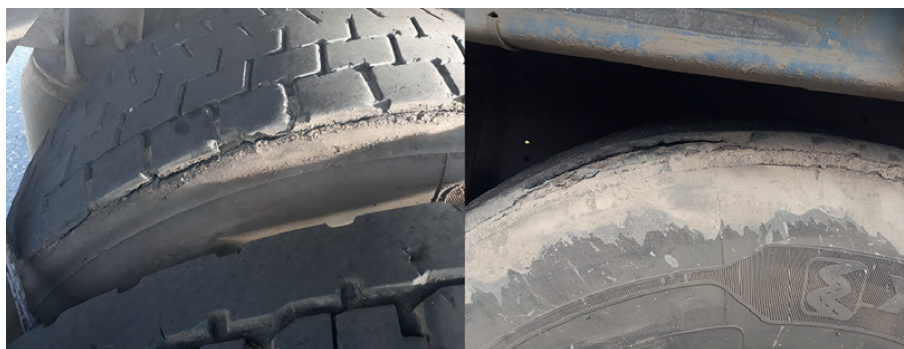
Figure 20 shows an example of damage involving delamination of the tread. The cause of tread delamination is the use of a tire with too

little pressure or with an excessive load. Another cause may be oxidization of the metal and rubber structural elements of the tyre.

Fig. 20. Example of delamination of the tread layer

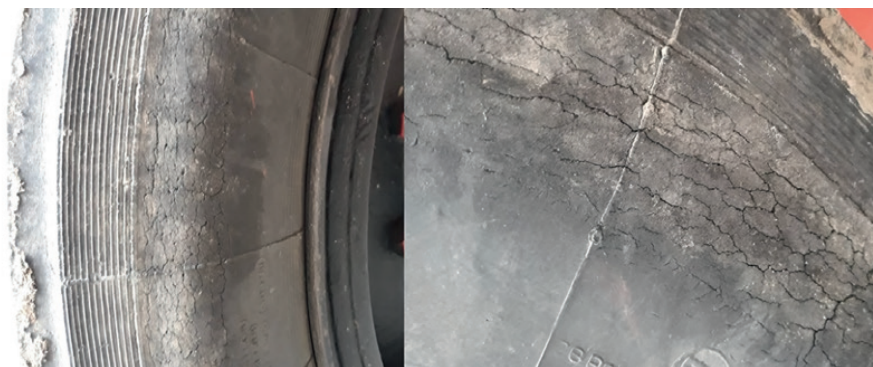
Figure 21 shows an example of fatigue and aging cracking of a tire after a long period of operation. Such damage can be accelerated by using too

high a tire pressure or by not adjusting the vehicle load to the tire load index.

Fig. 21. An example of fatigue and aging cracks in a tire after long-term use

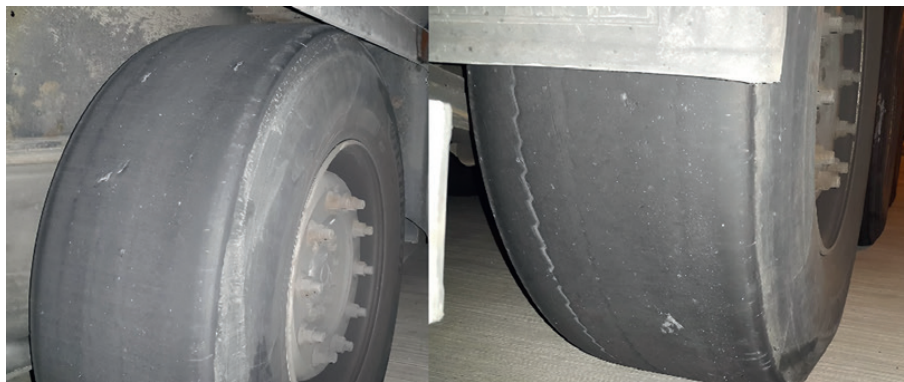
Figures 22-24 show examples of emergency and uneven tread wear. Emergency wear (Figure 22) is understood as the size of the operational

tread height loss, which exceeds the contractually or legally defined limit and is a wear that directly threatens road safety

Fig. 22. Examples of emergency tread wear

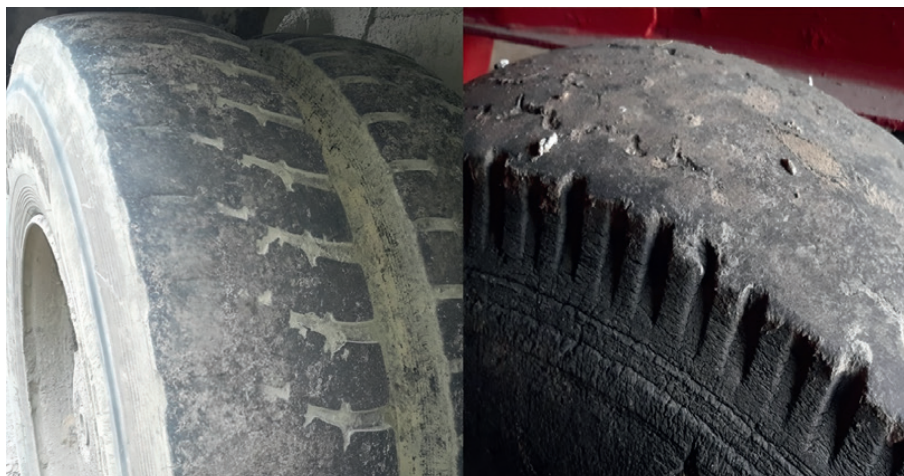
Examples of uneven wear are shown in Figure 23 and Figure 24. Uneven tread wear can be caused by incorrect wheel geometry, faulty car suspension or incorrect tire pressure caused by overloading the vehicle or poor operator handling.

Fig. 23. Example of uneven tread wear

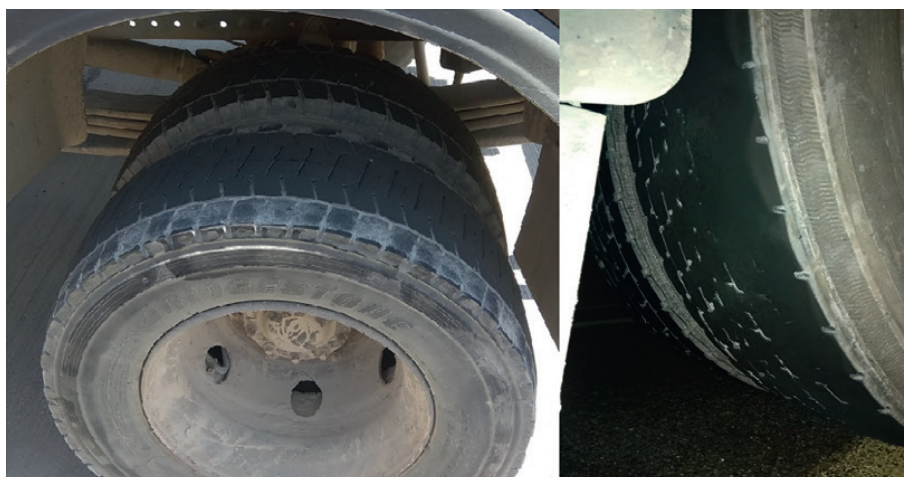
Fig. 24. Example of uneven tread wear
