Construction of optimized energy potential  
Budownictwo o zoptymalizowanym potencjale energetycznym

## Design and assembly errors in the realization of post-and-beam glass facades

**Abstract:** As a result of the dynamic development of technology, glass-aluminum facades are now widely used. Not only representative facades in city centers, but also small buildings, such as commercial and office buildings, are equipped with aesthetic glass facades. To properly fulfill the functions of a curtain wall (thermal protection, water tightness, etc.), glass-aluminum systems must be properly designed and assembled. The aim of the article is to identify the most common errors made when implementing small investments on the basis of information about problems that emerge during assembly, as well as the reasons for complaints filed by investors. The most popular post-and-beam systems on small construction sites were analyzed. The data was obtained from companies operating in the northern part of the Silesian Voivodeship, dealing with the distribution and assembly of these systems. Scoring was made of the negative impact of the identified errors on the structure. It was found that the main pro

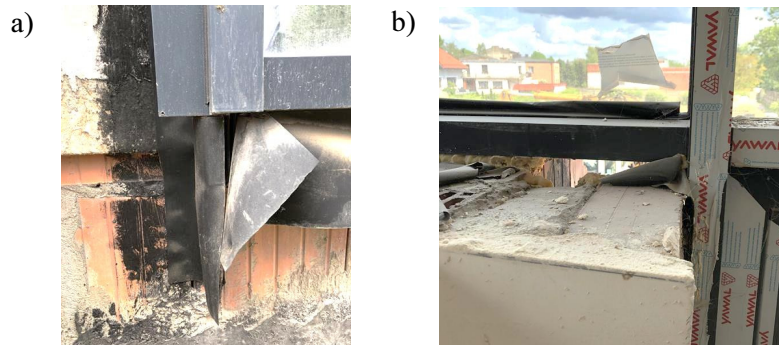
allowing it to evaporate from the space between the building structure and the aluminum profile. Incorrect installation is manifested by the apron falling off the profiles or the building structure (usually no glue) or failure to maintain the tightness between the apron strips. Lack of careful installation results in the loss of water tightness of the connection. Sometimes even the thermal insulation of the connection is omitted (Fig. 2a).

**Fig. 2.** Errors in the connection of the facade with the masonry elements: a) careless installation of the EPDM membrane, b) insufficient details at the interface with the wall (Photo: K. Chęciński)

**Incorrect solutions of details in critical places.** The construction of the curtain wall requires special attention to details such as the connection of the curtain wall with the ceilings, and the end of the facade at the bottom and top. Errors in this regard occur frequently and result in deterioration of water tightness and the formation of thermal bridges at the edge (Fig. 2b).

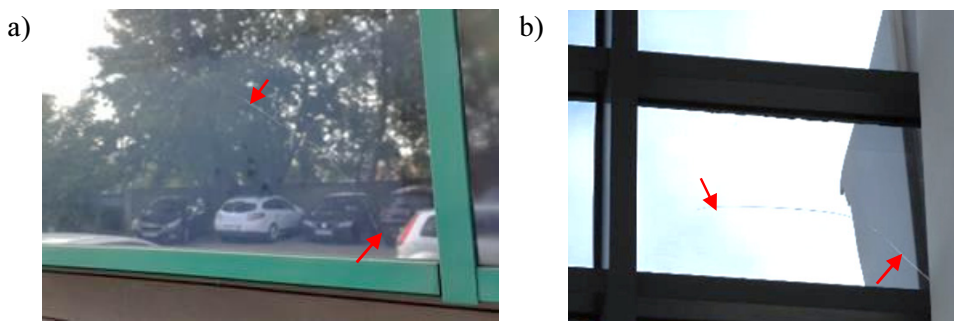
**Incorrect support of filling elements.** This is a mistake that is often made because of the popular opinion of a minor requirement. In principle, the beams are used to maintain a constant distance between the posts, but their other, equally important function is to transfer the weight of the filling to the posts. Thus, the uneven distribution or lack of the glass washers may result, firstly, in an uneven load on the posts, and, secondly, in a glass breakage caused by large local stresses in the area of the glass-washer interface. It is usually an initially small crack propagating from the edge of the glass pane in a direction close to perpendicular (Fig. 3a).

**Wrong dimensions of fillings.** Usually the sizes are selected automatically by programs dedicated to a given system, hence the number of errors is limited. Nevertheless, for example, in the case of the need to replace the panes or due to manufacturing errors in the spacing of posts and beams, the dimensions of the fillings may not be properly adapted to the real structure. If the glass is too shallow in the post profile, it may cause leaks. Too deep embedding of the glazing can lead to thermal cracks usually propagating from the side edge of the glass unit (Fig. 3b).

**Fig. 3.** Cracks in the fillings caused by: a) incorrect support of the glass panes (Photo: Z. Respondek), b) too deep setting of the IGUs (Photo: K. Chęciński)
