Causes of cracks of chemical apparatus made of austenitic steel

Subject of the research

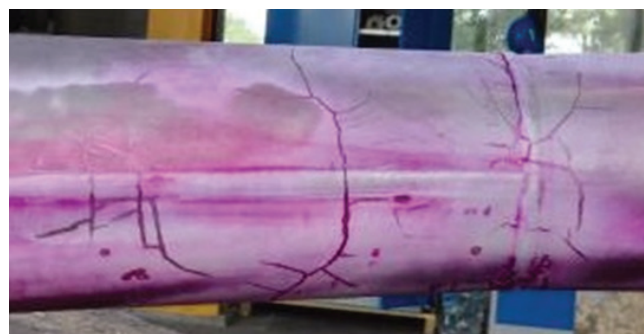
On the injector's surface (Fig.1), visible cracks in all directions are visible to the unaided eye and cover the whole perimeter of the tube. Most visible cracks pass through the material. After cutting out the middle part of the pipe sample, in which the longitudinal weld connects to the peripheral one, its self-acting disintegration into smaller fragments shown in Figure 2 occurred. A layer of brittle sediment was visible on the inner surface of the pipe.

Fig. 1. The appearance of the pipe after penetration tests

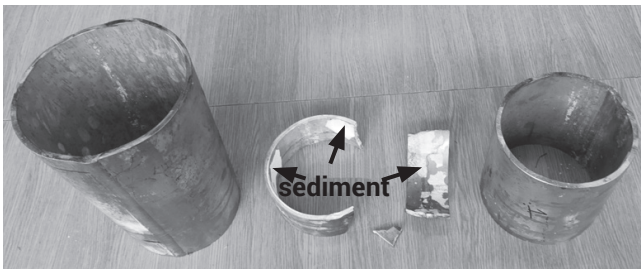
Fig. 2. View of the pipe fragments after cutting it open

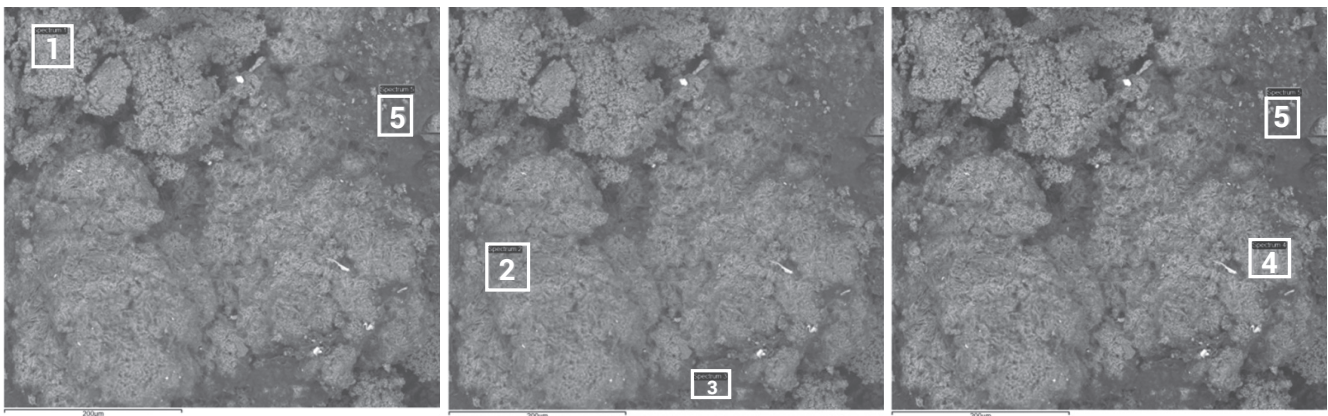
The sediment located on the inner surface of the pipe, resulting from the contact with the medium – the calcareous leachate, was taken for analysis. The analysis was performed on a Hitachi S-3400N scanning microscope with an EDX adapter. Two sides of the collected sediment were analyzed from the medium side and from the injector' surface (Fig. 3 and 4). The results of measurements are presented in tables II and III. Particular attention is paid to the high

Fig. 3. Marked places where chemical composition was analyzed by means of EDX on the side of the sediment in contact with the medium – calcareous leachate, SEM

chlorine content, which depending on the place of measurement reaches up to 10% by weight, which is a factor strongly conducive to such types of corrosion as: pitting, crevice and stress of the steel [8].

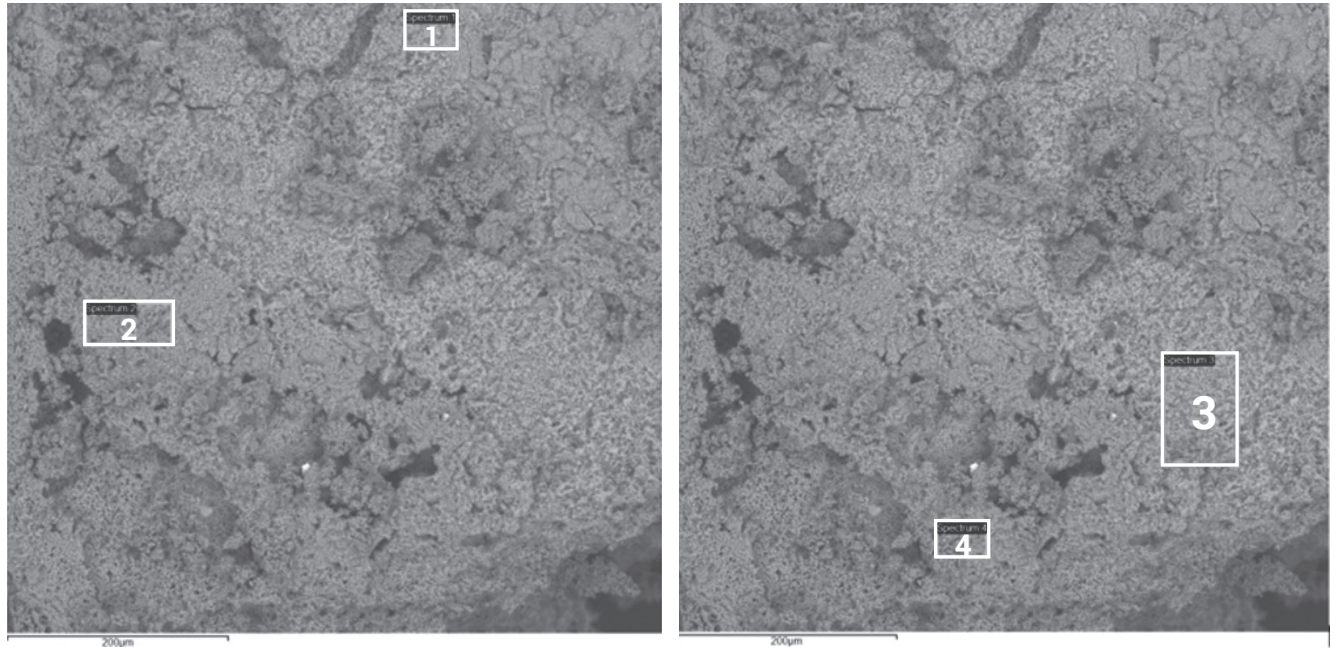
Fig. 4. Marked places where the chemical composition was analyzed by means of EDX on the surface of the sediment in contact with the inner wall of the pipe, SEM

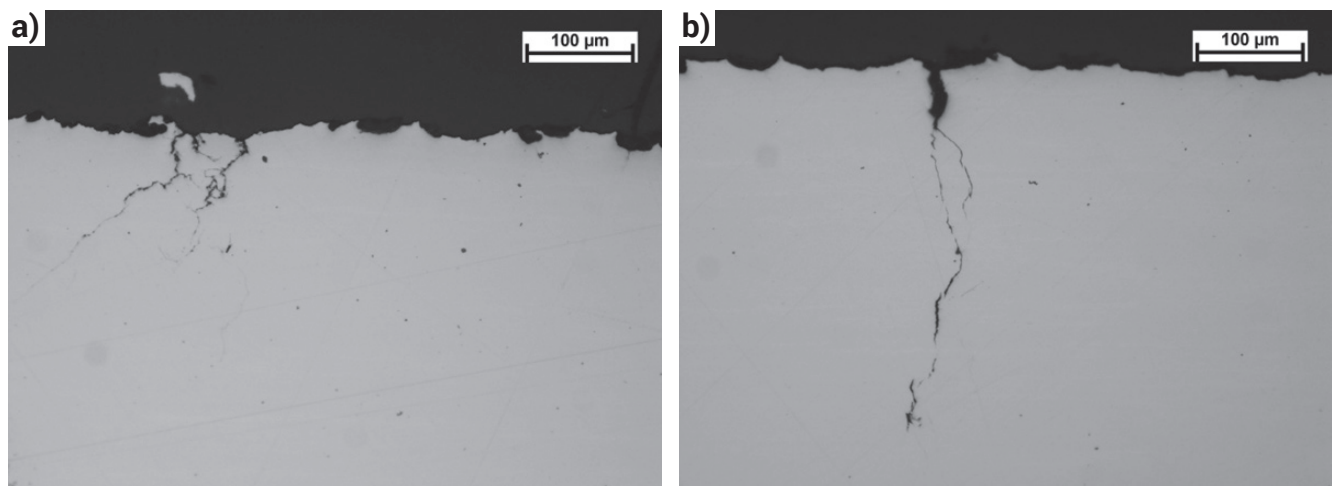
Cracks visible in the pictures are typical for stress corrosion. Corrosive cracks run deep into the material, generally trans-crystalline, and branch out at the ends (Fig. 6). Such cracks occur in both steel and in the weld zone as well as in the heat affected zone (Fig. 7).

Fig. 5. 0H18N9 steel: a), b) corrosive cracks. Chrome carbides at grain boundaries. Light microscopy. Non-digested samples. Magn. 200x

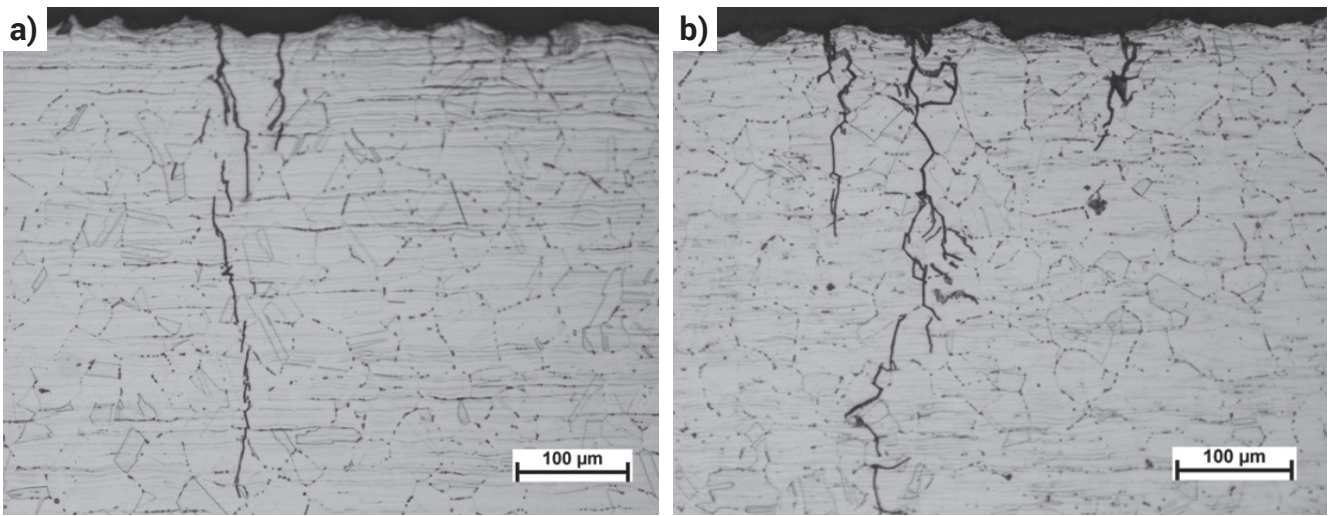
The chromium carbides visible at the grain boundary (Fig. 6) do not form a continuous net, but are arranged in separated precipitates. Only locally, on the part of the grain border, continuity of carbide precipitates can be noticed. This is

Fig. 6. 0H18N9 steel: a), b) corrosive cracks. Chrome carbides at grain boundaries. Light microscopy. Samples digested with Mi31Fe. Magn. 200x

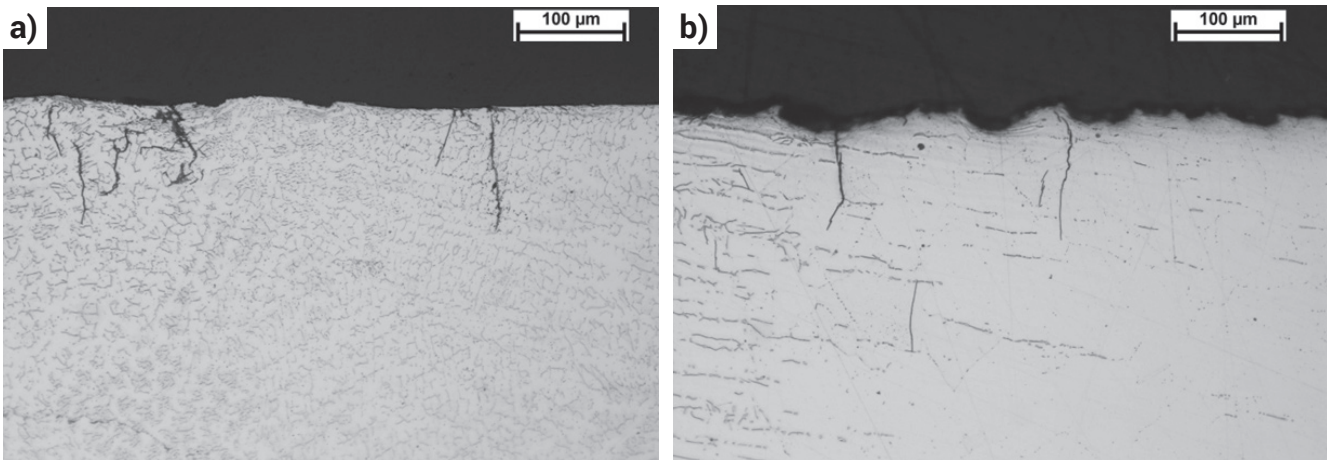
Fig. 7. Welded joint: a) weld structure, b) structure of the SWC zone. Light microscopy. Samples digested with Mi31Fe. Magn. 200x

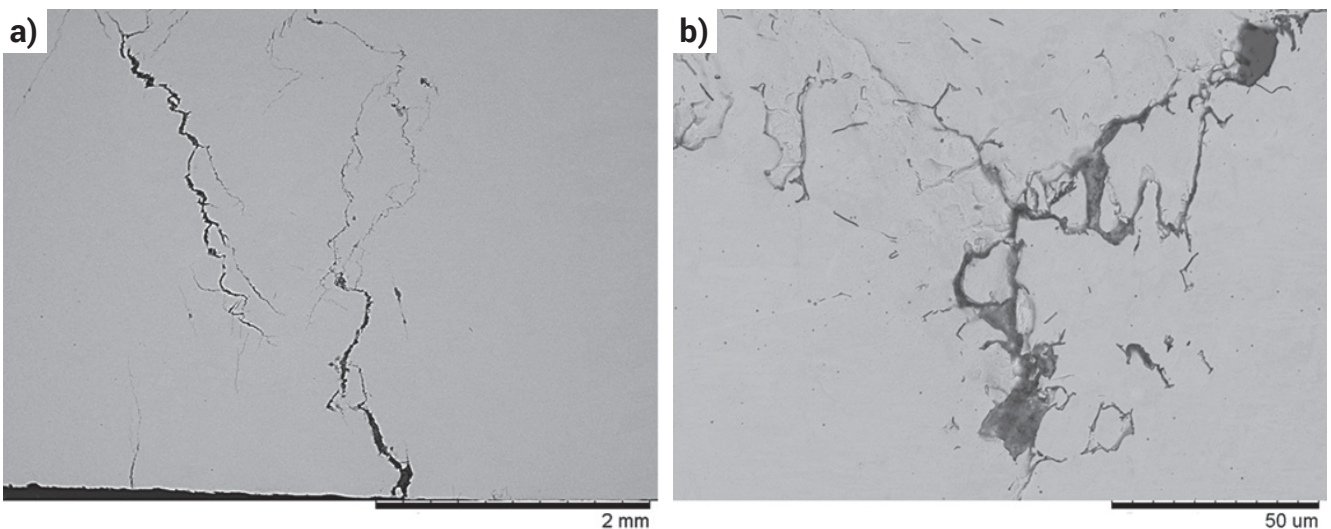
confirmed by the results of investigations of microstructures made with a SEM microscope (Fig. 8÷9) of samples with cracks. The chemical composition analysis was made from the fragment of material marked in Figure 8. The presence of separated carbides confirms the results of the analysis of the chemical composition of the precipitates, shown in Figure 9 and Table IV.

It can therefore be concluded that in the case of the pipe under test, intercrystalline corrosion was not the reason for the material cracking. It should be noted, however, that

Fig. 8. Cross-section of a pipe section: a) corrosion cracking, b) enlarged crack fragment, SEM

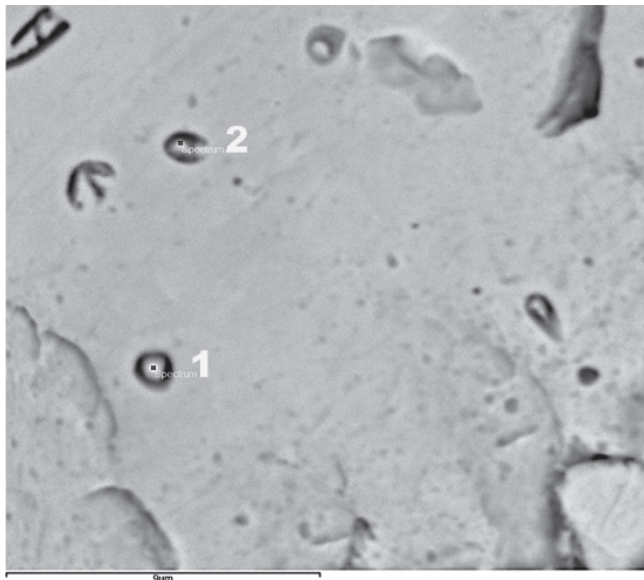
Fig. 9. Marked places where the chemical composition of precipitates was analyzed by means of EDX

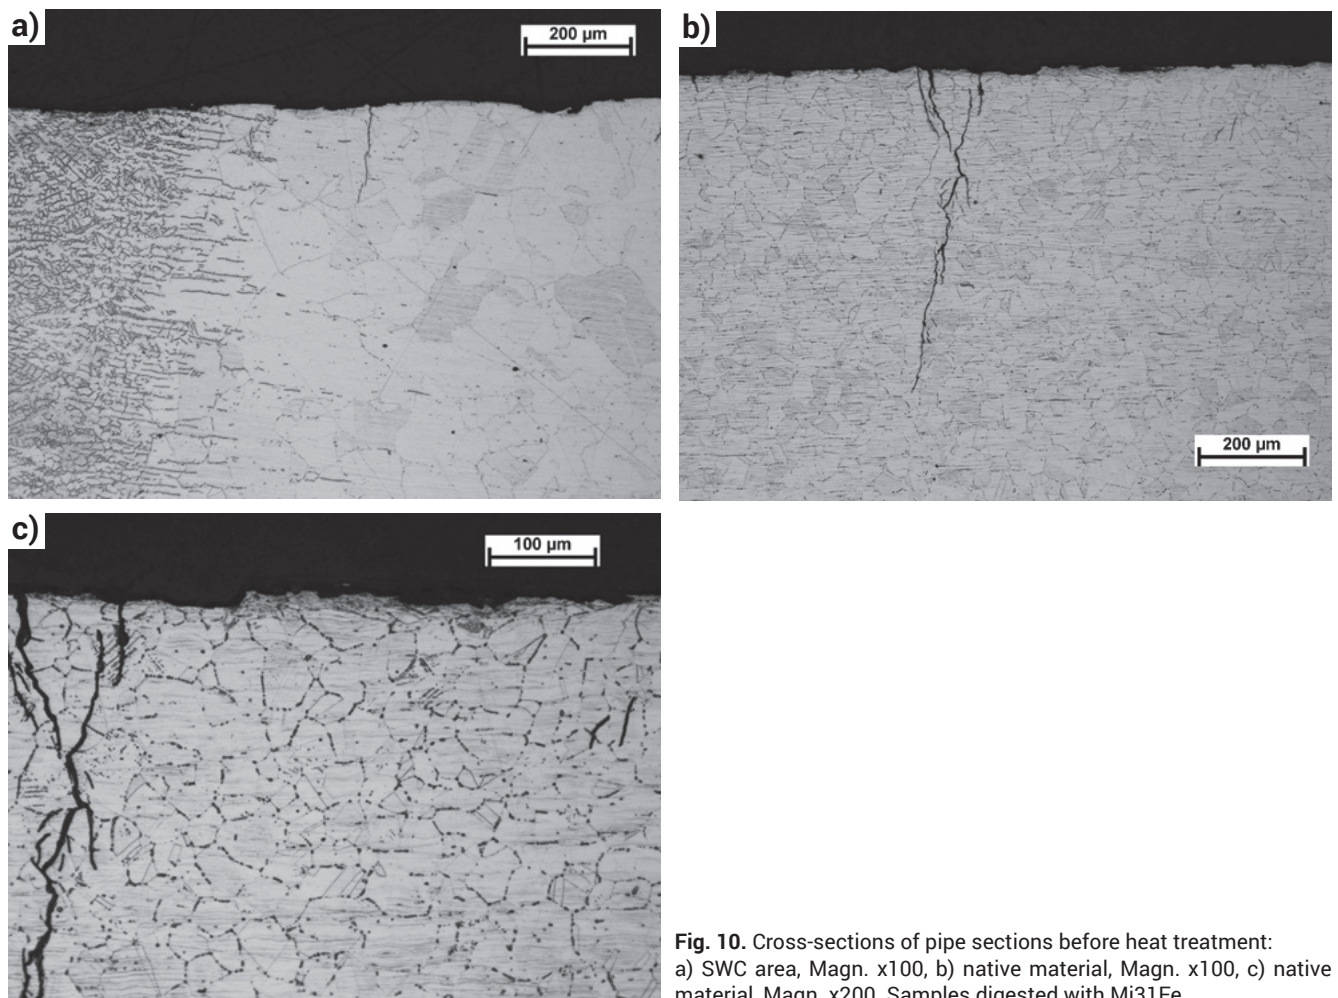
Heat treatment caused a decrease in the amount of carbides in the steel structure as a result of their dissolution in the material's matrix and an increase in grain size (Fig. 10 and 11). The hardness was also significantly reduced in both the parent material and the weld (Fig. 12 and 13). Before the heat treatment, the hardness was about 180 HV0.1 and after heat treatment about 150 HV0.1 PN-EN 1043-1:2000. Heat treatment removes residual stresses, which increase the likelihood of stress corrosion [9], as well as the removal of some of the precipitates that may be the origin of pitting.

Fig. 10. Cross-sections of pipe sections before heat treatment: a) SWC area, Magn. x100, b) native material, Magn. x100, c) native material, Magn. x200. Samples digested with Mi31Fe

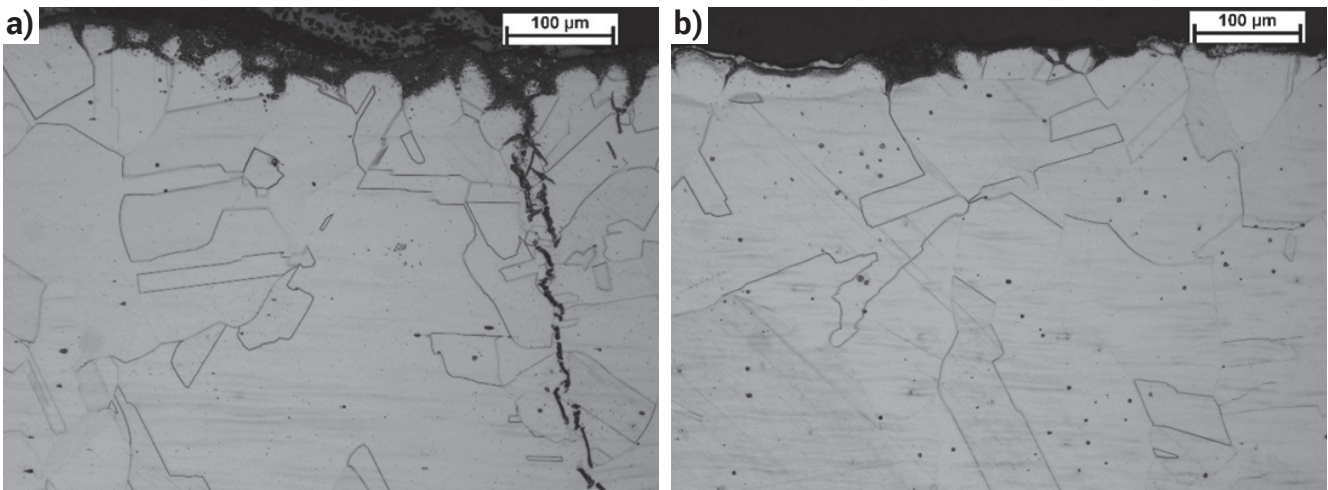
Fig. 11. Cross-sections of sections from the tube material after heat treatment: a) corrosion crack visible on the austenite background, b) austenite. Samples digested with Mi31Fe. Magn. x200

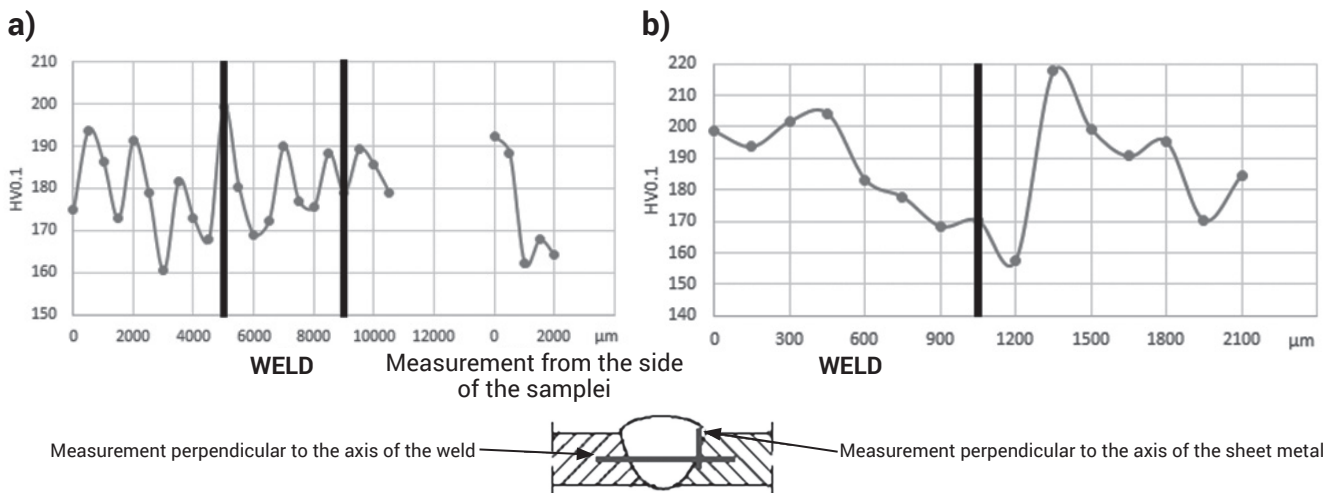
The hardness measurement was carried out using the Vickers method on a Sinowon HVS1000 hardness tester at a load of 0.98 N which corresponds to HV0.1 PN-EN 1043-1:2000. As a result of hardness measurements, it was found that the hardness of the weld is similar to the hardness of the native material.

Fig. 12. Hardness graphs for a weld before heat treatment: a) measurement perpendicular to the axis of the weld, b) measurement perpendicular to the sheet metal surface, c) measurement scheme

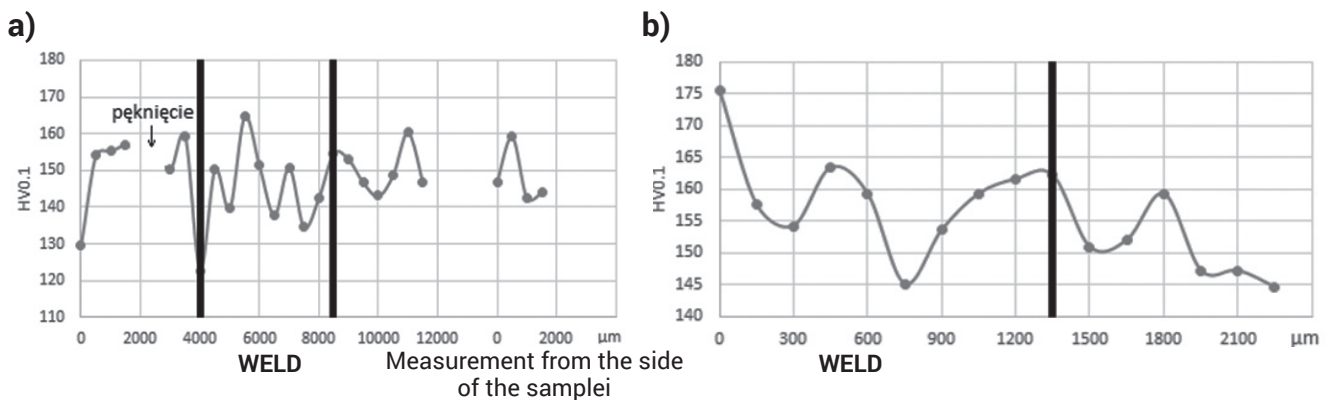
Fig. 13. Hardness graphs for a weld after heat treatment: a) measurement perpendicular to the axis of the weld, b) measurement perpendicular to the axis of the sheet metal
