MICROSTRUCTURAL AND TOMOGRAPHIC ANALYSES IN GEOTECHNICAL ASSESSMENT OF SOIL MEDIA

MACIEJ KORDIAN KUMOR

University of Technology and Life Sciences, Geotechnical Department, Bydgoszcz, Poland,
e-mail: maciej.kumor@engeo.com.pl

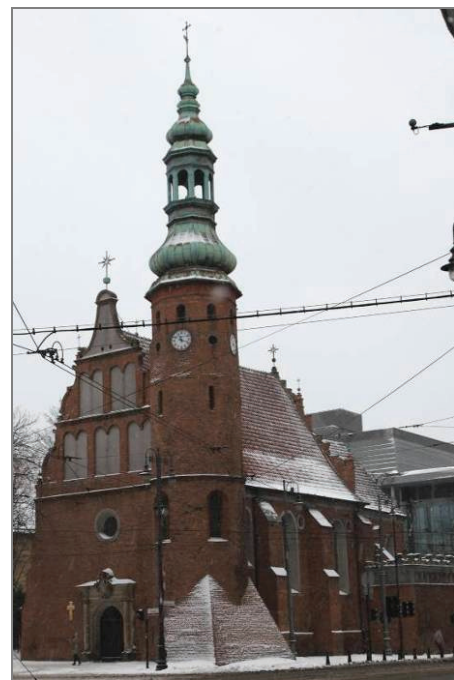
Fig. 1. A general view of the damaged object, March 2013

As it is assumed, because of deep excavations conducted since 2005 in the vicinity of the church subsoil, stability was disturbed and dangerous fracturing was observed in that object. After analyses of the structural damage the object was classified as 1° failure [5]. In walls marked concentration zones of cracks of various width and single cracks of 5 to 15 mm in width were observed, running from the foundation and expanding upwards. Problems appeared, such as doors and windows that could not be opened or closed, tilting ceilings, breaking window panes, detached stairs and annexes, etc. (Fig. 1).

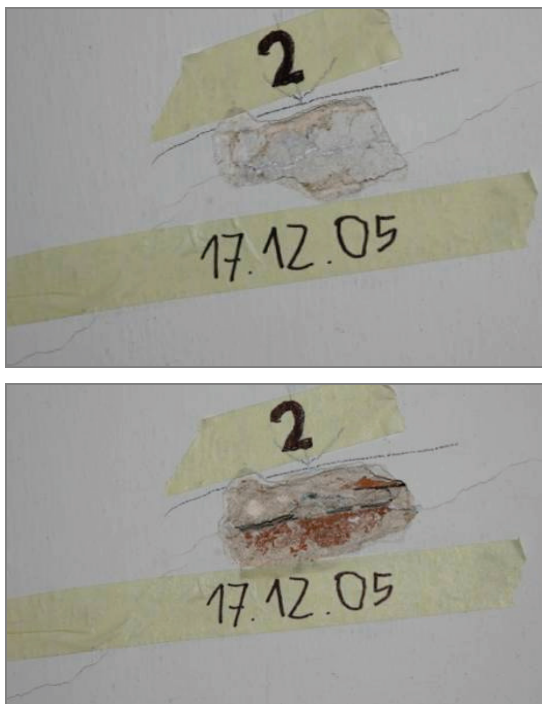
Fig. 2. Phases of sample collection for microanalyses of paint, plaster, fracture filling, material of the southern wall

- Plaster damage (cracks) was formed as a result of surface corrosion,
- The result of corrosion – a visible crack, Fig. 2, appeared relatively recently,
- Formed plaster damage is connected with an increase in salt contents.

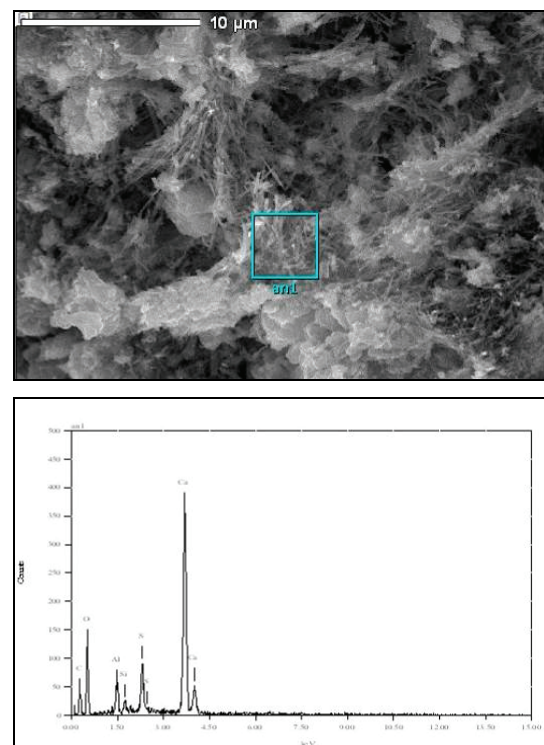
Fig. 3. A microphotograph of plaster surface adjacent to damage site with EDS spectrum of chemical composition

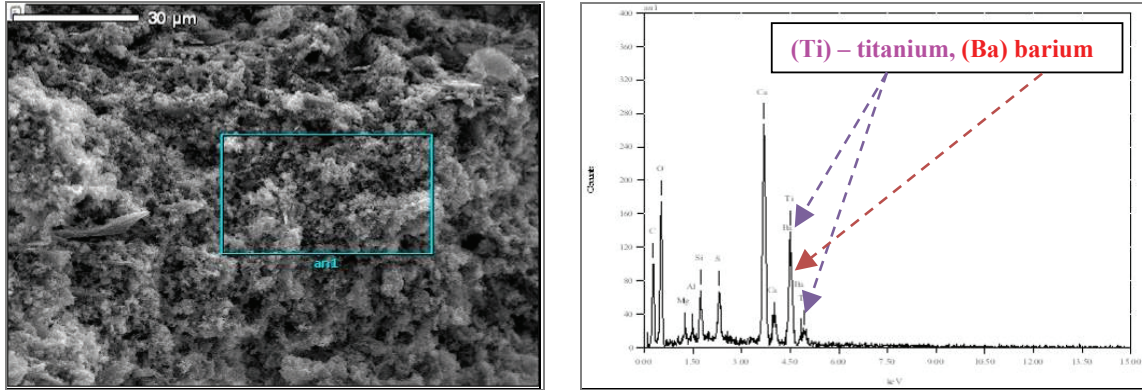
Fig. 4. A microphotograph of surface of damaged plaster with EDS spectrum of chemical composition of contamination with titanium paints (titanium Ti compounds, walls painted in 1936, barium Ba – painted in 1903)

The following findings result from the analysis of microphotographs of damaged plaster surface (Fig. 4), as well as EDS spectra for contents of individual elements and the chemical composition of paint pollutants:

Summing up the results of SEM and EDS analyses based on the microanalysis presented in Fig. 4 it may be stated that the analysed crack-fracture is an old case of damage, dating back to over 100 years.

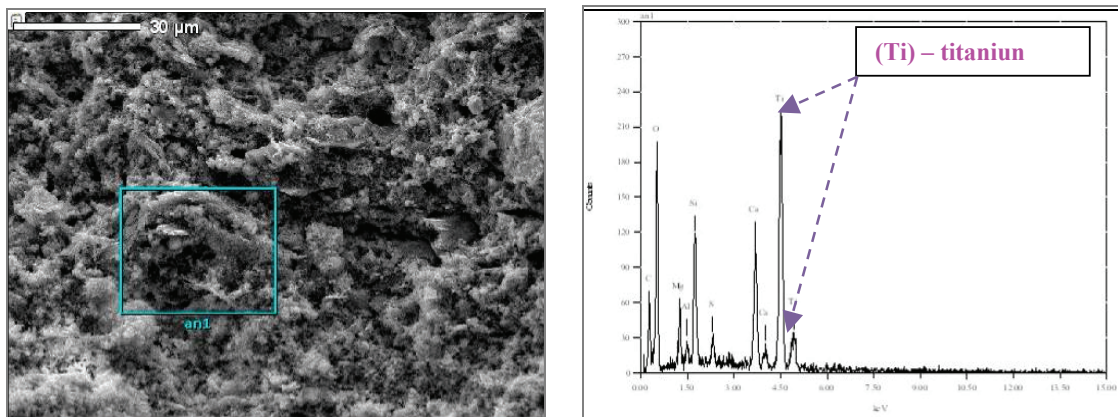
Fig. 5. A microphotograph of plaster damage surface together with EDS spectrum for the chemical composition of contamination of crack-fracture with titanium paints (titanium Ti compounds, walls painted in 1936)

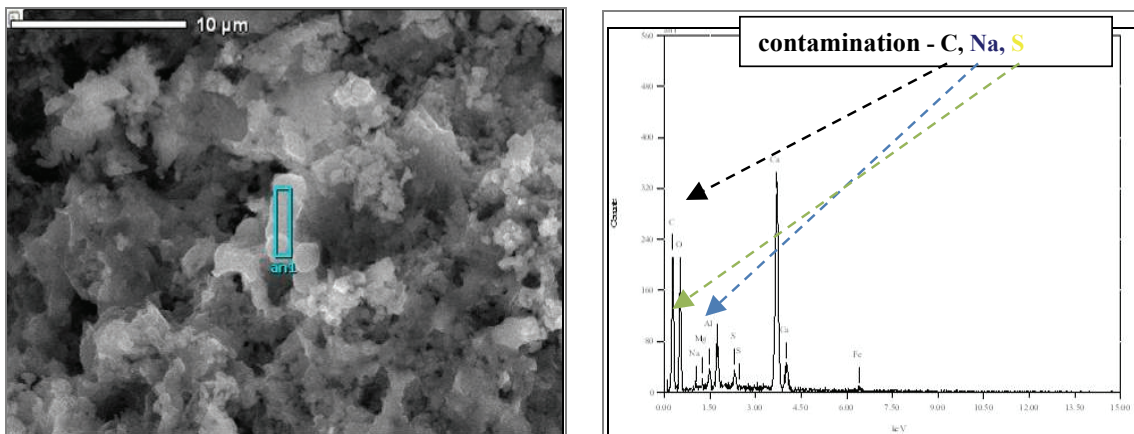
Fig. 6. A microphotograph of surface of damaged external plaster with EDS spectrum of chemical composition of anthropogenic pollutants

When analysing the chemical composition in the EDS spectrum (Fig. 6) for the crack reported by the owner as new we may see in the damaged plaster the deposition of potassium and sodium, which have salted from air from hygroscopic salt dusts, and an elevated carbon content. It is stated that:

- Plaster damage was caused by surface corrosion;
- The effect of corrosion, i.e., a visible crack-fracture of plaster (Fig. 2) appeared relatively recently;
- Visible damage is connected with salt crystallisation, i.e., an increase in volume of sulfur salt crystals, which in the structure of plaster produce pressure many times greater than that of freezing water and thus burst it (Fig. 8).

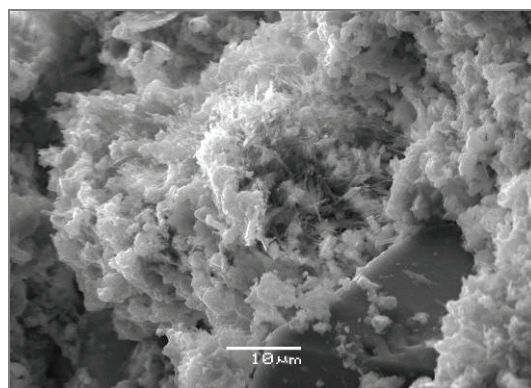
An increase in carbon contents indicates the deposition of such gases from air as CO and CO₂, which cause leaching and softening of the mortar structure. The occurrence of titanium and barium is connected with the fact that damaged fragments were previously painted (in 1903 and 1936, when paints for outdoor use were based on minerals, barium and titanium). A high sulfur content is caused by its deposition from gases, SO₂ and SO₃, causing sulfur corrosion, resulting in the formation of, e.g., ettringite (Fig. 7).

Fig. 7. A marked formation of ettringite in the structure of plaster

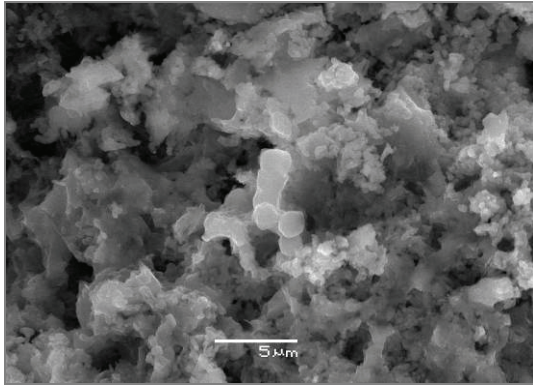
Fig. 8. Visible crystals of NaCl and KCl salts and gypsum in the structure of plaster

Summing up the recorded results of microstructural analyses the crack needs to be classified as new damage, incurred at least 20 to 30 years ago. However, it is only the visual effect of the long-term process of atmospheric corrosion of the plaster material. The process of air-dry corrosion is very slow (i.e., deposition of salt derivatives and aggressive gases in the material). Thus it needs to be remembered that the visual effect of this activity, i.e., the crack, is not formed immediately under similar conditions and develops quasi-statically.

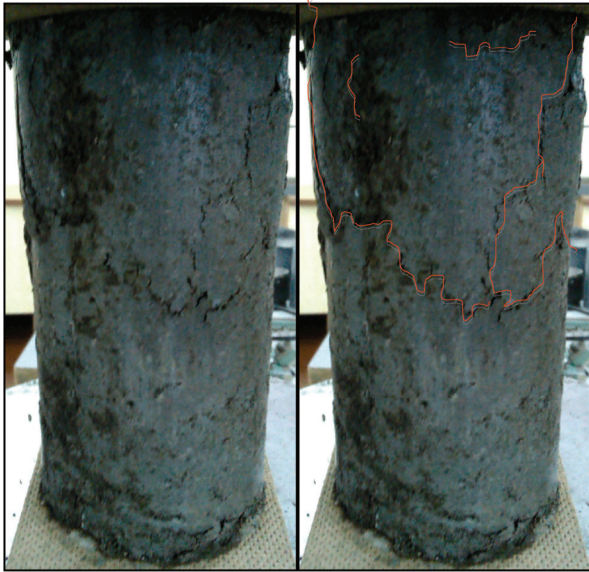
Fig. 9. Destroyed samples of composite K1 immediately after strength testing

sive strength. Formed deformation fractures are marked in red. Based on the macroimages we may identify the range of fractures, as well as the type of deformation formed as a result of damage. We may see the characteristic surface of brittle shear damage – slant surfaces at an angle of 45° .

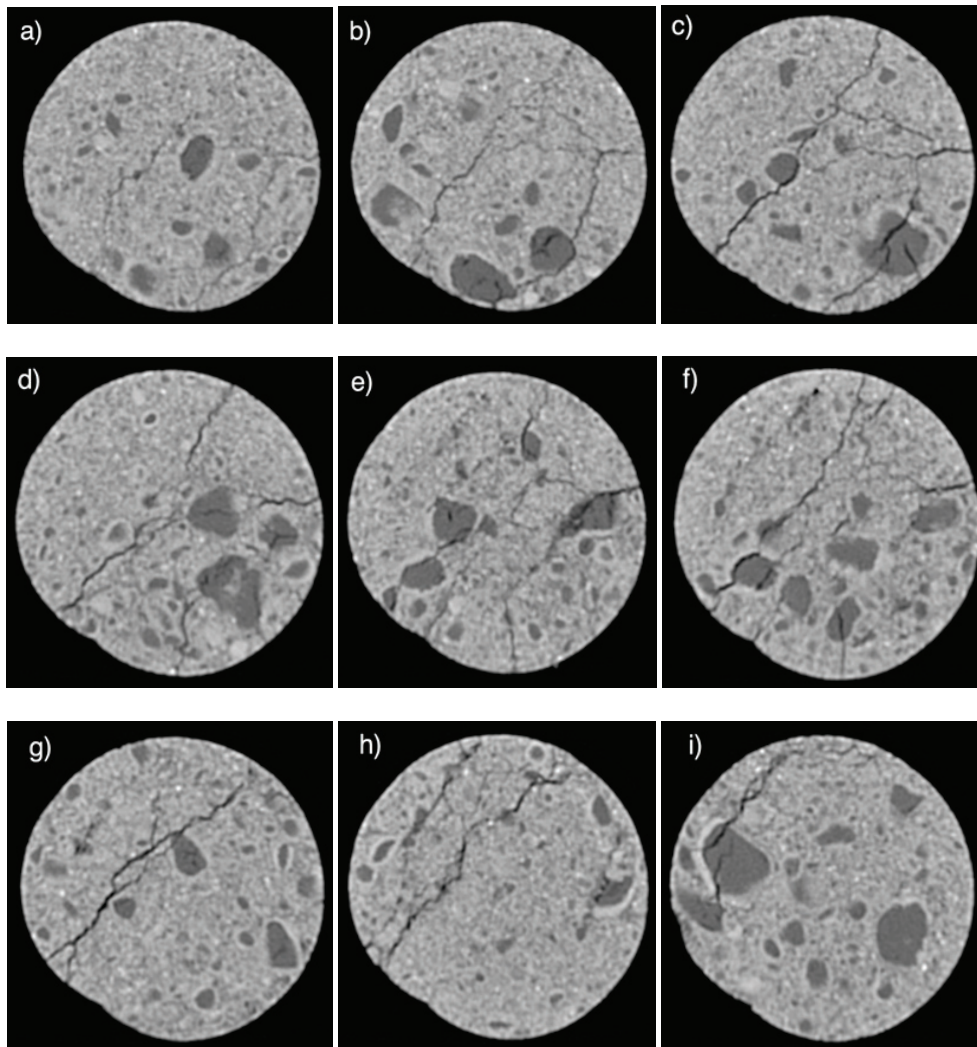
Figure 10 presents selected structural cross-sections of sample K1. We may observe a heterogeneous structure with a marked random concentration of microaggregates of organic matter in the sample mass. The fracture developed in the weakest zone, the concentration of organic matter, which was tracked downwards starting from the top (a) to approx. mid-height of the sample (i). General observations indicate regularities in the development of sample destruction zones. The location and range of shear surface are dependent on the accumulation of microaggregates of organic particles in the composite. This is particularly evident in Figs. 10 b, c and f, where microfractures

Fig. 10. Analysis of selected cross-sections of composite K1

are initiated. The shear surfaces unfold the destruction path further through natural weakenings, i.e. organic microaggregates (visible in photographs as darker clusters). This is consistent with the fundamental principle of mechanics, i.e. the principle of least action or Hamilton's principle [8]. This confirms and directly illustrates the significant effect of component homogenisation on the final strength of the composite and justifies the application of CT in its assessment.

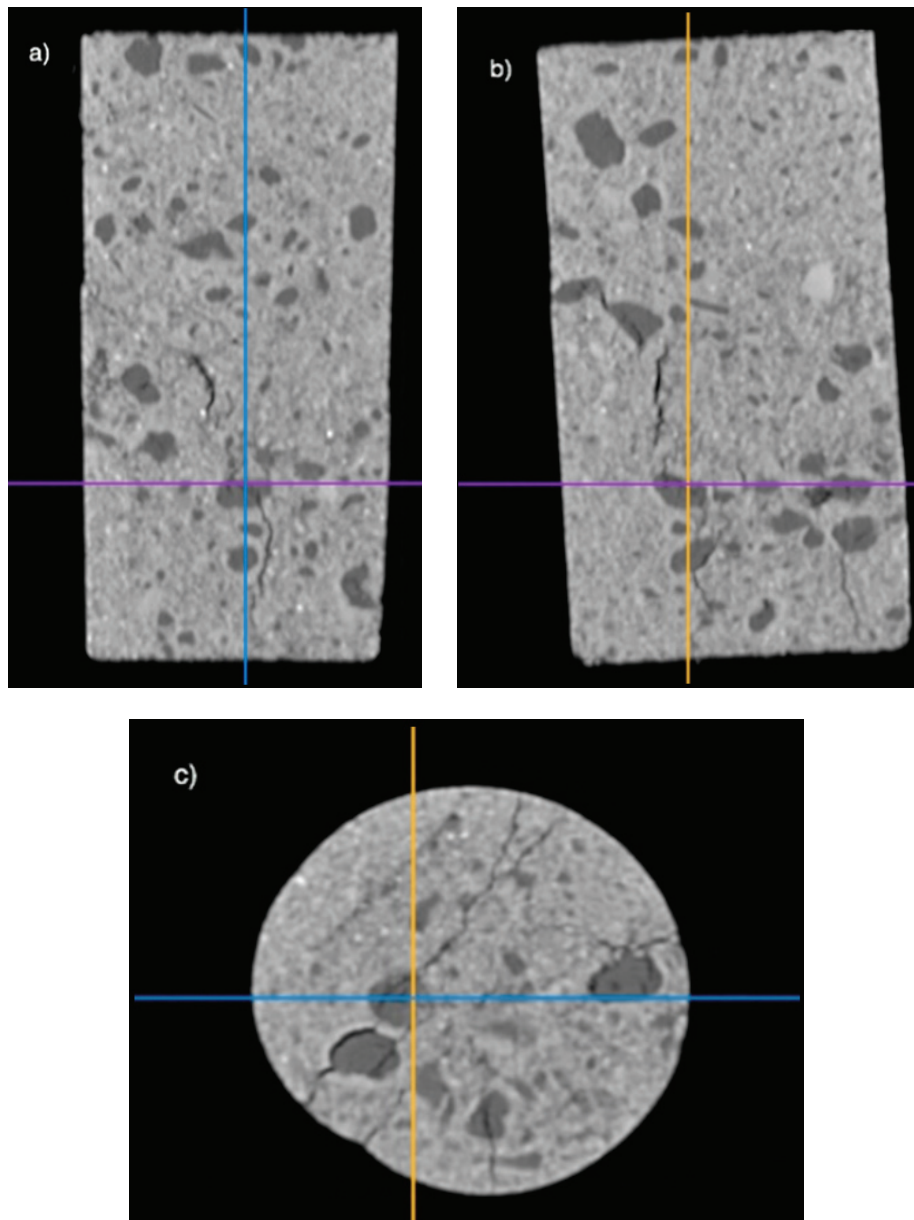
Fig. 11. A spatial image of peat microaggregate: (a), (b) longitudinal sections, (c) a cross-section

Further analysis using appropriate software facilitates precise localisation of a selected point of discontinuity, e.g. organic aggregate in the binder space. An example of deformation discontinuity is presented on mutually perpendicular longitudinal sections (Figs. 11a and b) and the corresponding cross-section (Fig. 11c).

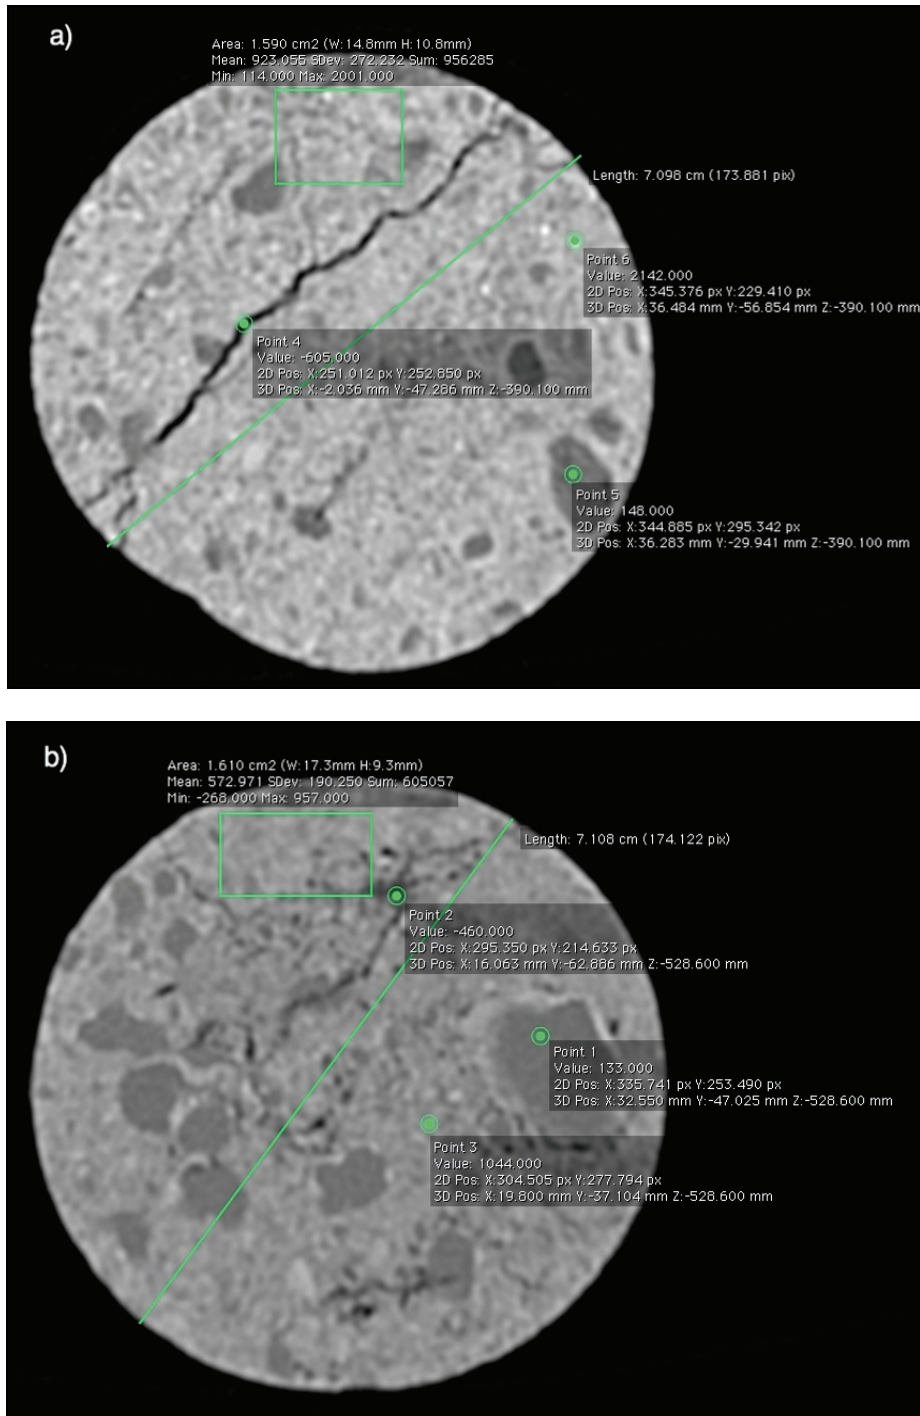
Fig. 12. Application of the ROI function in the analysis of example sections of composites: (a) K1, (b) K2

such as determination of absorption coefficient of a point as well as a marked arbitrary area. It is also possible to magnify the selected area, its dimensioning and many other functions. Below we compare example sections of composites K1 (Fig. 12a) and K2 (Fig. 12 b). Analysis of images indicate a considerably greater density of composite K1 (the greater value of radiation absorption, the lighter the colour in the grey scale). A markedly greater porosity of com-

posite K2 was observed in relation to K1. Analysis of selected rectangular ROI (denoted as *Area*) shows a mean HU for K1 (approx. +923) to be almost two-fold greater than K2 (approx. +572), as it could have been expected. A markedly greater maximum value of HU (approx. +2001) in composite K2 is connected with the occurrence of quartz sand grains. All pores, air-filled fractures, should have a negative value in the HU scale, e.g., point 4 in Fig. 12 (a) or point 1 in

Fig. 12 (b). Organic substance takes much lower values in analysed sections from +133 for K1 to +148 for K2 in the HU scale.
