Demolition of the cereal elevator building located in the conservation protection zone in the aspect of technical, functional-utility and economic conditions

Maciej NIEDOSTATKIEWICZ^{*1}, Tomasz MAJEWSKI²

¹ Department of Engineering Structures, Faculty of Civil and Environmental Engineering, Gdańsk University of Technology, Gdańsk, Poland

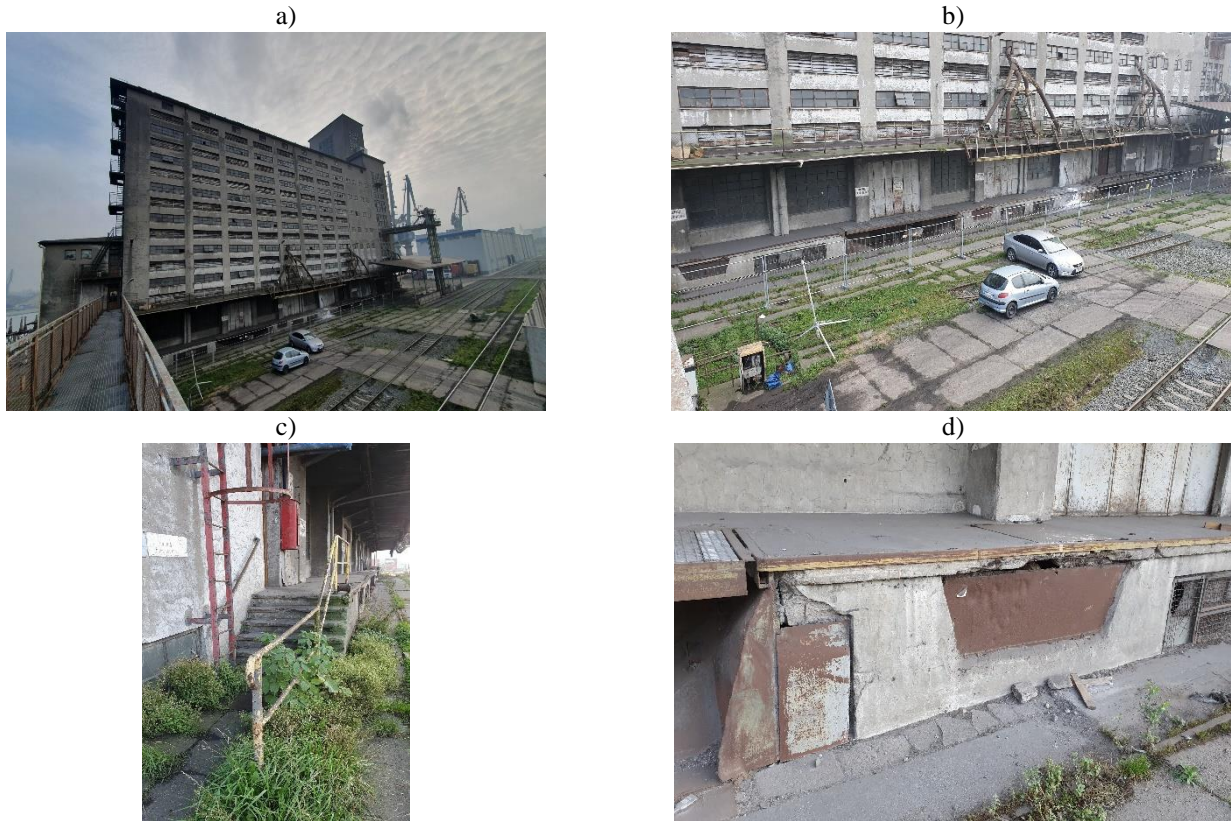
On the facade of the building, there were visible remains of the installation used in the past period for the transport of loose materials (Photo 1). The transport ramp along the outer longitudinal wall had extensive damage in the form of concrete defects - chipping and falling off of the concrete cover.

Photo 1: Grain Elevator building - elevation from the land side: a) general view, b) close-up, unloading ramp at the ground floor level: c) general view, d) damage in close-up
