The influence of mining activities on the Church of St. Cross in Bytom–Miechowice

Tomasz Lipecki^{1*}, Hanna Ligarska¹ and Małgorzata Zawadzka¹

Abstract

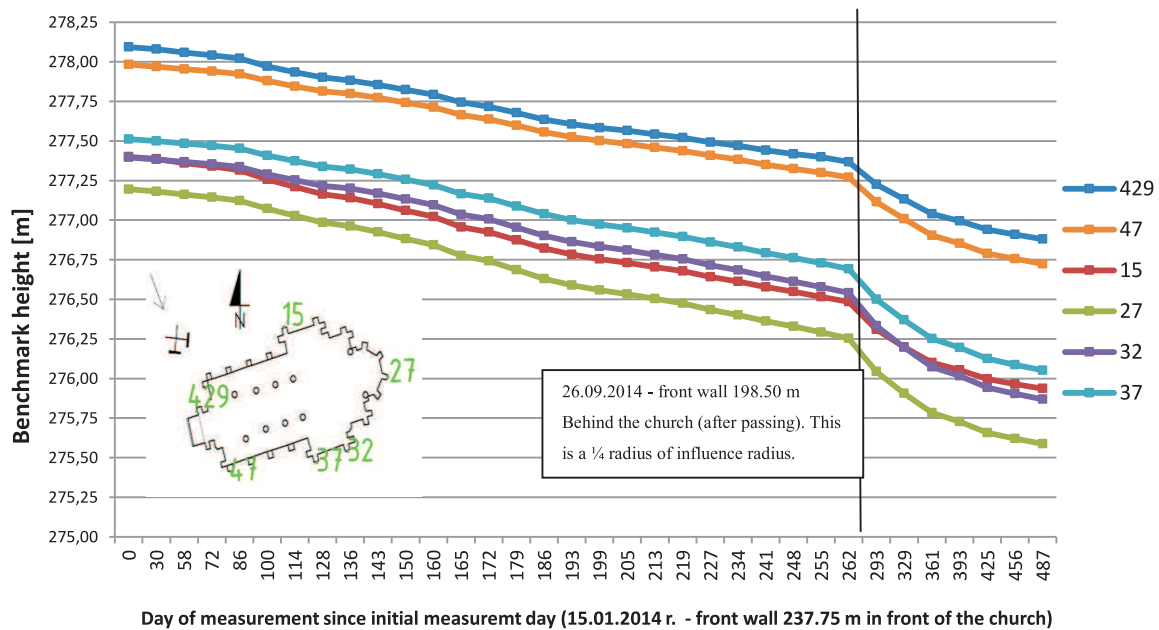
Figure 4. Summary of benchmarks subsidence from 01.2014 to 04.2015

In the initial period of running, all controlled elevation points were evenly distributed. After about 180 days (11.07.2014), when the operation was directly under the church, the values of the benchmarks were not homogeneous (the repertoire on the eastern side of the church settled more than on its western side). In analyzing the diagrams of the individual repairs (Fig. 4), it has been observed that approximately 260 days after the beginning of the operation there was a sudden decrease in elevation points (26.09.2014 when the front wall was about 200m behind the church after passing under the object) 0.3 m to $1.5 \div 2.0$ m. In the period from 23.05.2014 (the front of exploitation was 100 m behind the object from the north) to 26.09.2014 (front of exploitation was 200 m behind the object from the south) the most intense changes took place. Approximately 260 days after the start of measurements (September 2014), a clear break is visible on the graphs of each benchmark, indicating that the subsidence process has accelerated during this time. All repercussions decreased by at least 1.2 m. The repercussion number 27 decreased the most – the reduction value is 1.6 m, that is 0.4 m more than the repertoire value of 429. These points are located on two opposite sides of the church. Benchmark # 27 is located in the eastern part of the entrance, while benchmark # 429 is in the western part of the building. This means that the object does not settle evenly, but the direction of settling of the object is consistent with the depression trough system (Figure 2). Benchmarks 32, 37, 15 and 27 are located on the eastern side of the Church and they have reached the highest settlement values, which means a higher inclination of the church building toward E – NE.

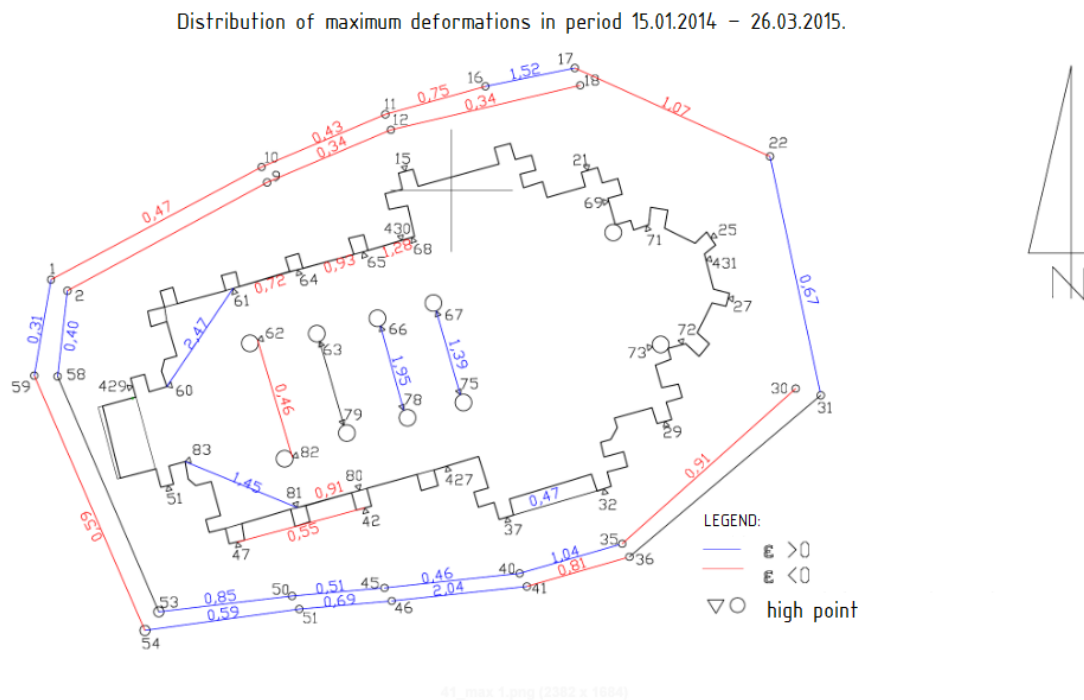
The period from 14.08 to 29.08.2014 brought the greatest deformations for the construction of the church – at that time the tensile values measured on the sections located inside the building on its western side were up to $+2.47$ mm/m. It was the time when the exploitation was already under the facility and it was about 150 m on its south side. The observed phenomenon is not consistent with the theory of behavior of the building during the transition of the basin, because at this moment the object should be affected by compressive forces, resulting from the formation of the basin after the front of the exploitation. Impact on this result can be related to exploitation of the second wall (30a) which timing is not known by the authors. When analyzing the values of deformation in time when the wall was behind the church, an analogy to the initial

Figure 5. Distribution of maximum deformations in period 15.01.2014 – 26.03.2015

It turns out that the deformations occurring in the church area mostly consist of 0 and 1 terrain categories. The exception is the strain value at length 41–46 in period 9 and 60–61 in periods 27–29 (X–XII 2014) and do not exceed the second category of terrain – reaching a maximum of +2.47 mm/m. Comparing this to the deformation forecast described in point 3, they are more than four times less than the predicted maximum values.

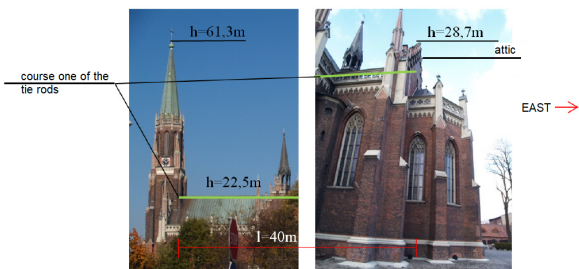
The next element analyzed was the attic (Fig. 13), which due to earlier exploitation was significantly stressed (December 2004 – 38.2‰). Measurement carried out during the last exploitation showed that its declination raised to 44.4‰ in March 2013 and to 55.4‰ in November 2014 (Kawulok et al., 2015). Analysis conducted in the Rhinoceros program showed that in June 2015 the incidence of this element was 41.8‰ (Fig. 14, Tab. 4). This means that the slope of the terrain and consequently the inclination of the attic decreased after the end of exploitation.

Figure 13. Church tower and analyzed attic – view from the south

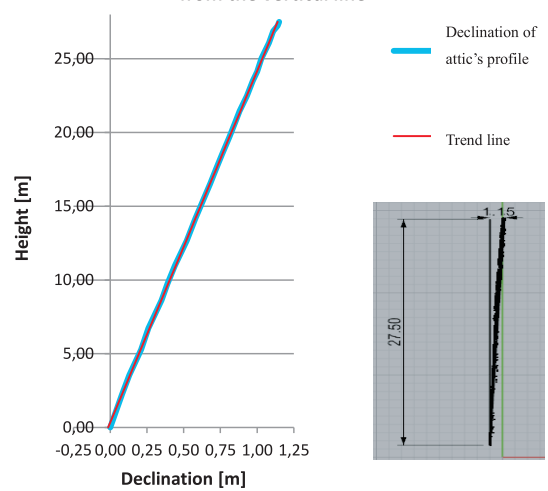
Declination's linearity was also checked by reading the value of declination on levels lower than 1 m. On this basis, the coefficients of the linear regression equation were calculated. The coordinates in the Rhinoceros program did not differ by more than 1 cm from the expected values determined from the regression equation (Fig. 15), therefore it has been found that attic's declination is linear.

Figure 15. Checking the straightness of declination of the attic from the vertical line

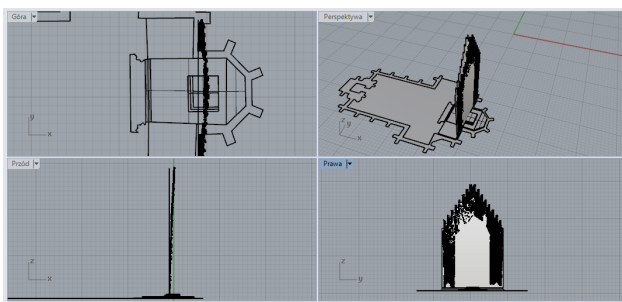
Figure 14. Declination of the attic cross-section from the vertical plane
