**Emmanuel MATSIKA\***

**Qian PENG**

## CRASH SAFETY OF A TYPICAL BAY TABLE IN A RAILWAY VEHICLE

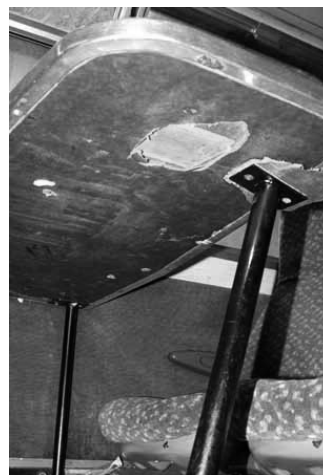
Tables were either deformed (Fig. 1) or detached (Fig. 2).

Fig. 2. Typical example of table detachment  
Rys. 2. Typowy przykład oderwania stołu

Due to the injuries caused by tables, one of the recommendations made in the report was: “a review of the crashworthiness performance of the tables in the type of train involved in the accident”.

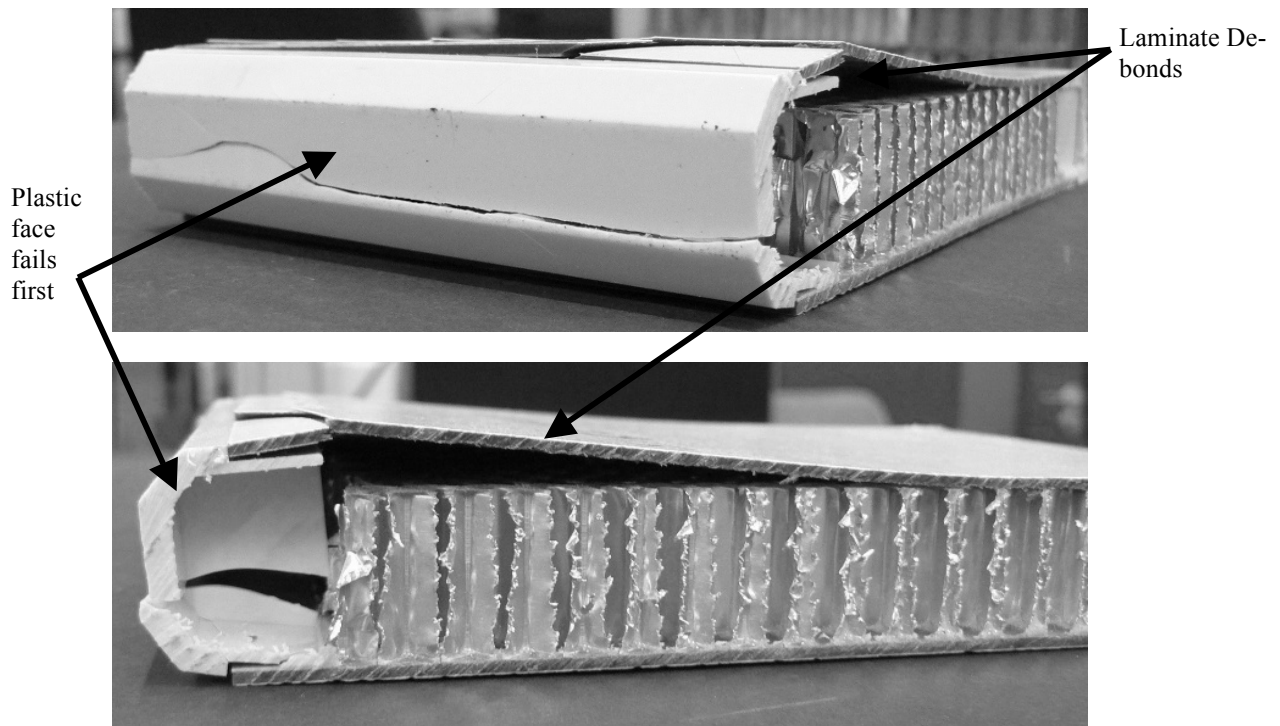
Upon loading the test specimen, the front plastic collapses, then its edges push the laminates sideward (see Fig. 8). Subsequently, de-bonding between the laminate and honeycomb core occurs, resulting in the final abrupt collapse. The composite had a yield and ultimate compressive strengths of 6.0MPa/7.2MPa, respectively. It was observed that during the test, the flap did not fold about the table hinge.

From the tests conducted, it was concluded that failure of the full composite is triggered by the collapse of the front (occupant impact part) plastic through the failure mechanism described earlier, with the Young's Modulus ranging from 1GPa to 1.2GPa. The ultimate strength of the flap under quasi-static loading is 7.2MPa.

The maximum load for this test with a width of 100mm and thickness of 22mm was 15.8kN. As such, the maximum load for a width of 300mm (equivalent to a body block impact width) would be 47.6kN, - a loading far higher than the 0.5kN to 6kN range for injury tolerance of abdominal organs [8,9] and 8kN tolerance of the chest [9]. This implies that the occupant is far weaker than table edge. In the event of an impact, it is expected that the occupant could suffer fatal injuries.

Fig. 8. Failure (mechanism) of the Complete Composite structure  
 Fig. 8. Uszkodzenie (mechanizm) kompletnej struktury kompozytu

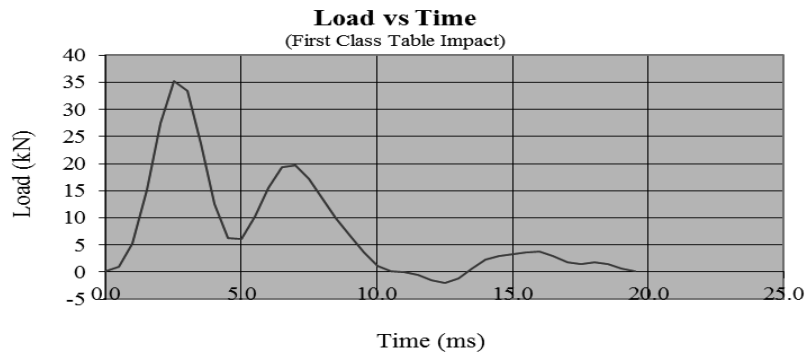
For the First Class table design, the impulse lasted for 10 ms, and the corresponding velocity change was 3.56 m/s. Fig. 9 shows the load curve as a function of time. Fig. 10 shows the frame from the video footage just after the pendulum struck the table. Soon after, the Formica top moved upwards (de-bonding). This failure mechanism is similar to the one observed during quasi-static tests of the table parts (see Section 3.1.1).

Fig. 9. Impact Characteristics of the TGV First Class

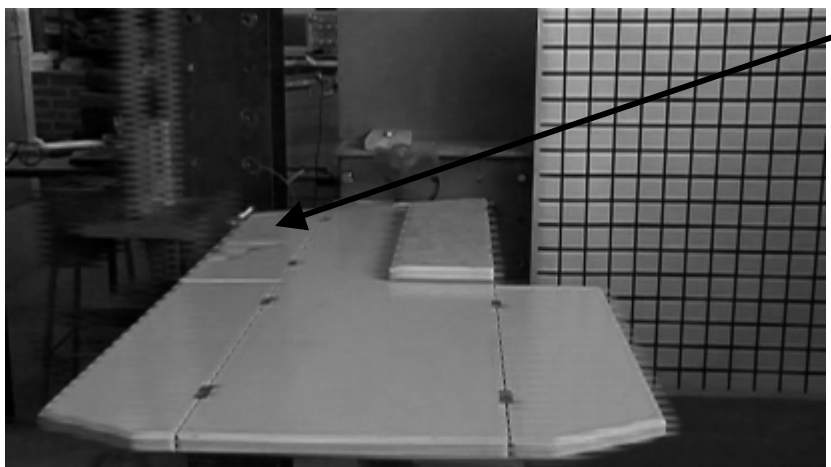
Fig. 10. Image Captured from First Class Test Video

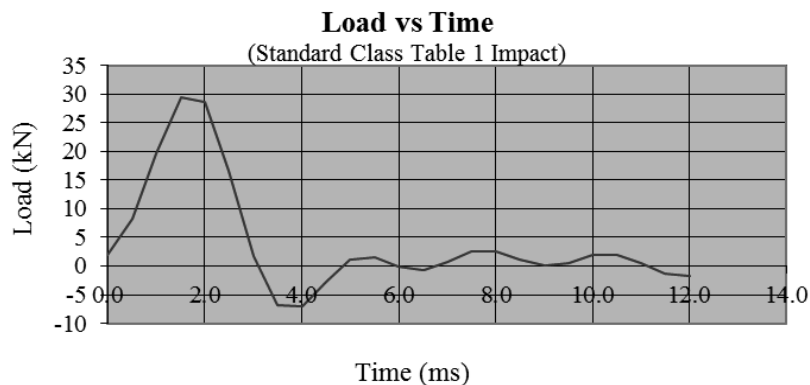
For this first Standard Class table design, the impulse lasted for 3ms, and the corresponding velocity change was 1.32 m/s. Fig. 11 shows the load and energy curves as a function of time. Upon impact, the aluminium side fixing webs sheared off, resulting in the table falling while hinged about the floor fixing. Subsequently, both the floor plate and the bolt on the side of impact collapsed under tension. Hence the table fell as shown in Fig. 12. The impacted flap remained intact.

Fig. 11. Load Impact Characteristics of the TGV Second Class Table 1

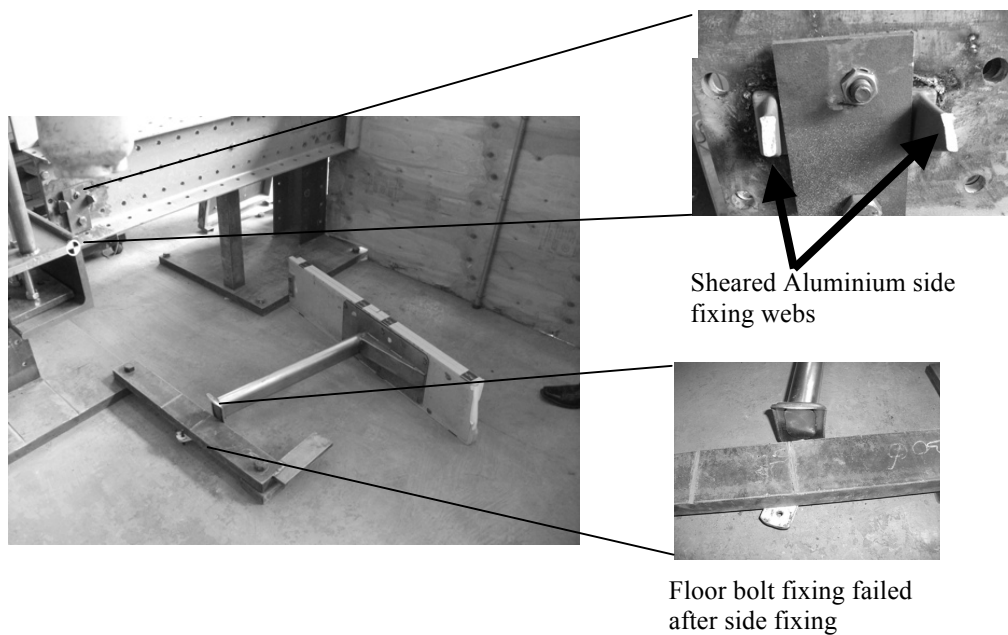
Fig. 12. Still pictures after impact  
Rys. 12. Obrazy po uderzeniu

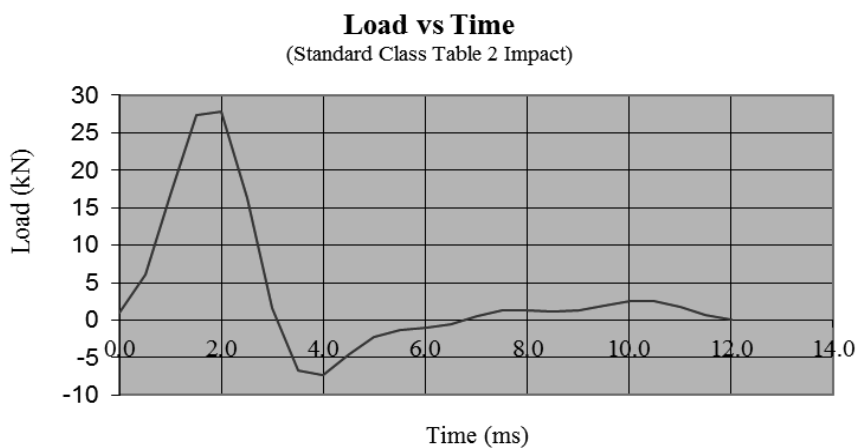
For the Standard Class design Table 2 design, the impulse lasted for about 3ms, and the corresponding velocity change was 1.21 m/s. Fig. 13 shows the load curve as a function of time. Soon after the pendulum struck the table, the Formica top moved upwards (debonding). Further examination showed that the front plastic edge failed first. The plastic then pushed the laminate outwards, causing it to debond (which is similar failure mechanism observed during quasi-static tests).

Fig. 13. Impact Characteristics of the TGV Second Class Table 2  
Rys. 13. Charakterystyka obciążenia w czasie dla stołu 2 w wagonie TGV klasy drugiej

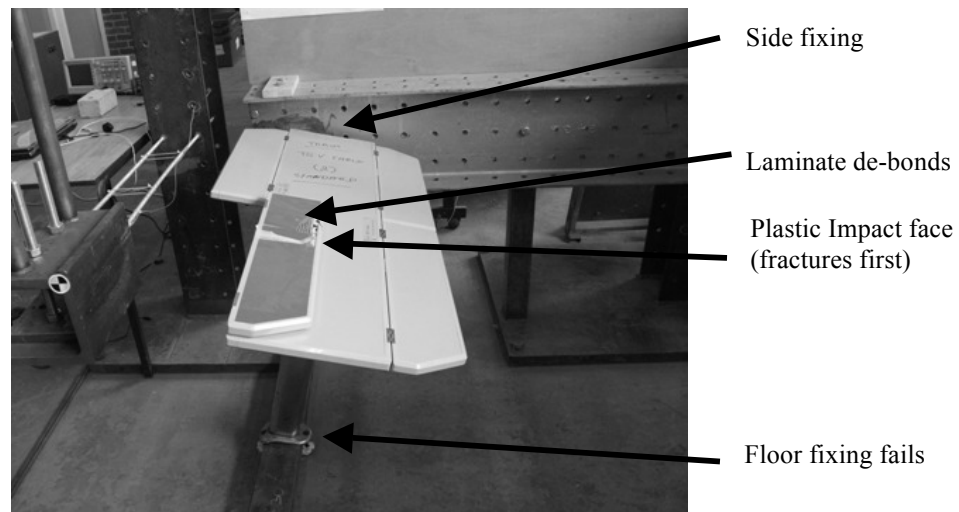
Fig. 14. Still Picture of Failed Table 2
