the International Journal
on Marine Navigation
and Safety of Sea Transportation

Volume 17 Number 2 June 2023

Analysis of Pier Contact Accident in Busan New Port of South Korea by System-Theoretic Accident Model and Processes (STAMP)

S.R. Kim, W.J. Wangui, G. Camliyurt, D.W. Kim & Y.S. Park Korea Maritime and Ocean University, Busan, South Korea

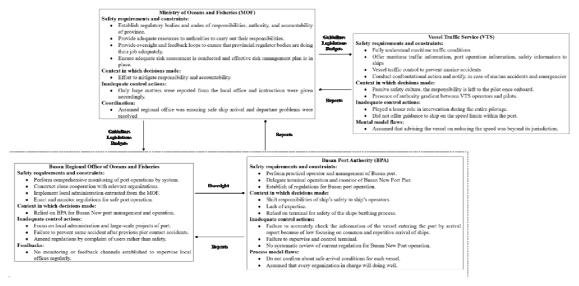
Figure 9. Analysis of government regulatory authorities

Figure 9 shows the highest hierarchical control structure that ensures safe arrival of cargo ships in Busan. The safety control structure is initiated by the Ministry of Oceans and Fisheries (MOF), which has guidelines and legislations to ensure that ships can navigate the domestic waters safely while complying with the International Maritime Organization (IMO) Convention. MOF is the headquarters responsible for the safety of ship navigation in Korea, so regional administrations are delegated to local administrative agencies assigned to each port. Accordingly, the regional office of MOF will carry out regional port administration and the port authority will carry out port operations. In addition, the Korea Coast Guard, which is in charge of vessel traffic service, belongs to the MOF and performs tasks such as marine security and pollution control.

However, the Ministry of Oceans and Fisheries only received reports of major issues from local administrative offices and believed that local offices will doing well. The regional office of MOF entrusted the operation of Busan Port to the Busan Port Authority (BPA), and no consultations were held during the COVID-19 epidemic. BPA did not closely check the ship entry reports that are too common, and it was believed that the ship operator would safely manoeuvre ship for berthing even the ship which is exposed one-third of the propeller. Those of local institutions have also failed to prevent the accident because they have not been able to come up with sufficient countermeasures against the same accidents that occurred before. They had their own rules, but they were mainly revised by civil complaints, and there was no change after the accident. VTS has not been reported on the condition of the vessel, but the system has shown that it is operating at an excessive speed unlike other ships. However, proper control was not carried out, and finally the vessel was contacted with the pier at high speed by the pilot, without being advised anywhere.

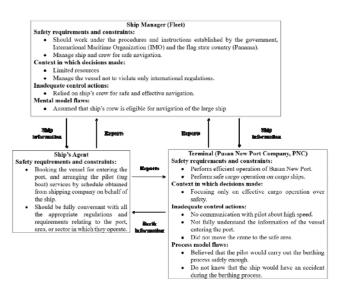
Figure 10. Analysis of industry association and ship manager

As shown in figure 10, for ship berthing and cargo operations, major industry-related agencies consult closely before ship berthing. The ship manager has the duty to manage the ship and crew so that the ship can safely carry the cargo under the charter contract. The charterer or ship manager contact the terminal for cargo loading and unloading and appoint an agent for administrative processing for entry into the port to delegate their tasks. Terminal prepares the berths according to the vessel's schedule and prepares for safe cargo operations. The Agent conducts a ship entry report to institutions such as port authority through the information received from the terminal and the ship manager.

However, the ship manager did not advise the crew to inject more ballast water, despite receiving reports of the ship's condition when the Milano Bridge left the shipyard in China and when it arrived in Busan. Additionally, although ship managers were responsible for ensuring that adequately qualified crew members were assigned to operational duties, crew members failed to act in accordance with Bridge Resource Team Management training and

consequently failed to prevent accidents. According to the terminal's own regulations, the vessel foreman must listen to the transceiver to communicate with the pilot and check the speed and direction of the ship one hour before berthing. But the pilot was not given any advice from the vessel foreman, and no action was taken to adjust the ship's speed by him, resulting in an accident. Agents who are delegated with administrative tasks for the arrival and departure of ships play a role in sharing ship information. However, the agent's inappropriate control actions could not be found through the special investigation report and interview.

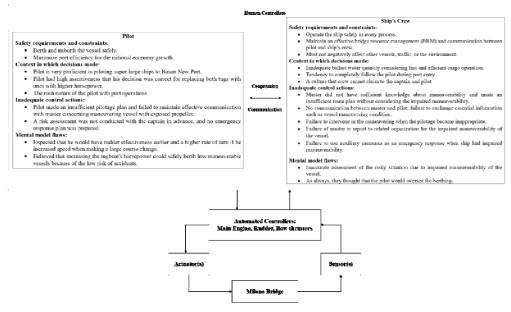
Figure 11. Analysis of human controller and vessel operating process

Figure 11 shows human controller and vessel operation flow. As a main human controller, crew members, including captain, are hired by ship owners and ship managers to ensure safe cargo transportation. Since ships must live independently once they leave port, bonding and communication between crew members are essential and must be trained. As a port expert, marine pilots act as guides through skilful manoeuvring so that ships can safely berth and load and unload cargo. Since captains are usually not familiar with the geography of a particular port, they must work closely with pilots to safely complete the berthing operation.

Despite this heavy responsibility, the captain failed to exchange sufficient information with the pilot. The specific information that could be helpful in steering the ship was ignored, and he just believed that a foreign pilot would do it well. Although he delegated manoeuvring to a pilot for berthing, but when there was a risk of an accident, he had to manoeuvre by himself, but it was not carried out, and appropriate emergency response procedures also were not implemented. The pilot worked as a pilot in Busan Port for more than 10 years and manoeuvred many ships of the same size as the Milan Bridge. Therefore, he judged that he would be able to ship for berthing sufficiently by increasing the horsepower of the tugboat and drove the ship in a hurry as before. However, he belatedly judged that the turning of the ship was late and panicked, failing to take additional actions that could have prevented the accident.

- 3. Seafarers must receive appropriate on-the-job training in order to have sufficient knowledge about ship handling and ship conditions, and must be continuously checked for knowledge. Even in the case of delegation of manoeuvring authority, proper training must be given to take responsibility for the safety of the ship by communicating closely with foreign pilots.

- 4. Even if the pilot is a port expert, a detailed pilotage manual or plan customized for each port must be supported, and the effectiveness of pilot training conducted on a regular basis must be checked and improved according to practice. In addition, institutions around pilots should have a procedure for checking safety once more.
