Factors underlying persistently high radon levels in a house located in a karst limestone region of Ireland – lessons learned about remediation

Stephanie C. Long,
David Fenton,
Chris Scivyer,
Eugene Monahan

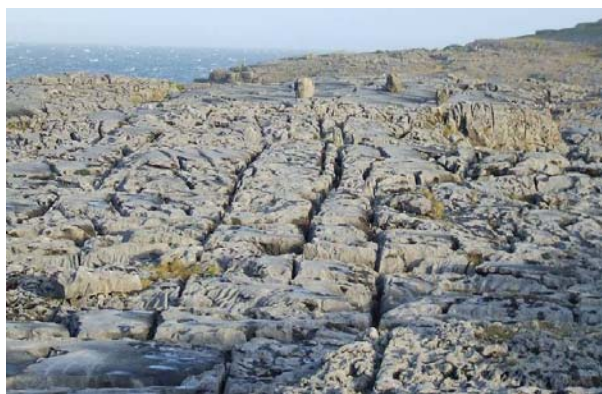
The house in question is located in an area of limestone interdigitation, a finger-shaped piece of land, covered in a thin layer of soil, from which the shale has been removed. The three different geological layers are all likely to have an impact on radon movement through the ground and ultimately on indoor radon concentrations. Radon-222 is part of the uranium-238 decay series and, since granite is relatively rich in uranium, it is often associated with elevated indoor radon concentrations [3]. Both shale and limestone can act as a conduit for radon as it can easily pass through cracks and fissures in

Fig. 2. Exposed limestone pavements separated by grykes.

both rock types, particularly limestone. The land surrounding this area of interdigitation is overlain with shale, and it has been postulated that radon can travel more freely to the surface in the area of interdigitation, as there is one less layer of rock for the radon to move through. In this way, the area of interdigitation may be acting as a ‘release valve’ for radon in much of the surrounding area.

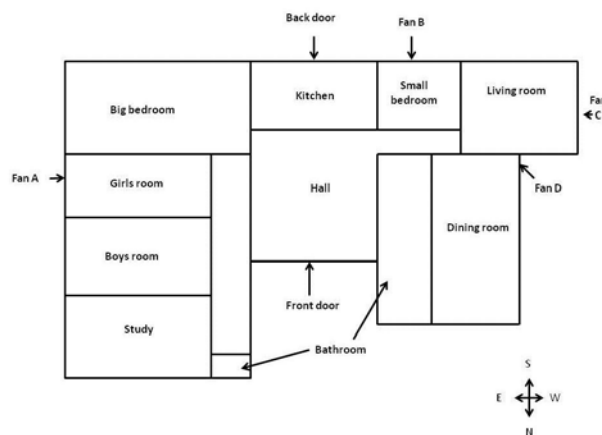
The house is a single storey building facing north and consisting of ten rooms and a hallway leading to two corridors (Fig. 3). The house was first built prior to 1841 and over the years, it has been converted and extended. The original house was made up of the present day living room, dining room, bathroom and small bedroom, the flooring in this part of the house is made of chipboard slabs laid over bare earth on dwarf walls. Some of the walls in this part of the house are up to 75 cm thick. In 1965, the home was extended to include the kitchen and the big bed-

Fig. 3. Schematic diagram of the layout of the house.

room. In 1974, the girl's room, boy's room, the study and small bathroom were added with suspended timber floors laid in this part of the house. At this time, the courtyard area was enclosed to form the hall and concrete floors were laid in this area and the short corridor between the small bedroom and the bathroom. It is likely that a damp proof course was laid in this part of the home. Under floor ventilation was installed via louvered vents at regular intervals around the perimeter of the building, however, it is likely there was little through ventilation between the different underfloors.

preventing the gas from entering the occupied indoor space. This system was installed at the location marked 'fan B' in Fig. 3. Follow up tests showed that this work had not resulted in any reduction in radon concentration (Table 1). The contractor then moved the fan that had been installed to the east of the building (to the position marked 'fan A') and an additional fan was installed on the west side (in the position marked 'fan C'). Follow up tests carried out that year demonstrated that, while this work had largely been unsuccessful, a reduction from the initial result of 1467 Bq/m³ to 1138 Bq/m³ had been achieved; this was confirmed by a repeat test that December. Later in December, the contractor decided to seal up the 12 external vents and changed the fans such that one extracted and one introduced air. A subsequent 10-day test showed that this work seemed to have exacerbated the levels of radon in the house, so some of the vents were re-opened and both fans set to extract radon. Further, 10-day tests showed that this did not result in any reduction in concentrations.

Following inspection of the house in December 2011, it was concluded that due to the fact that the house had been extended several times it was likely that there was little through ventilation between the different under floor voids. For example, it seemed likely that vents in the former external wall to the small bedroom and bathroom would have been blocked by the concrete floor in the hall. For this reason, the use of multiple extraction systems for the house was considered appropriate. However, it was recommended that the direction of the four fans installed should be reversed to pressurize the under floor space with fresh air rather than extracting air (Fig. 4). This is because extracting the air may have been increasing the radon concentration below the floor by drawing up more radon laden air from the ground. By reversing the direction of the fans the floor void would be pressurized to minimize the entry of radon laden air from the ground and the fresh air introduced would also dilute the radon laden air. In addition, by positively pressurizing the under floor air space, the system of fans would be working in conjunction with the positive pressurization system installed in the roof space. Overall, this means that the air pressure and dilution of radon laden air should counter the natural stack effect of the property [3, 9].

In February 2010, two additional fans were installed (at the locations 'fan B' and 'fan D') and the two existing fans were re-started. Tests to measure the effectiveness of all four fans running simultaneously showed that radon concentrations continued to be elevated. By August 2011, radon concentrations were still high at 803 Bq/m³. No substantial reduction had been achieved in the radon levels despite multiple attempts to reduce concentrations. At this time, the homeowner offered her home to the RPII as a case study to better understand why remediation had proved so difficult and to learn more about the behaviour of radon in homes built on this geology type.

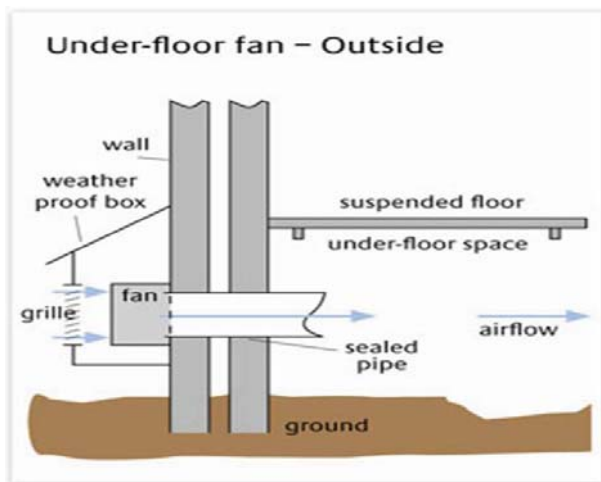
Fig. 4. Schematic of ventilation of under floor space.

In July 2012, the direction of the fans was reversed to blow air into the under floor space. In addition, the piping was used to connect the space under the floor of the big bedroom to 'fan A' to ensure that

this space was pressurized as it was unlikely that the space under this room had been vented to any of the other rooms. The vents under the floors of the girl's room, the boy's room and the study were also sealed to maximize the positive pressurization of the under floor space.

The house was retested, and the seasonally adjusted average had reduced to 480 Bq/m^3 . It was considered that this was likely to be the minimum radon concentration that could be achieved without either replacing the floor with a concrete slab or increasing the fan speed further. The advantages and disadvantages of these options were discussed with the householder. Clearly, the first option would be expensive and very disruptive and difficult to justify to achieve a further reduction in the radon concentration. Increasing the fan speed would mean further increasing the already significant ventilation of the house and would be likely to cause it to be quite cold. It was felt that the benefit of either of these measures would be outweighed by the disadvantages associated with them and therefore further remedial work was not recommended. A follow-up test 12 months later showed that concentrations had remained stable at 454 Bq/m^3 .
