# PRODUCTION ENGINEERING ARCHIVES

## An analysis of the causes of track twist at high speed of driving

Andrzej Pacana<sup>1</sup>, Dominika Siwec<sup>1</sup>

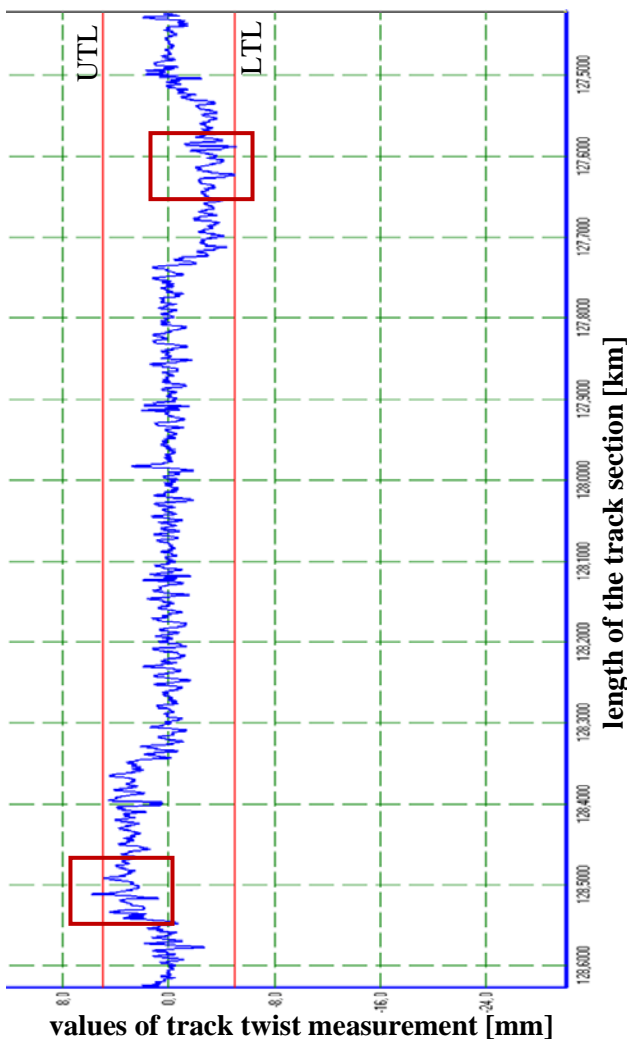
After analyzing the results from the geometric measurement of the track in the case of achieving the possible speed of 180 km/h the track twist was identified (fig. 3). Three values occurred that were not within the tolerance limit of the admissible deviation of track twist. The first value, which was not within the upper tolerance limit (UTL) amounted 6,25 mm and it occurred on the measuring section at the point of 127,5120 km. The second and third value, which was not within the lower tolerance limit (LTL) of the admissible deviation of track twist amounted respectively -6,05 mm and - 6,09 mm and they occurred on the measuring section of, respectively 127,6240 km and 127,5900 km.

Fig. 3. An example of a chart for twisted track at a rail vehicle speed of 180 km/h for the total measurement performed on a 1,1270 km section. Own study

The first of the track (from 128,5470 km to 128,3400 km) was characterized by the values of track twist significantly close to the upper tolerance limit of the admissible deviation of track twist (6 mm). While the second section of the track

(from 127,7130 km to 127,5350 km) was characterized by the values of track twist significantly close to the lower tolerance limit of the admissible deviation of track twist (-6 mm). It was concluded that in the case of achieving the possible speed of 180 km/h on the section track which was analyzed, the track twist occurred and it could be problem in the view of safety and the comfort of driving a rail vehicle. In order to identify the potential causes of the problem (the track twist) the Ishikawa diagram was drawn up (fig. 4).

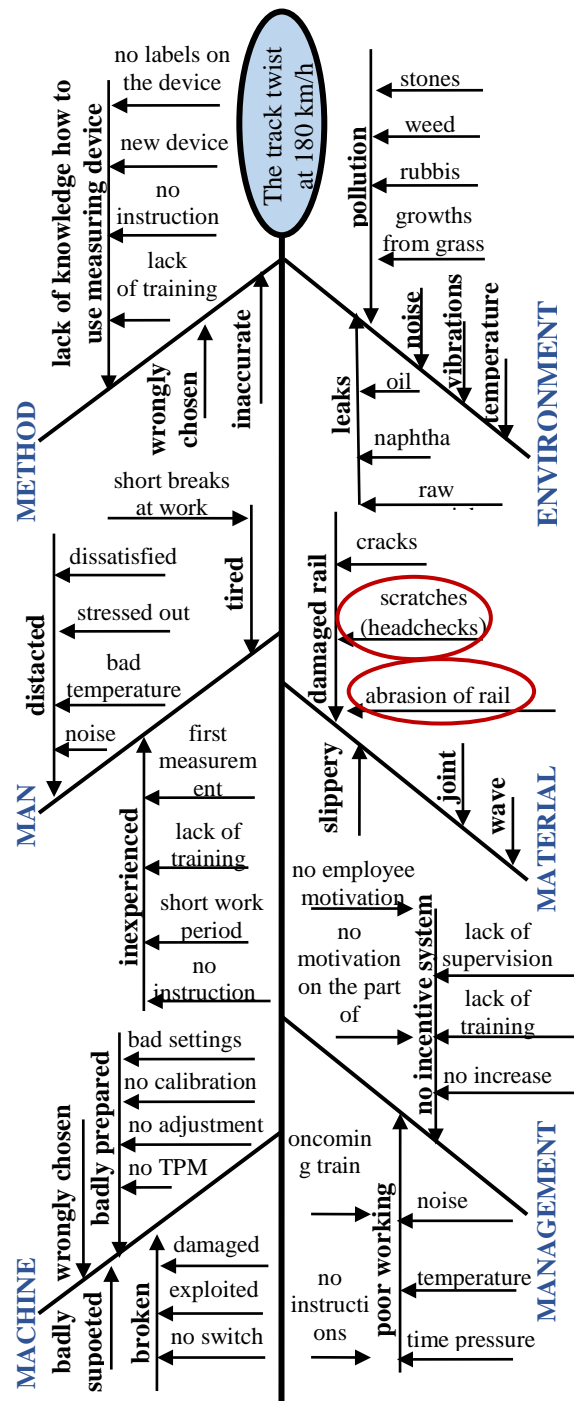
Fig. 4. An example of Ishikawa diagram for the analyzed problem. Own study

After analyzing the problem (the track twist at the speed of 180 km/h occurred) by using the Ishikawa diagram it was concluded that the main causes of the problem are scratches (the so-called headchecks) and abrasion of rail. These inconsistencies occurred locally on the rolling surface and both side surfaces of the head of the rails (Guide, 2017). The scratches, or headchecks, developed mainly in the arches with radius of 600 – 1000 m. The abrasion of rail appeared as local wipe-down of rails, which resulted from start of heavy trains. These faults occurred at the depths ranging from a fraction to a few millimeters from the surface of the rail (Bałuch, 2009; Grulkowski, 2014; Stencel, 2016). In order to identify the source cause of the problem (the track twist) the 5Why method was applied (fig. 5).

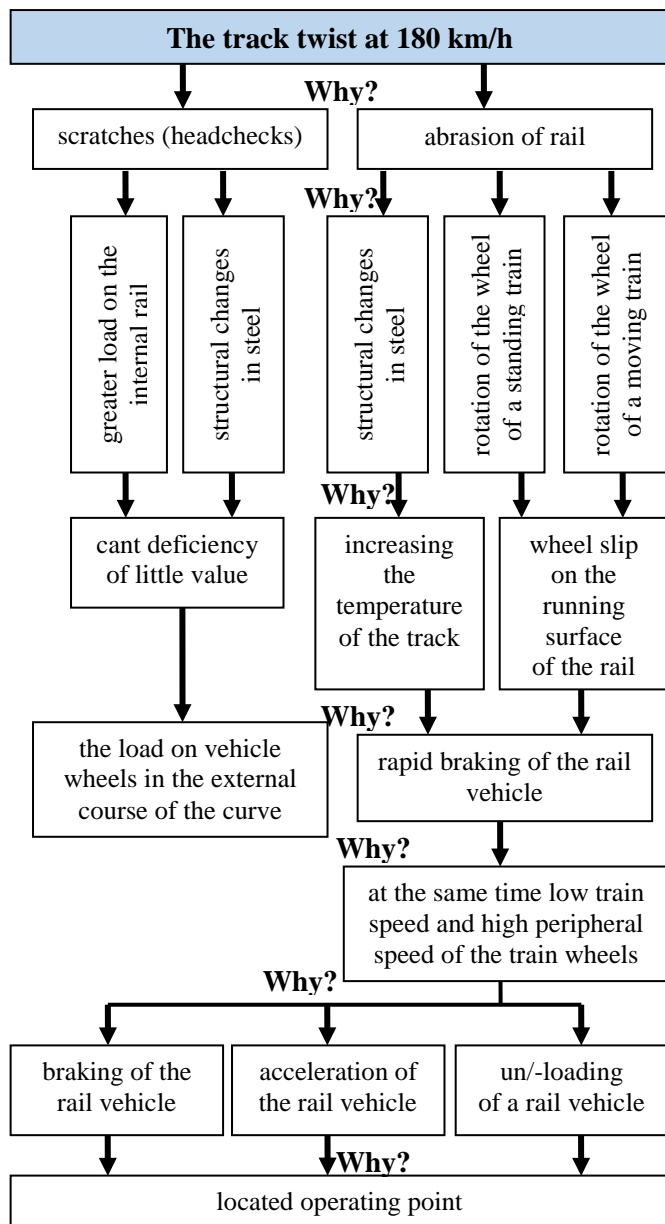
Fig. 5. An example of 5Why diagram for the analyzed problem. Own study

Analysis of the problem of track twist at possible speed of 180 km/h of a rail vehicle using the 5Why method allowed to identify the source cause of the problem which was a located operating point, i.e. railway station or level crossing.
