Settlement of a historic building due to seepage-induced soil deformation

3. Soil seepage-induced deformations within the area of the St. Nicholas basilica in Gdańsk – case study

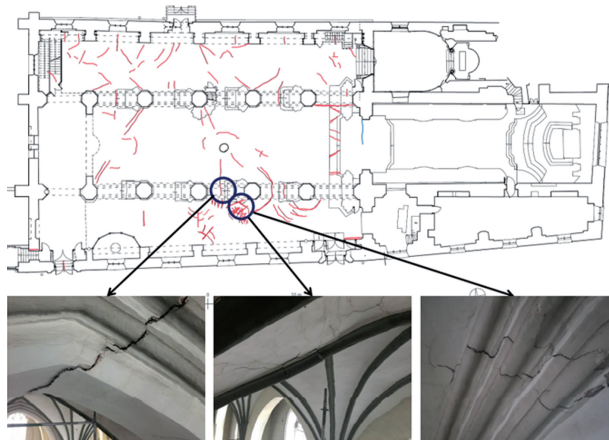
Disturbing damage to the vault over the southern aisle was observed in autumn of 2018, at the end of October. Intense (in terms of number and opening width) scratches of the squinches and deformations (buckling relative to the vault plane) of the ribs were identified during a thorough inspection.

Vault ribs were cracked with a displacement and detached from the squinch surface, and the opening width reached 6–8 mm. Arch wall crack (crevice with a mutual edge shift) between the second and third pillar of the southern aisle, with a maximum opening width of 28 mm was identified. Fig. 3 shows damage concentration in the southern aisle pillar area and the cracks of wall elements.

Fig. 3. Simplified stock-taking of Basilica southern aisle damage [43]

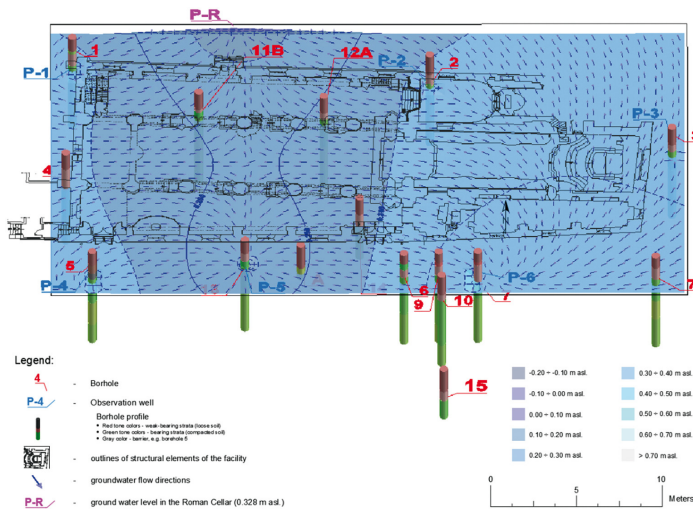
Fig. 5. Groundwater table level map with marked soil profiles at the borehole and piezometer location, with seepage directions for 31/7/2019, against the background of the Basilica basement level plan

31/7/2019, against the background of the Basilica basement level plan, with marked soil profiles in test boreholes and piezometers. Fig. 5 also shows water seepage directions resulting from piezometer groundwater levels. The analysis covered changing water levels on individual piezometers, as well as varying water seepage directions and seepage gradient values. Gradient values were analysed both along the entire length between the piezometers and locally, e.g., in the area of the pillars that experienced the greatest settlement.

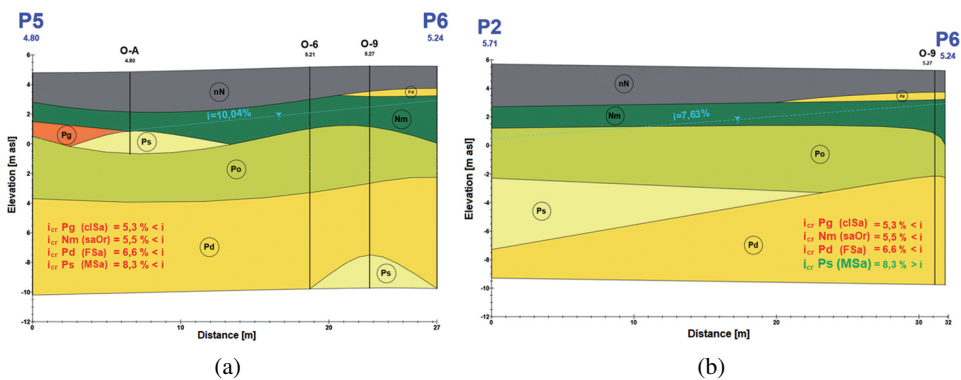
Fig. 7a shows the P5-P6 longitudinal profile and the position of the groundwater table curve position on 2/12/2019, and Fig. 7b shows the P2-P6 longitudinal profile and the position of the groundwater table curve position on 2/12/2019. Fig. 8 shows the P5-P2 longitudinal profile and the position of the groundwater table mean curve position and the local mean curve on 12/7/2019, as well as a diagram of pillar foundation level. Fig. 7–8 also show determined mean gradients between piezometers, relative to the critical gradients for

Fig. 7. Averaged groundwater table position within the Basilica area for 2/12/2019: a) P5-P6 longitudinal profile, b) P2-P6 longitudinal profile

given soil types. Red colour marks the soils with exceeded critical gradient values (Bligh criterion) [37].

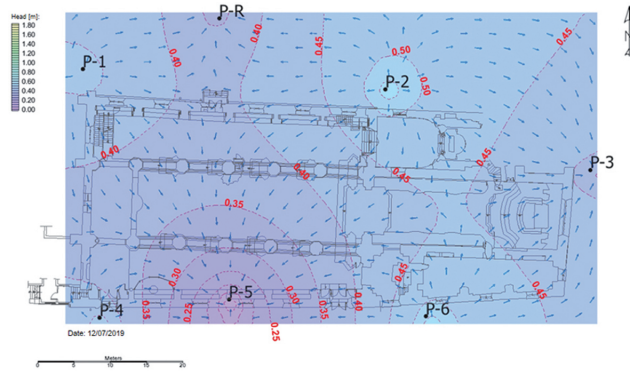
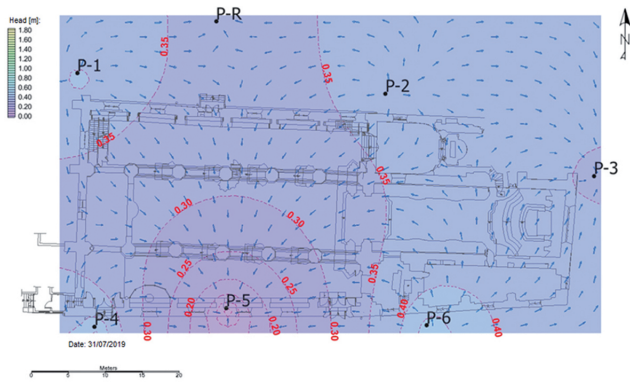
Fig. 9. Groundwater table level map with seepage directions for a) 12/7/2019 and b) 31/7/2019, against the background of the Basilica basement level plan

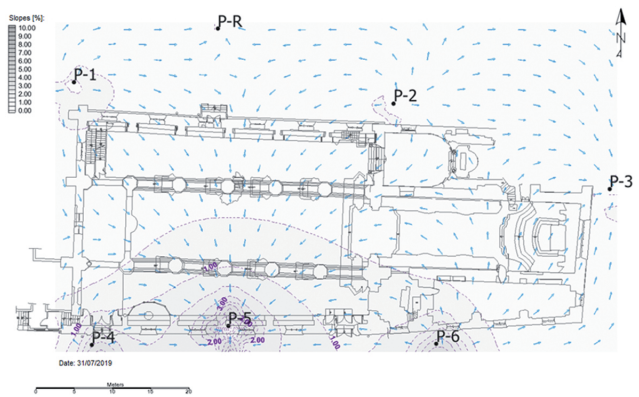
Fig. 11. Map of local groundwater table declines with seepage directions for a) 12/7/2019 and b) 31/7/2020, against the background of the Basilica basement level plan

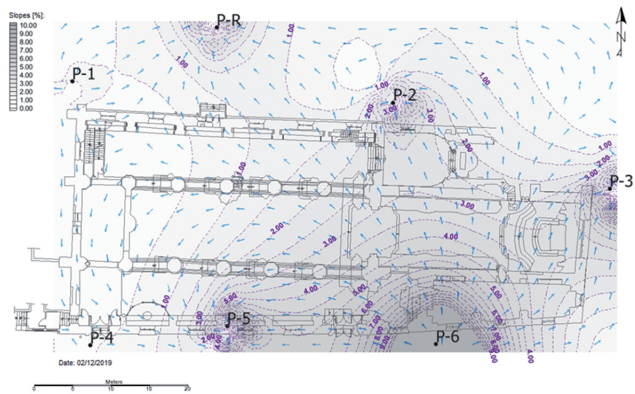
Fig. 12. Map of local groundwater table declines with seepage directions for 2/12/2019, against the background of the Basilica basement level plan
