Multifaceted diagnostic inference process for identifying the causes of self-ignition engine faults resulting from PM sediments

Key words: VGT turbocharger, PM particulates, diagnostic tester, spectral analysis, error codes

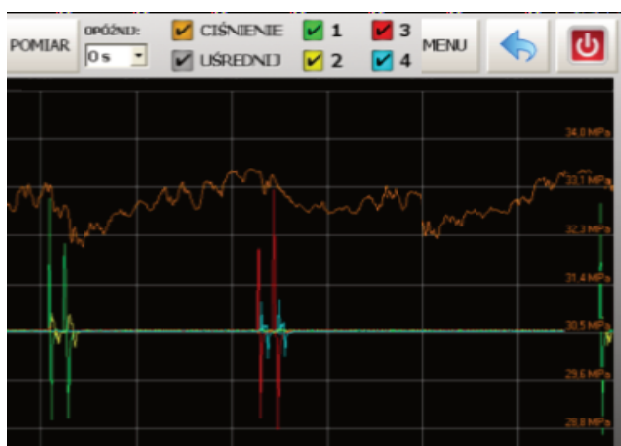
The recorded characteristics show the high pressure maintenance conditions for the 3rd cylinder injector over the extended periods of time, suggesting the possibility of "clogging the atomizer openings". In this case, one aspect is worth noting of the injector damage condition in the absence of fault indications generated by the MIL indicator [15]. Contaminated fuel and improper filtering quality lead to permanent defects of the injector's ball control valve,

which cannot close the cross-channel leakage despite the EDC controller's failure to control the valve. The lower pressure in the control chamber of the injector causes an uncontrolled fuel injection. In this case, the controller will not register any fault, and the excess fuel contributes to the exhaust smoke increase. Despite such a serious fault in the system – the MIL indicator on the instrument cluster [14] will not be activated.

Fig. 6. Current characteristics of injector coils and pressure in the fuel rail.

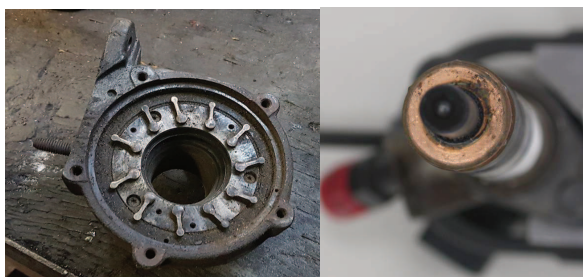
The last step is to erase the errors recorded in the controller's memory. This is an action that must always be performed after a repair or replacement of damaged components. Disassembly of the turbocharger confirmed the expected excess of the sediment in the lever and steering vanes area, and also the excessive deposits were found in the injector outlet zone (Fig. 7). After error deletion and a test run, the tester record showed no error codes.

Fig. 7. Residual sediments in the area of the levers positioning the exhaust nozzle blades and in the zone of injector outer openings

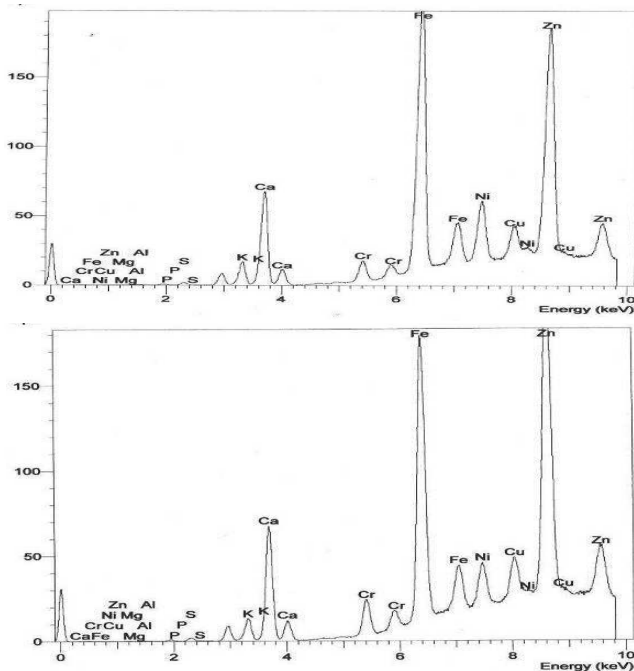
XRF (X-ray fluorescence) method was applied in the qualitative analysis and the sample of the sediments was taken after washing the analyzed zones with hexane (Fig. 9). On the basis of the assessment of band intensity changes for the identified elements, a qualitative assessment of the sedimentation was conducted. The presence of metals such as iron, zinc, chromium, nickel, and copper was found in the analyzed sediments. In addition, the presence of such elements as calcium and phosphorus and sulfur was noted. The presence of zinc, calcium and phosphorus results from the engine oil degradation, including the additive package. In addition, depressants also contain iron ions [8]. In the XRF spectrum for the sediments taken from the levers, a high intensity of iron bands was recorded. These impurities are mainly due to the corrosion processes of steel elements, whose structure is more susceptible to corrosive FAME. The relatively high intensity of the calcium and zinc bands was noted, indicating engine oil contamination as well as a significant share of the spectrum indicating nickel.

Fig. 8. XRF spectrum for sediments from the injector openings and nozzle levers

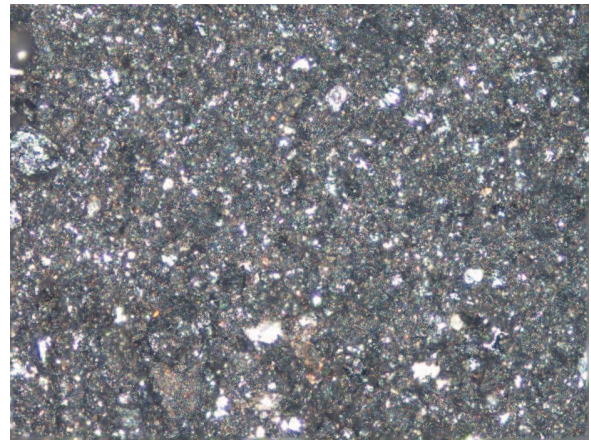
In the microscopic analysis of the deposit collected from the levers (Fig. 8), the sediment grains were observed, which were stained with a tarry substance. The sediment from the injection zone of the 3rd cylinder injector was characterized by a finer and "dry" structure with a visible fraction of the mineral material. The XRF ED X-ray fluorescence spectra were taken from the Oxford Instruments ED 2000 recorder, while the infrared IR spectra (FTIR) were recorded on the BIO-RAD FTS 175.

Fig. 9. Microscope image (magnification 100 ×, reflected light) of the sediment collected from the exhaust nozzle levers

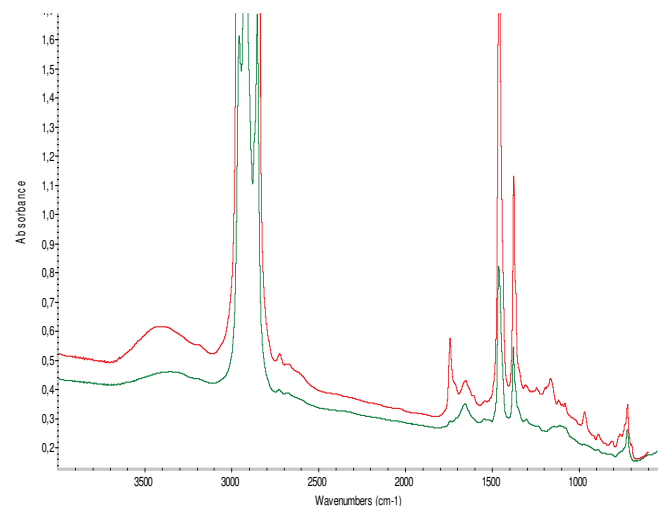
After the sediments from the outer surface of the analyzed zones were washed with chloroform, the sample was analyzed in the infrared spectrum. The fuel residue and the engine oil residue were observed, as well as degradation products. The IR spectrum for the substances isolated in the 3rd opening of the injector is poorer (Fig. 10). At first a comparative analysis was conducted of hydrocarbon bands, i.e. the range of wave numbers: 2850–3000 cm^{-1} , 1464 cm^{-1} , 1377 cm^{-1} , 722 cm^{-1} [10]. In both cases, the background was more raised, which is related to the presence of soot. In addition, vibration bands typical for hydroxyl groups (about 3400 cm^{-1}) are present, which may be derived from the absorbed water, and also from the alcohol and carboxylic acids structures [10].

Fig. 9. Infrared spectrum of the soluble sediment from the injector openings (green) and nozzle levers (red)

The band in the range of about 1655 cm^{-1} in the diagnostic area of 2000–1600 cm^{-1} is also intensive, which indicates the presence of oxidation processes of organic compounds to carbonyl and carboxylic structures. The effects of these compounds on nitrogen oxides are related to the presence of hydrated carboxylic acid salts. These substances may also be derived from the oxidation and degra-

The approx. 1630 cm^{-1} band is derived from other compounds containing C-O-NO₂ bonds, resulting from nitro-oxidation of engine oil components and fuel in contact with nitrogen oxides. The observed intense 1747 cm^{-1} band is related to the presence of esters, for which the representative ones are the relations of C=O (aliphatic) carbonyl groups with the bands in the $1750\text{--}1735\text{ cm}^{-1}$ range [5].
