# Characterization of oxide layers formed on 10CrMo9-10 steel operated for a long time in the power industry

**Abstract.** This paper presents the results of diagnostic examinations conducted on the coils of super-heaters made of 10CrMo9–10 steel that were operated in industrial conditions at 480°C for 130 thousand hours. The tube was exposed in a coal-fired boiler. The chemical and phase composition of the oxide/deposit layers formed on both sides of the tube walls (outside – flue-gas side and inside – steam side) and their sequence was examined using optical microscopy, scanning electron microscopy with electron backscatter diffraction and energy-dispersive X-ray spectroscopy, and X-ray diffraction. The changes in the mechanical properties caused by corrosion and aging processes were concluded from the hardness measurements. In addition, the nature of cracks in the oxide layers caused by pressing a Vickers indenter was determined. The results of these examinations have shown a high degradation of steel on the flue-gas inflow side and identified the main corrosion products and mechanisms.

**Key words:** power industry; 10CrMo9–10 steel; oxide layers.

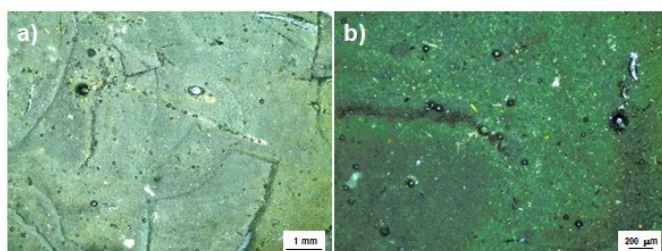
Quite small but deeper chipping of the layer can be observed. Based on the analysis of the chemical composition (SEM) and X-ray diffraction (XRD), it was shown that three zones have been distinguished in the oxides layer formed.  $\text{Fe}_2\text{O}_3$  occurs at the surface, followed by magnetite ( $\text{Fe}_3\text{O}_4$ ) and wustite ( $\text{FeO}$ ). Microscopic observations show discontinuities in the oxide layers. In the oxide layer produced on the 10CrMo9-10 steel, there are numerous defects in the form of pores and gaps, as shown in

**Fig. 3.** Optical micrographs of the oxides formed on 10CrMo9-10 steel of the inner side at elevated temperature

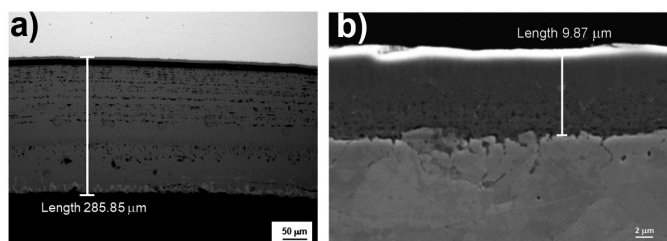
Fig. 4. These defects are the dominant factor causing the chipping and flaking of the oxide layer. The microscopic observations carried out show a large proportion of pores in the layer directly from the steel side. This porosity is oriented parallel to the steel substrate. On the side of the flowing medium, the number of pores present is smaller, but there are areas where the pores become quite large. The voids are probably produced by the diffusion of chromium off the iron oxide layer. From the thermodynamical point of view, Fe<sub>2</sub>O<sub>3</sub> and Cr<sub>2</sub>O<sub>3</sub> are fully miscible, but the lattice parameters of Fe<sub>2</sub>O<sub>3</sub> obtained from XRD correspond to hematite (Fe<sub>2</sub>O<sub>3</sub> without chromium). Probably because of the reaction kinetics, Cr oxidizes faster than Fe. Thus, the chromium oxide is leached from the sample surface. Crevice corrosion appears on the oxide layer/steel interface.

**Fig. 4.** Cross-section(s) of the inner side of the pipe showing the layered structure of the iron oxides: (a) LM, (b) SEM micrograph taken with secondary electrons

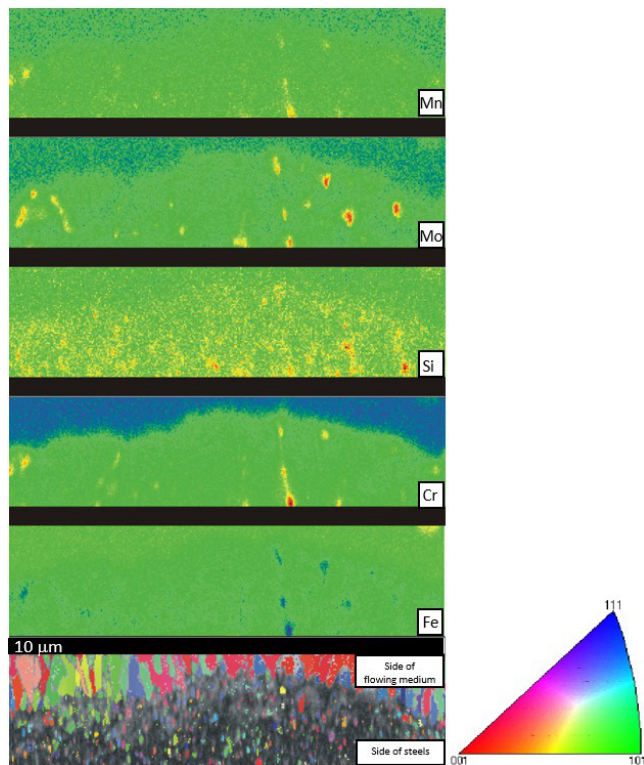
In the interior of the tube directly from the steel side, the magnetite structure is close to the equiaxial, but it becomes columnar with much larger grains from the steam side (Fig. 5). In the interior of the tube directly from the steel side, magnetite with equiaxial grains is enriched with chromium, silicon,

**Fig. 5.** Upper panel: EBSD analysis of magnetite, the inner side. Different colors indicate different orientations of magnetite grains (s. color map). Other panels: Local concentrations of Fe, Cr, Si, Mo, and Mn

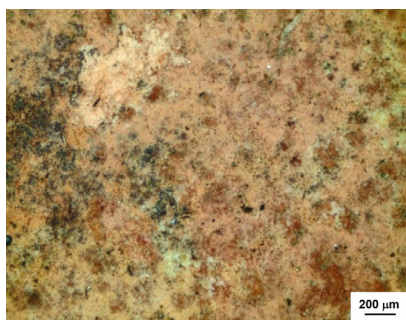
Minor deposits were low quartz (SiO<sub>2</sub>) and a phase whose crystal structure is very similar to the chemical composition of sillimullite [23] that has the general chemical formula (Al, Fe, Ti, Mg)<sub>8+4x</sub>Si<sub>4-4x</sub>O<sub>20-2x</sub> with  $x = 0.02$ . The presence of these phases was substantiated by the results of the EDX analysis, which revealed 68 at. % O, 9.6 at. % Si, 7.5 at. % Al, 5.9 at. % S, 5.2 at. % Ca, 1.5 at. % Fe and 0.3 at. % Ti on the outer surface of the worn pipe. As shown by the (macro and microscopic) tests, the oxide/sediment layer on the outer side was characterized by a more attacked surface as compared to the inner side (Fig. 7). The macroscopic tests performed showed that the oxide layers formed on the tested steel were discontinuous in places. Superficial damage is clearly visible over a large area of the layer surface in places of small cracks, which then take a more developed form with irregular shapes, reaching deep into the layer, down to the steel substrate. Macroscopic observations show that the outer layer consists of deposits under which hematite occurs, as evidenced by the red-brown color of the scratch. Under this layer, iron-black magnetite is visible.

**Fig. 7.** Oxides formed on 10CrMo9-10 steel of the outer side at elevated temperature

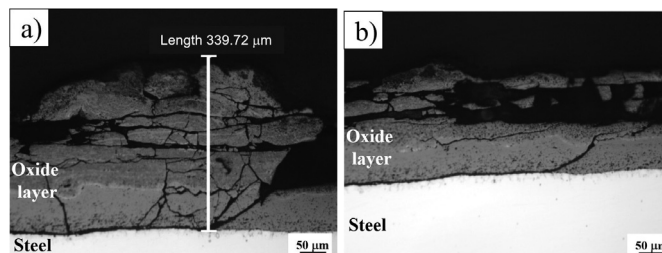
The optical microscopic observations carried out on the cross-section of the oxide layers (Figs. 8a and b) have shown

that the oxide layer is seriously degraded on the flue-gas inflow side. Numerous fissures and cracks occur directly on the flue-gas inflow side. The cracks run mainly parallel to the substrate (steel). Additionally, some cracks propagating perpendicularly to the substrate can be observed to a small extent. The oxide layer losses occur mainly in the oxide layer directly on the flue-gas inflow side. On the steel side, cracks have been observed that propagate into the oxide layer. Directly on the steel side, also the oxide layer porosity is smaller, and increases towards the layer interior.

**Fig. 8.** Optical micrographs of the cross-section of the oxide layers formed on the outer side – different positions (a, b)

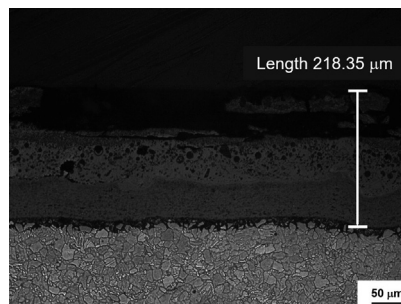
In addition, substantial degradation of the bainitic structure can be observed on this side as compared with the inside of the tube wall (Fig. 9). In the case of unstable pipe parameters such as temperature and pressure and considering different thermal expansion coefficients of metal oxides and  $\text{CaSO}_4$  enriched molten salt, the layer of this salt will easily fall off. After the layer falls off, the flue gas will react with metals, which will result in the pipe resistance to sulfur corrosion [24]. According to the literature [25], the destruction of the oxide layer occurs according to two mechanisms. In the first case, cracking of the layer occurs when the volume of the oxide is much smaller than that of the material on which the oxide has formed, and as a result, the oxide will break, reducing its own deformation. If the volume of the oxide is much larger, it will tend to reduce the deformation energy by breaking adhesion to the substrate material, which will result in flaking and chipping. Corrosion occurs on this side, mainly along the boundaries of the former austenite grain.

**Fig. 9.** The delamination between the oxide layer and the steel as seen by optical microscopy on the outer side

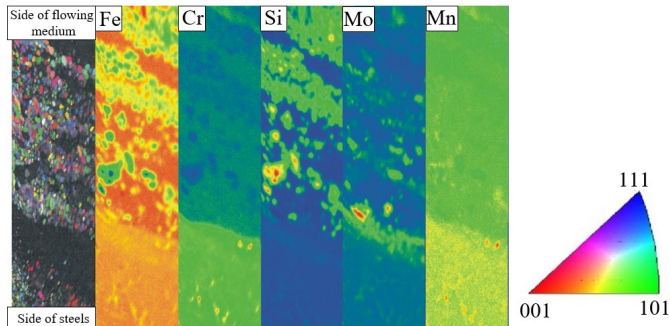
The EBSD examinations performed on the magnetite layers that formed on the outer (Fig. 10) side of the tube have shown the magnetite grains are nearly equiaxial. On the outside, di-

rectly on the flue-gas inflow side, areas enriched in silicon oxide ( $\text{SiO}_2$ ) can be observed apart from the iron oxides. Moving towards the original steel substrate, the magnetite layer is enriched with chromium and manganese.

**Fig. 10.** Left panel: EBSD analysis of magnetite, the outer side. Different colors indicate different orientations of magnetite grains (s. color map). Other panels: Local concentrations of Fe, Cr, Si, Mo, and Mn

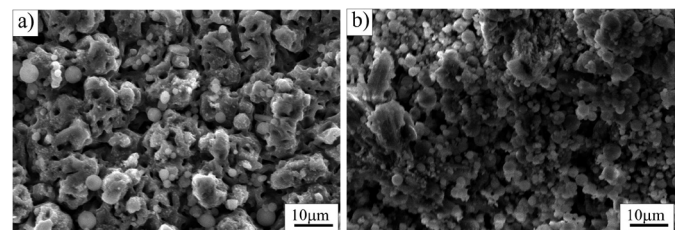
tion, as in Fig. 12. The SEM measurements performed on the respective surface (Fig. 13) revealed a mixture of the iron oxides on the steam side and a mixture of the iron oxides and deposits on the gas side. In the case of the outer side, local damage of the deposit layer can be observed. Figure 13 presents SEM images of the inner and outer surfaces of the steel tubes which illustrate the structural changes caused by chemical corrosion. Both images reveal lumpy, well-developed surfaces covered with regular bits of solid material, although with different morphological characteristics. Inner surface (Fig. 13a) is made of a mixture of particles the vast majority of which approaches 10  $\mu\text{m}$  in diameter. Approximately half of these particles are regular, smooth spheres, while the remaining half takes the form of irregular, pitted pieces of the material. On the other hand, the outer surface of the tube is covered with many rounded, tiny grains not exceeding few micrometers in diameter. Because of their small sizes, these particles are not covered with holes, although they tend to aggregate into larger clusters.

**Fig. 13.** SEM images ( $85 \times 58 \mu\text{m}^2$ ) of the corroded surfaces of the pipe: (A) inner surface, (B) outer surface

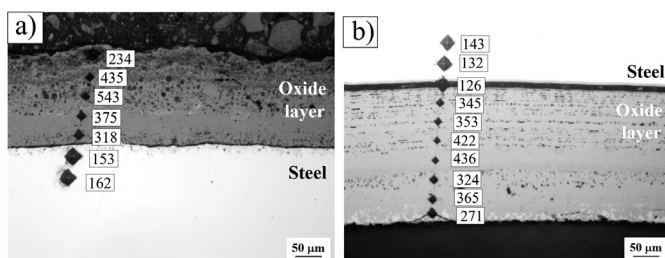
Indentation experiments performed on the outside and the inside have shown that in both cases, there are microcracks, regardless of the hardness values. A greater spread of microcracks was observed in the sediment layer directly from the side of the exhaust gas inflow (Fig. 14). Microscopic observations showed that this layer was brittle and prone to cracks (Figs. 8 and 9). A similar effect was observed on the boundary between the oxide layer and the steel. Less development of microcracks was observed in the dense oxide layer with a small number of pores. In the oxide layer formed on the steam side, the largest microcracks have been observed on the boundary between the oxide layer and the steam.

**Fig. 14.** The indentations produced during the Vickers hardness measurements (HV0.1) on the outer (a) and inner side (b) of the oxide layer
