Dominika GRYGIER*

EVALUATION OF THE OPERATIONAL WEAR OF THE SANDVIK CV117 CENTRIFUGAL CRUSHER

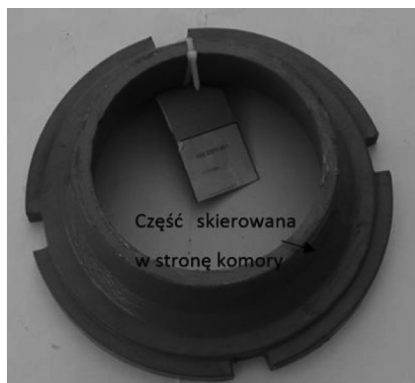
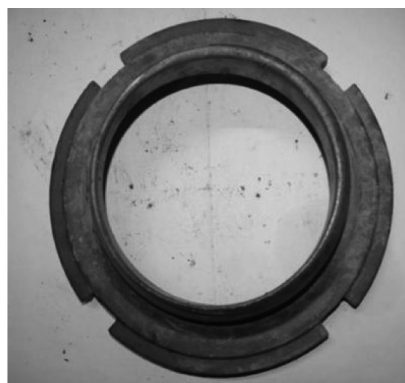
The directional sleeve should be replaced when the part facing towards the rotor chamber is worn away to a maximum height of 6mm above the top abrasion-resisting plate. This wear should be even up to the head; therefore, it is important to position the pipe correctly. It also affects the wear of the upper abrasion-resisting plates. Incorrect assembly or use may cause cracks and fractures of the bottom edge.

Macroscopic examinations showed that the reason for the replacement was excessive wear of the part directed towards the chamber (Figs. 7 and 8). No visible fractures or cracks in the lower edge were observed. The working surface was used in the range of 20%, and the total weight loss of the element was 22% (Table 1).

Fig. 7. Macroscopic image of the directional sleeve prior to operation in the crusher

Fig. 8. Macroscopic image of the directional sleeve after operation in the crusher

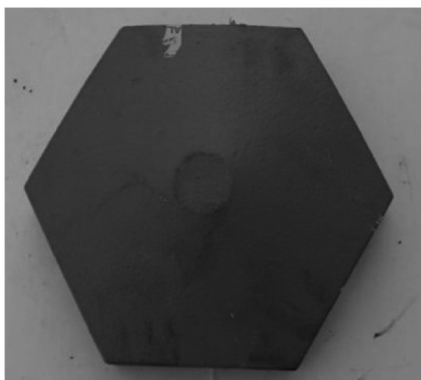
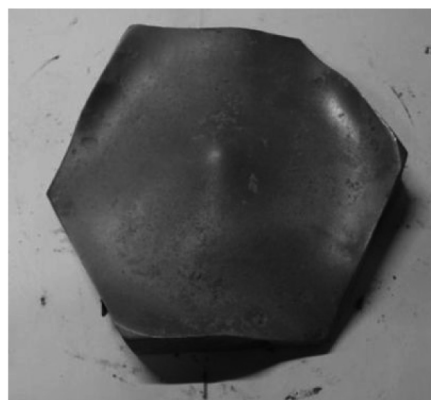
The distributor baffle wears in three areas opposite the impeller inlets. The partition is replaced when around 3–5 mm of material remains in the most-used place. Often, its premature wear is caused by oversize of the grain in feed, the dropping of the feed from the conveyor at high speed and sliding it directly onto the

dispenser partition. In the case of the post-operational components from the mine in Grzędy, macroscopic examination showed that the reason for the replacement was wear in places corresponding to the feed inlets to the rotor (Figures 9 and 10).

The partition of the distributor from the mine in Grzędy used up evenly and was replaced accordingly with the manufacturer's recommendation (leaving

3–5 mm of material). The working surface was used in the range of 38%, and the total weight loss of the component was 57% (**Table 2**).

Fig. 9. Macroscopic image of the dispenser partition before operating in the crusher

Fig. 10. Macroscopic image of the dispenser partition after operating in the crusher

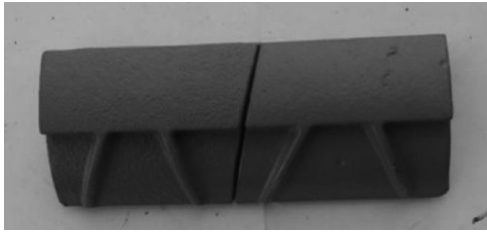
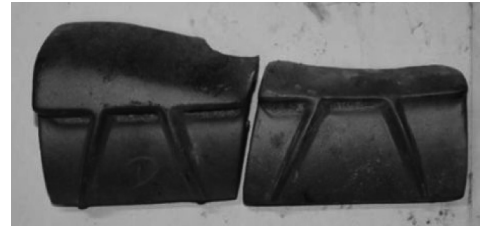
The standard hammer assembly is replaced before their wear reaches the rotor body. They are replaced in sets, e.g., all top or bottom ones, in order to maintain proper balance of the entire rotor. Macroscopic studies have shown that the reason for the exchange was a large loss of material from a fragment of the hammer directed

to the stream space (the place of the feed outlet from the rotor). A much higher wear of the upper element is also visible compared to the lower one (**Figs. 11 and 12**). The exploited surface was worn in the range of 12%, and the total weight loss of the elements was 13% (**Table 3**).

Fig. 11. Macroscopic image of the rotor hammer assembly before operation in the crusher

Fig. 12. Macroscopic image of the rotor hammer assembly after operating in a crusher

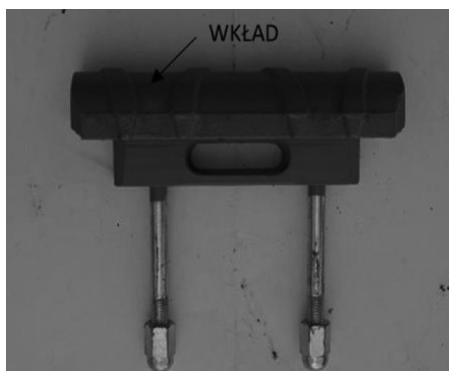
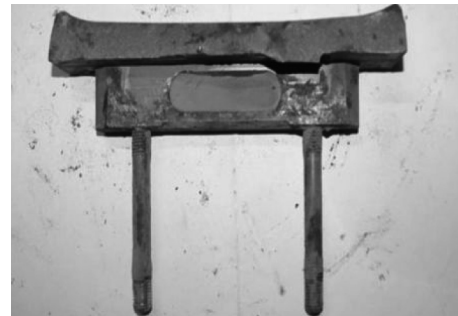
The assessment of the amount of wear on the impeller tip is carried out by checking the degree of wear on the cartridges, and the tip is replaced before exceeding 95% of the consumption of the middle part of the cartridge. They are also replaced in the event of breakage, cracking, or visible wear of the insert. A signal announcing the need to replace the impeller tip is also the appearance of a large amount of mesh fraction (oversize particles) in the feed, as well as cast steel and cast iron debris.

Macroscopic studies showed that the reason for the exchange was even wear of the elements in the central part and visible fractures in places of material narrowing (**Figs. 13 and 14**). The exploited surface was worn in the range of 8%, and the total weight loss of the element was 17% (**Table 4**).

Fig. 13. Macroscopic image of the rotor tip cladding prior to operation in the crusher

Fig. 14. Macroscopic image of the rotor tip cladding after operating in a crusher

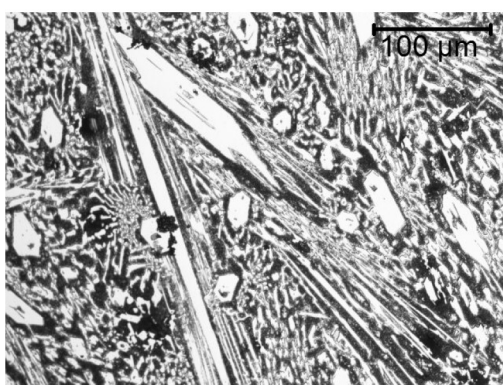
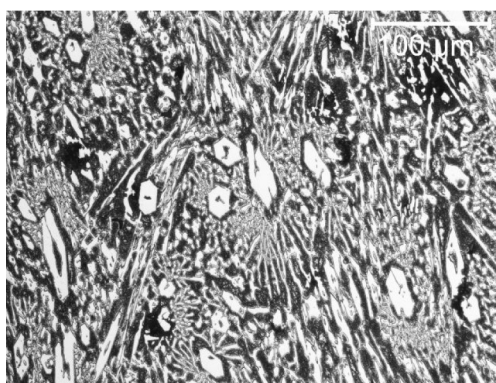
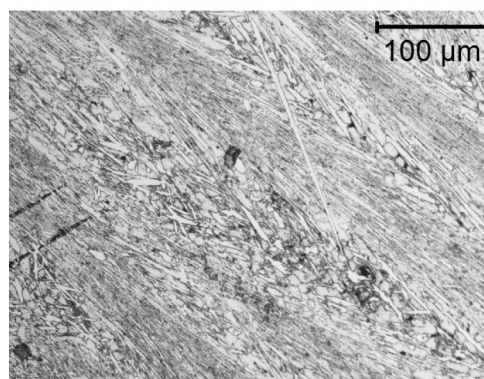
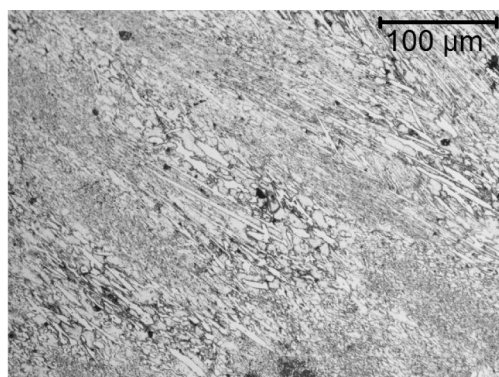
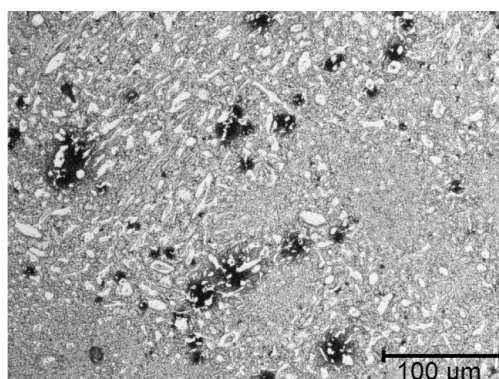
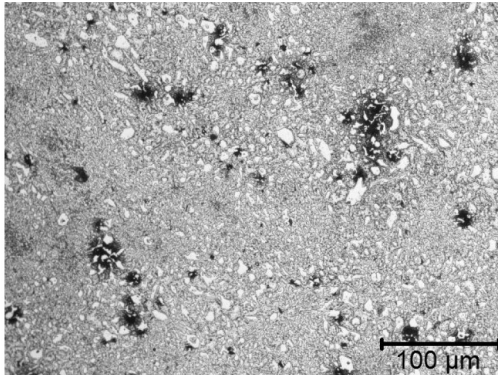
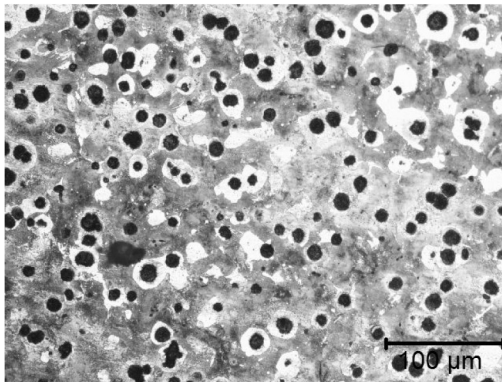
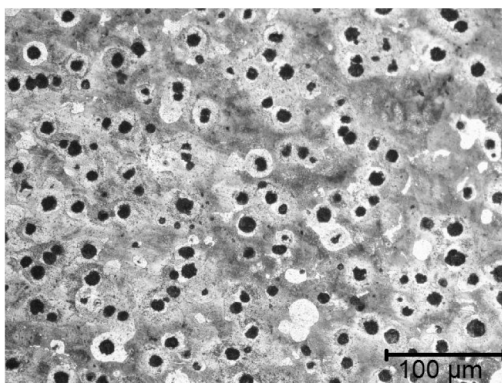
Microscopic studies have shown diversity in the material used for individual working elements of the SANDVIK CV117 centrifugal crusher. The directional bushes and the distributor's partition are made of Fe-C-Cr alloy resistant to abrasive wear and corrosion [L. 5, 12–15]. In both cases, in the microstructure of the tested materials, the primary acicular precipitations of the M7C3 type chromium carbide are visible in the ferritic-austenitic matrix (Figs. 15–18). The hammer assembly material is Fe-C-Cr-Si system alloy, and the primary fine precipitations of chromium carbide type M7C3 in the ferritic matrix were observed in its structure (Figs. 19 and 20). The rotor tip linings are made of ductile grey cast iron with a pearlitic ferritic matrix (Figs. 21 and 22) [L. 5, 12, 15].

At the same time, no structural or phase changes that could indicate a negative impact of exploitation on the structural properties of the materials of the tested elements were observed during microscopic studies (Figs. 15–22). Slight observed differences in the amount and size of carbide precipitations depend only on the cooling rate of the alloy during the production process.
