APPLICATION OF DIGITAL RADIOGRAPHY (DR) IN AN APPROACH TO EVALUATE THE TECHNICAL CONDITION OF MIG-29'S VERTICAL STABILIZERS

Abstract

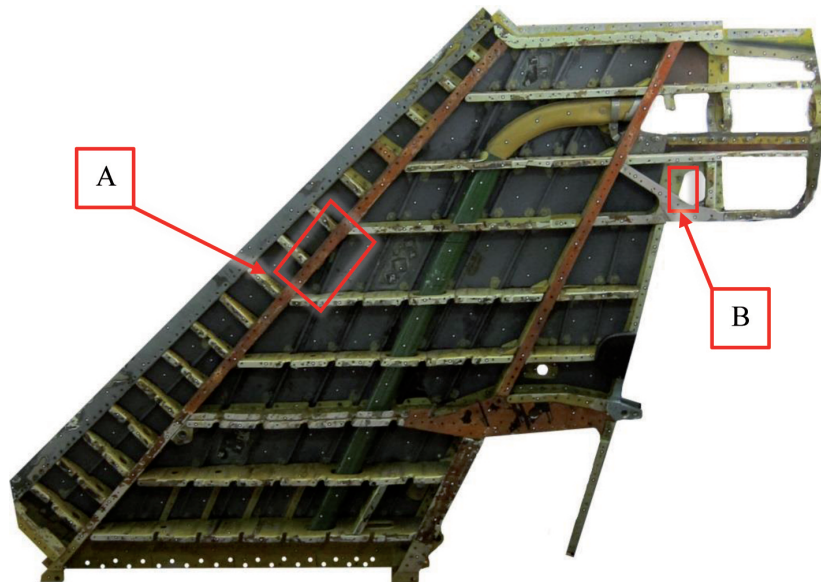
A post-fatigue test vertical stabilizer was used as the test object. One of its composite skins was removed during teardown inspection, and a visual and eddy-current inspection was performed. Cracks were detected and marked. In the work presented, a group of cracks was chosen to be registered with the digital radiographic method in order to evaluate the method's capability in this field. The cracks are located on the front spar and the rib adjacent to it in an area marked with letter *A* in Figure 1. Additionally, a crack detected on another stabilizer of the same type in an area marked with letter *B* in Figure 1 was inspected. The crack in *B* area is on the edge of an inspection opening, under a removable metal lid and could have been caused by an accidental impact during maintenance.

Figure 1. Inspected structure of MiG-29 vertical stabilizer with inspected areas marked red.

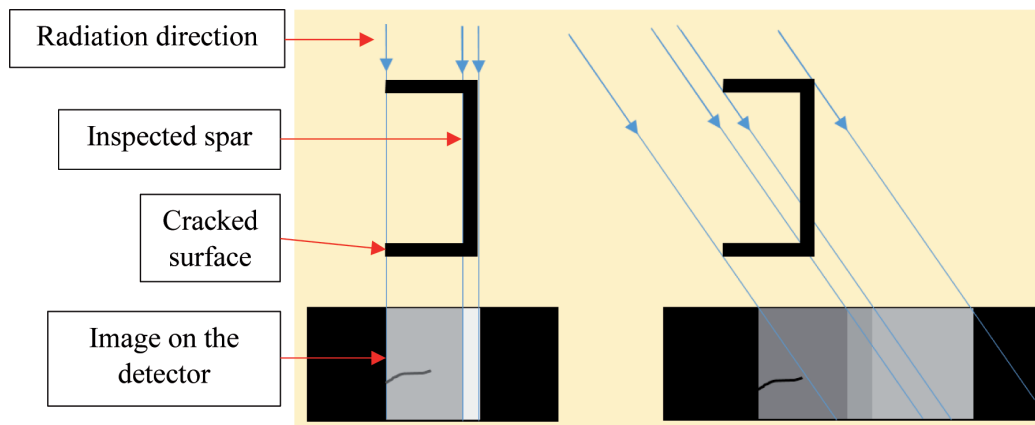
Figure 2. Schematic presentation of radiographic images of a spar achieved with positioning the x-ray source at different angles.

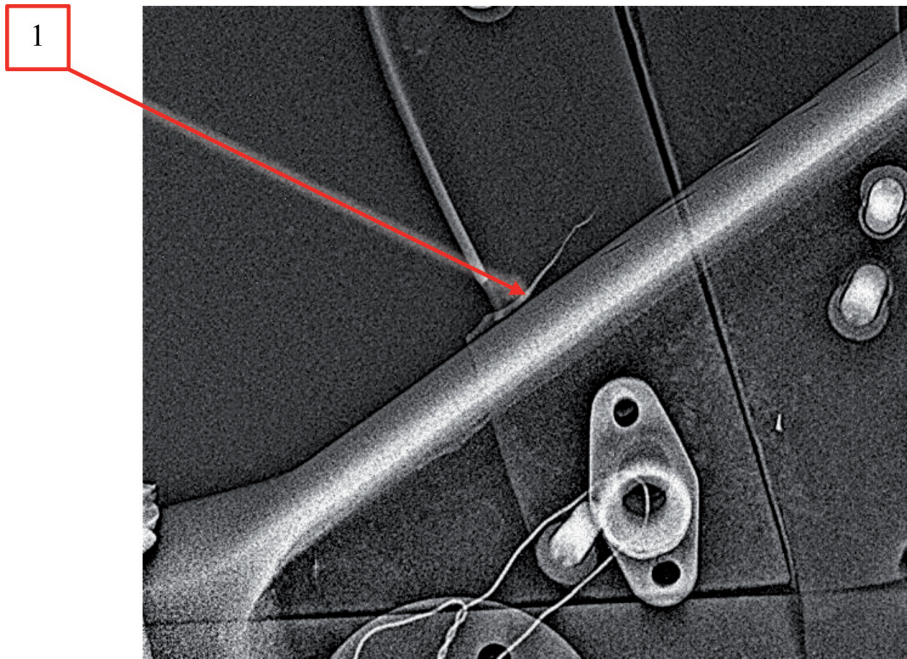
The radiographic testing was preceded with visual inspection whose purpose was to locate the cracks. The result presented in Figure 3 was obtained at 500 mm source-to-detector-distance (SDD). The crack's length was 15 mm.

Figure 3. Crack detected on a rib near the rear spar.

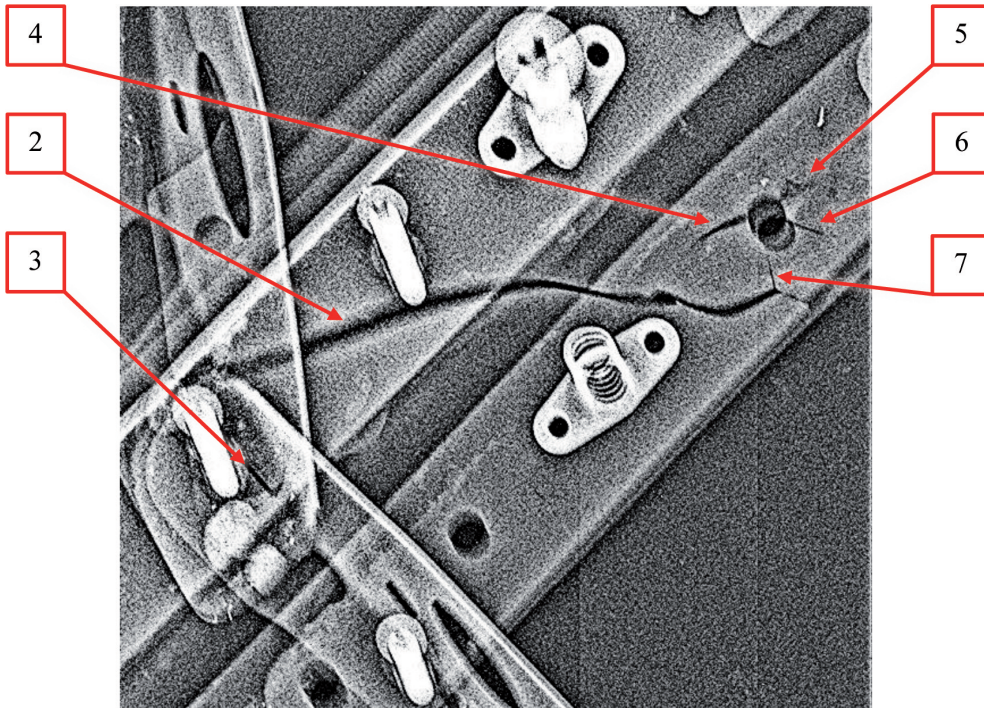
Figure 5. Six cracks detected on the front spar.

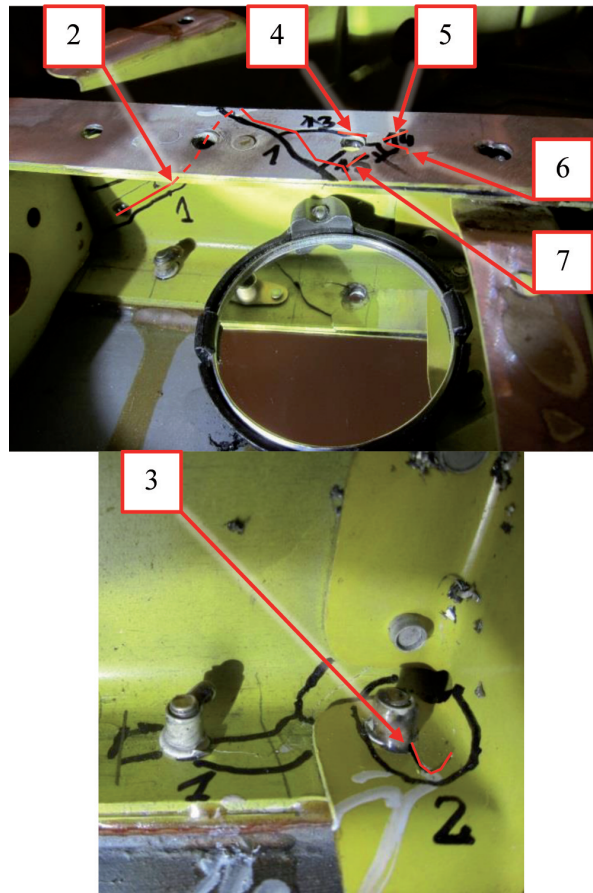
Figure 6. Photograph of six cracks presented on Figure 5.

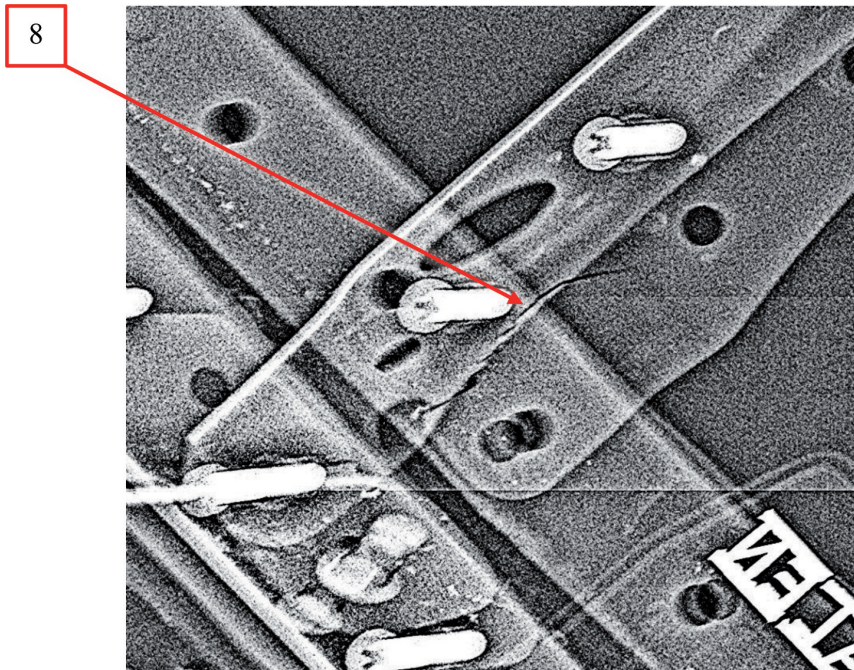
Figure 7. Crack detected on one of the ribs near the front spar.

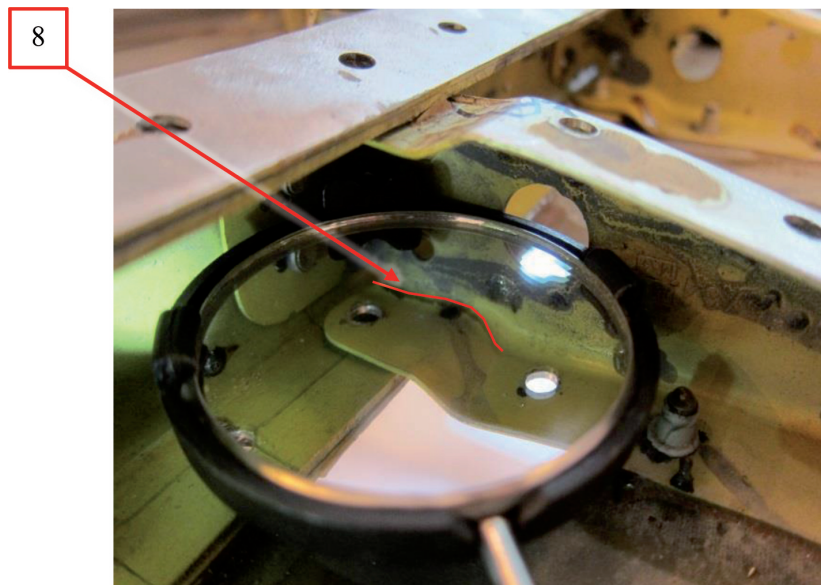
Figure 8. Photograph of the crack presented on Figure 7.
