The restoration problems of the gothic alabaster portal of the parish church in Drohobych

Key words: alabaster; portal; Drohobych; restoration; problems

Cytowanie / Citation: Fomina O. The restoration problems of the gothic alabaster portal of the parish church in Drohobych. *Wiadomości Konserwatorskie – Journal of Heritage Conservation* 2019;58:44-47

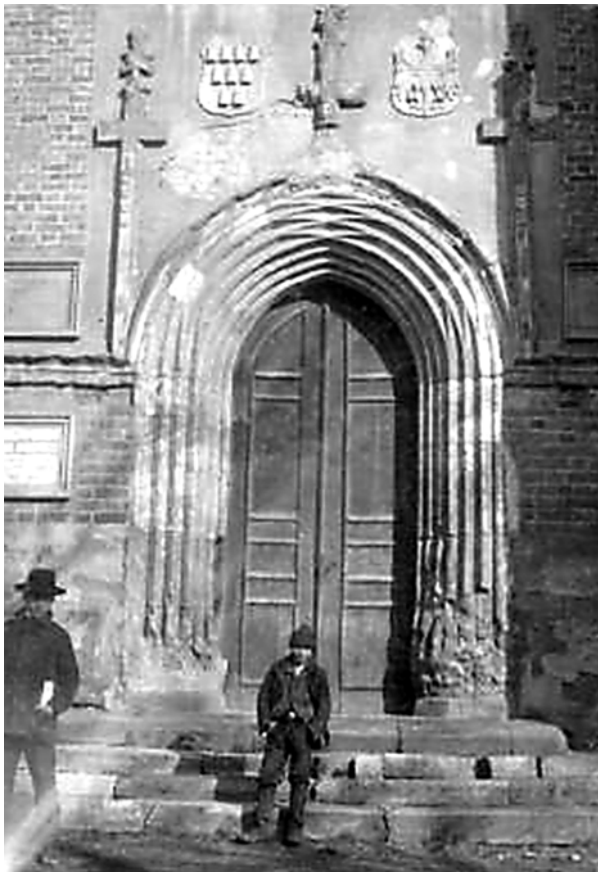
Fig. 1. Drohobych, parish church, south portal. Photo by B. Lieberman, 1906. Photograph collection of the Institute of the History of Arts UJ (repr. W. Walanus) [6]

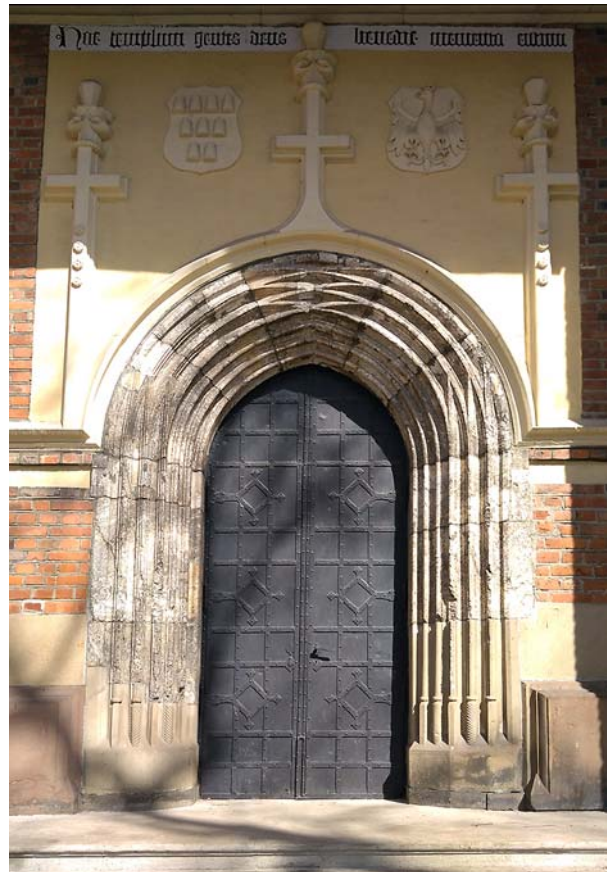
1. The portal is 3 meters high. It consists of 14 blocks, each of which is hewn of one solid. The blocks height and width are different. Consequently, the weight also differs. The keystone of the portal is in critical condition. Constant stress and weather conditions increase the collapse risk of the portal's keystone. It is necessary to arrange a safe disassembling of the blocks and their transportation to the restoration workshop.

2. Numerous secondary additions of different types of alabaster, different conservation state and a few types of cement mortar create additional problems during the restoration process. All of the alabaster panels are fixed of the cement mortar. Some of them are unstable. Cement was used to fill the cracks, gaps, additions of losses and to smooth out the stone surface. When removing cement the structure of alabaster will be damaged anyway. Therefore, it is necessary to select the most effective and safe method of removing the cement layers.

Fig. 2. Drohobych, parish church, south portal, 2018

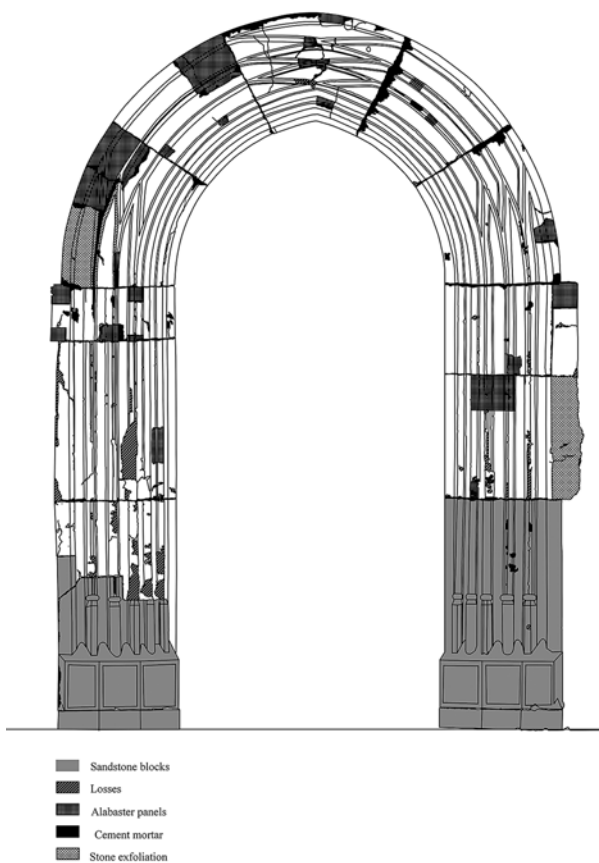
Fig. 3. The scheme of the alabaster portal losses

There are three possible variants for the reconstruction of losses. The first one is the use of polyester resin mixed with alabaster powder and pigments. The second – application of acrylic gypsum with pigments. After such addition, it is necessary to make gypsum hydrophobic. The third variant is to cut out the lost fragments from alabaster. The pigments are used for tinting the additions by replicating the stone texture. Alabaster panels must be attached to the high-quality gypsum mortar.
