Michnej M, Młynarski S, Pilch R, Sikora W, Smolnik M, Drożyner P. Physical and reliability aspects of high-pressure ammonia water pipeline failures. *Eksploracja i Niezawodność – Maintenance and Reliability* 2022; 24 (4): 728–737, <http://doi.org/10.17531/ein.2022.4.13>

Physical and reliability aspects of high-pressure ammonia water pipeline failures

The object of the study is the high-pressure ammonia water pipeline of the coke oven battery complex. The pipeline is placed on sliding supports with certain movement restrictions and fixed supports. The supporting elements are brackets connected with the trestle bridge common to two other process pipelines. The entire route of the pipeline runs with a slope of 3 ‰ to 8 ‰ between successive supports. The pipeline is operated in the natural ambient conditions of the coke oven battery. The pipeline components are protected against weather conditions with a varnish coat. The ambient temperature of the pipeline is defined as being between -25°C in winter and +30°C in summer. The structure of the pipeline ensures compensation of changes in its length due to temperature changes. Length change compensators were made by local U-shaped profil

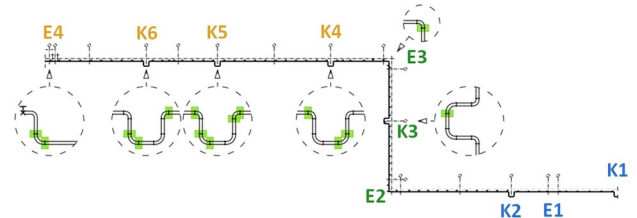
Fig. 2. Scheme of the pipeline with marked compensators (K1-6) and changes to its route (E1-4) [10]

The location of the damage may indicate the relationship of their formation with the local nature of the operation of a compensator profile. However, as shown in the scheme, the damage was not found in all of the affected areas. Therefore, the pipeline components were further tested.

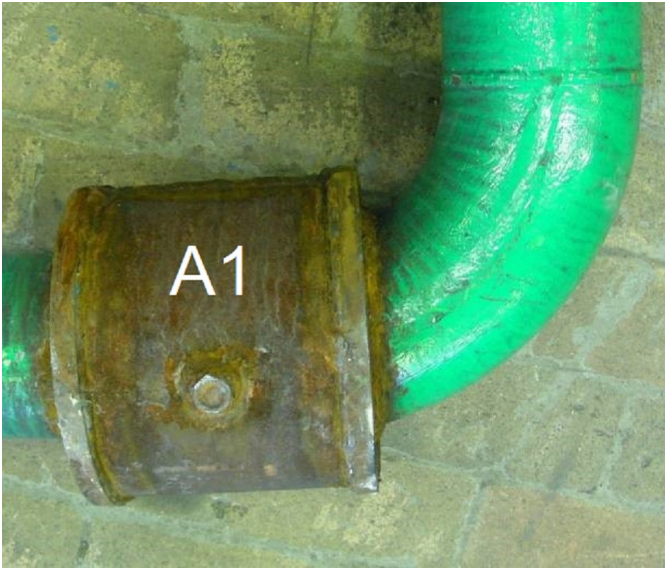
Figures 3 and 4 show selected pipeline welds tested, marked with symbols A1, B1 and C1. There were sealing bands on the welds placed on the pipeline during its operation after the occurrence of leakage. The joint A1 was sealed with a double flange with an external band.

Fig. 3. A1 joint of the high-pressure ammonia water pipeline

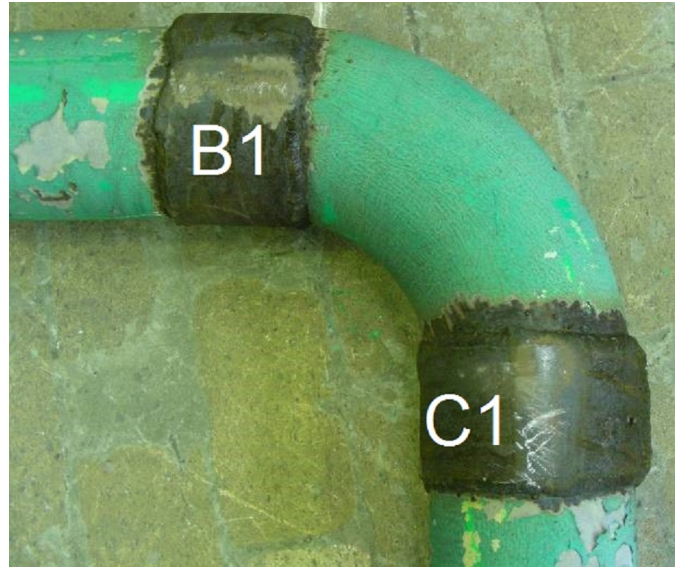
Fig. 4. B1 and C1 joints of the high-pressure ammonia water pipeline

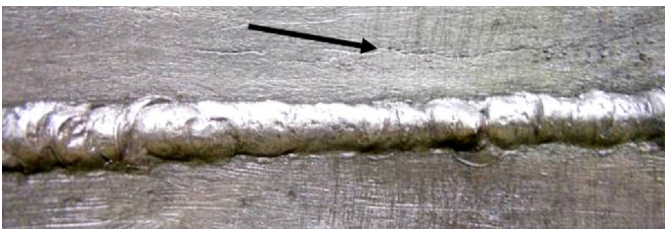
Fig. 5. View of the A1 welded joint from the root side (from the inside of the pipe)

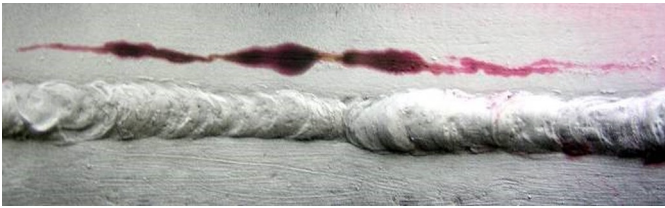
Figures 6 and 7 show the pipeline cracks visible from the inside, detected by penetrant tests. Dye penetrant has leaked to the outside of the pipe in some places.

Fig. 6. View of the A1 welded joint from the root side after penetrant testing

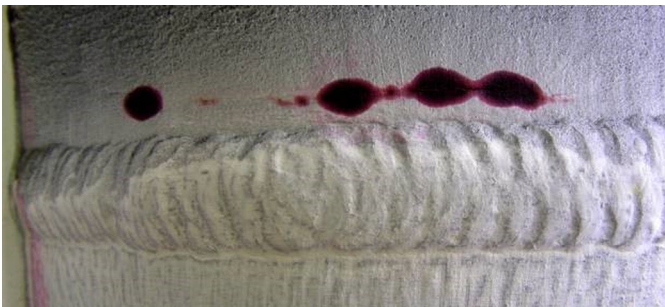
Fig. 7. View of the A1 welded joint from the face side after penetration of the dye penetrant from the inside of the pipe

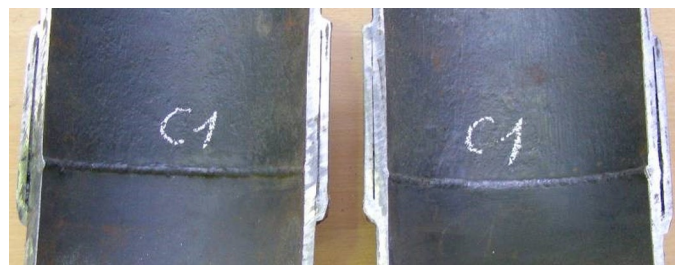
Fig. 8. shows a part of the pipeline with C1 joint after it has been cut open. Fig. 9 shows the pipeline cracks visible from the inside, detected by penetrant tests

Fig. 8. View of C1 welded joint from the root side; visible sealing band

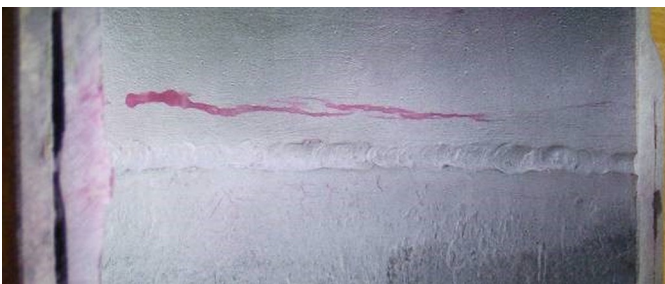
Fig. 9. View of the C1 welded joint from the inside of the pipeline after penetration testing

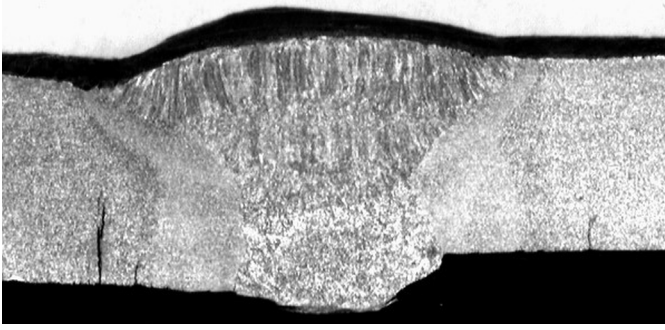
material of the pipeline in various places around the welded joints A1 and C1 are shown in Fig. 10. These cracks are located in the material outside the joint.

All the cracks in the pipeline near the joints were located in its bends and propagated from the inside of the pipeline. Where the crack reached the outer surface of the pipe, the medium penetrated the gap and the pipeline began to leak. Defects of joints visible in the cross-sections, such as shifts of the joined edges, may be of significant importance for the operation of the joint and the occurrence of the observed defects.

Fig. 10. Cross-sections of A1 (left) and C1 (right) welded joints

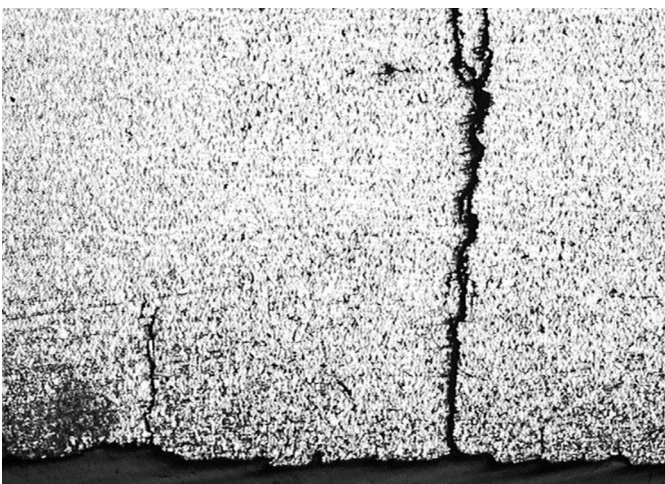
Fig. 14. Crack in the bend material in the vicinity of the A1 welded joint. 100x magnification, nital etching

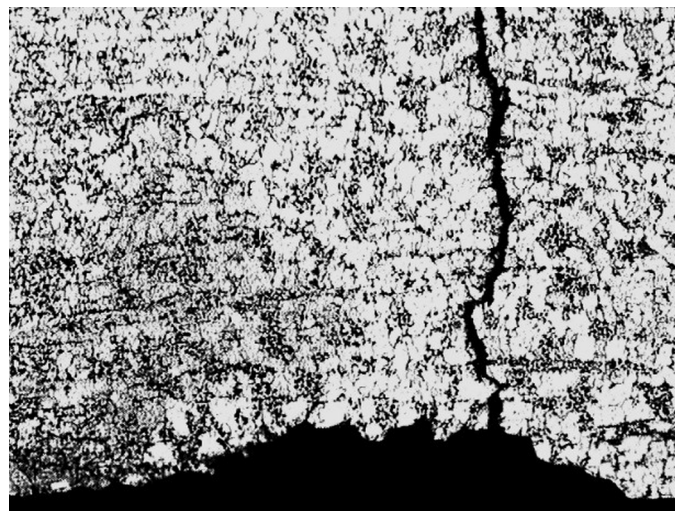
Fig. 15. Crack in the bend material in the vicinity of the C1 welded joint. Approx. 50x magnification, nital etching

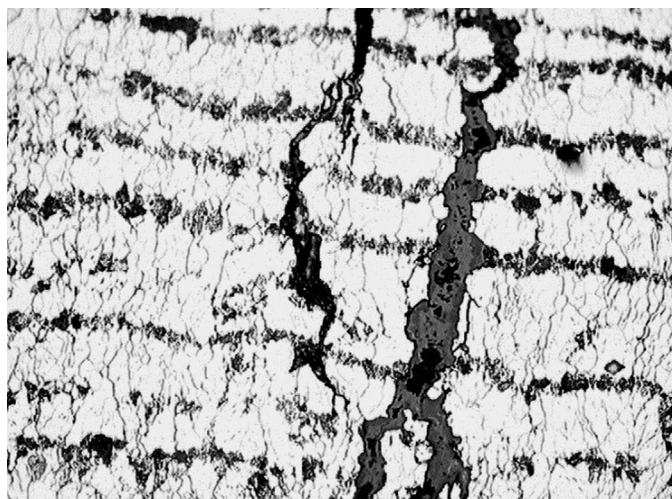
Fig. 16. Crack in the bend material in the vicinity of the C1 welded joint. Approx. 500x magnification, nital etching

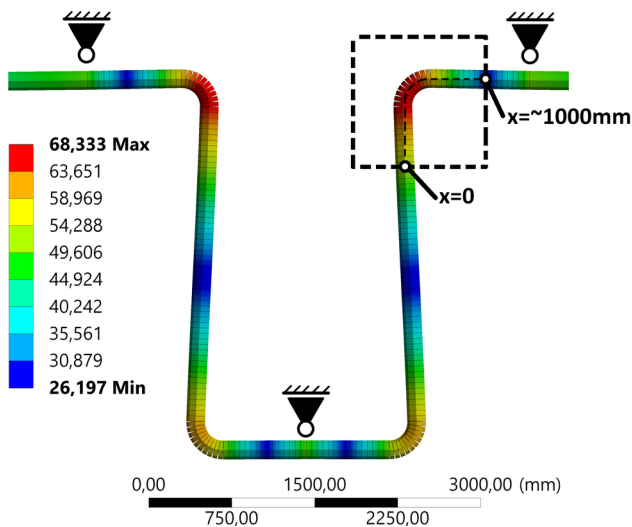
The example of the stress distribution in K2 compensator for environmental temperature and pipe outer surface temperature equal to -20°C is shown in Fig. 17. This stress results from the normal stress coming from bending and tension/compression. The figure shows its maximum value in a given location along pipeline axis. In each of the compensators, the stress distribution is very similar as in Fig. 17. The highest values can be observed in bends located by the main pipeline. Calculated specific values are, however, varied and dependent on which of the three pipeline segments given compensator is located.

Fig. 17. Equivalent stress [MPa] distribution in the K2 compensator for the environmental temperature and pipe outer surface temperature both equal to -20°C . Intermediate supports locations are shown. Visible deformation is scaled. Dashed rectangle shows pipeline part from Fig. 20

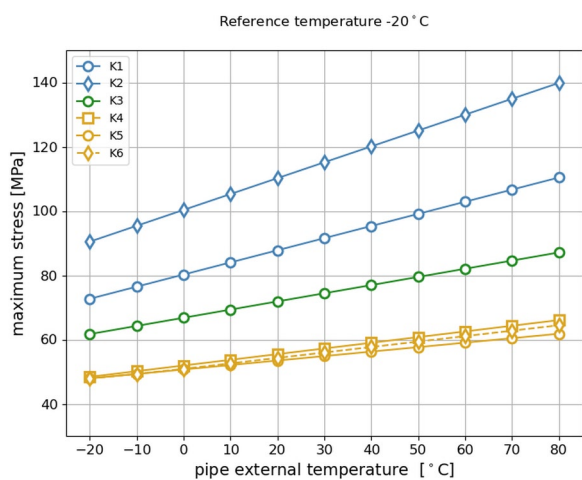
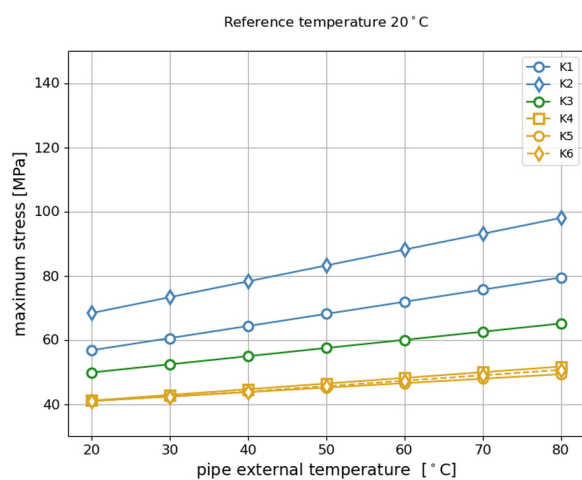
Based on Fig. 18 and 19, which present the maximum values of stress in locations K and E as a function of temperature of the pipe outer surface, it can be observed that compensators K4-6 are loaded almost in the same way and stress level there is significantly lower compared to the rest of compensators. Next, according to the ascending load order, are compensators K3, K1 and K2. Higher value of stress in these pipeline parts can be explained through the lower number of compensators in the regard to the length of the given pipeline segment. In all these locations and for all temperature variants, maximum stress did not exceed yield stress for steel P235GH ($Re \approx 235 \text{ MPa}$)

from which pipes were manufactured. They remained at a safe level (max. 140 MPa). For locations marked as E, stress values were comparable with those in the compensators.

Fig. 18. Maximal equivalent stress [MPa] in pipeline compensators, as a function of pipe outer surface temperature for environmental temperature a) -20°C b) 20°C

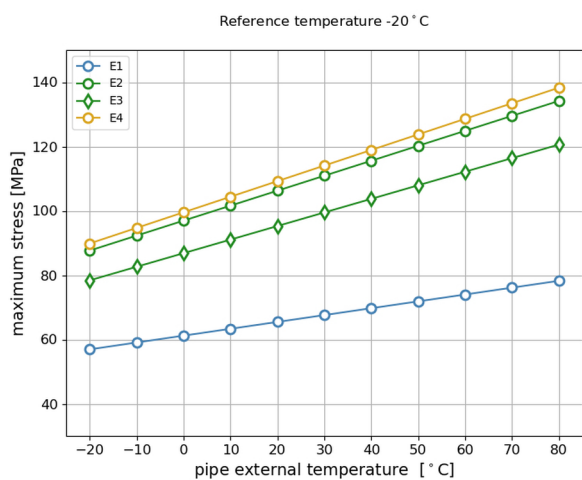
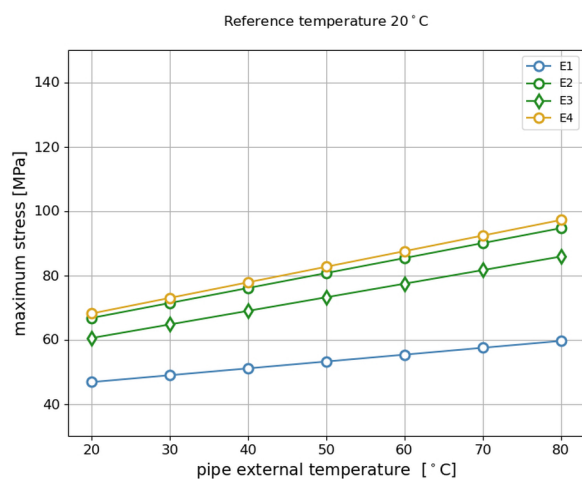
Fig. 19. Maximal equivalent stress [MPa] in local pipeline route changes, as a function of pipe outer surface temperature for environmental temperature a) -20°C b) 20°C

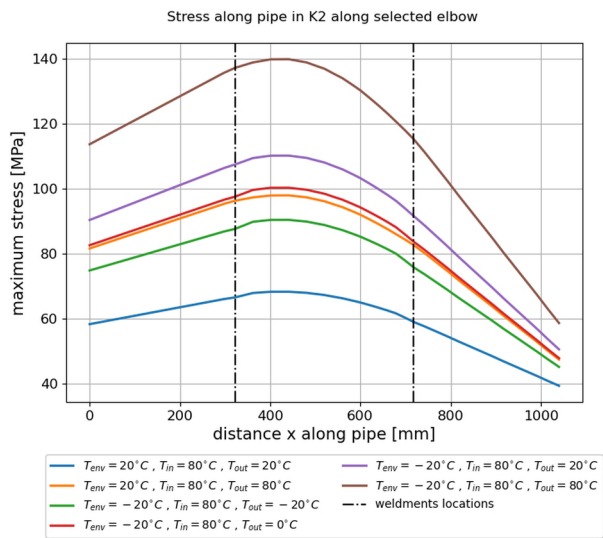
The stress distribution in the vicinity of a single bend of the compensator K2 (Fig. 2) is showed in Fig. 20. The stress is plotted as a function of the pipe length measured along its route. Maximum stress occurs within the bend, but a bit further from it, in both directions, where the actual welded joints are located, the stress is significant lower. More sharp decline appears in case of the part located on the main pipeline route, which is caused by a close proximity of the pipe support. Therefore, actual value of the stress in the place where welded joints are located should be even lower that it was initially estimated in Fig. 18 and 19.

Fig. 20. Maximal stress [MPa] distribution along pipeline in the part depicted in Fig. 17 for selected cases of temperatures. Dash-dotted lines show actual location of welded joints connecting bend with the straight pipes.

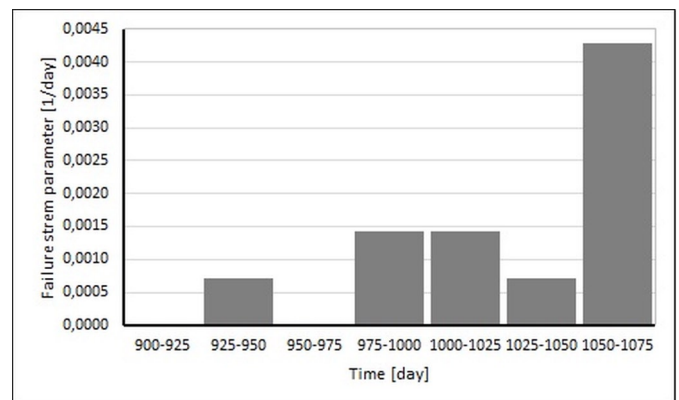
Fig. 21. Failure stream parameter values

The observation of its course shows that after the 925th day of operation, the value of the parameter becomes greater than zero and begins to increase. Generally, such a fact is interpreted as the time the technical object enters the aging period. In this case, the beginning of the increasing course over time can be interpreted as the beginning of the period in which the cracks initiated by corrosion and propagating from the inside of the pipeline, in some elements, already reach a length equal to the wall thickness and cause the failures observed as a pipeline leak. It can be assumed that in the further operation, the number of such failures will increase since the subsequent considered elements will most likely be damaged in the same way, and the observed values of failure stream parameter will continue to increase.

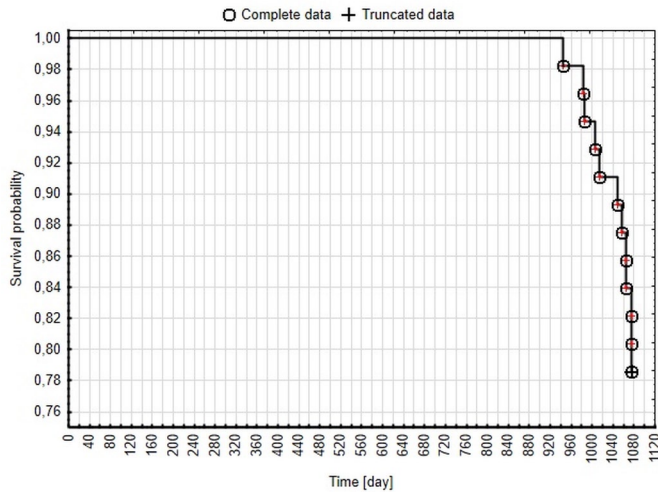
Fig. 22. Survival function for truncated data in the Kaplan-Meier analysis

The graph indicates the probability of surviving without a failure for a certain number of days for each individual element. This value drops very quickly after reaching the operating time of 940 [days]. It can be concluded that each of the remaining available (undamaged) components is less and less likely to survive the next days without a failure. As the probability decreases quickly, it is possible to predict the appearance of many successive failures in the observed set of elements over a short time.
