CONDITIONS OF USAGE ANALYSIS OF THE TWO-STROKE, SLOW-RUNNING, HIGH POWER RATING, MAIN ENGINES AND THE CAUSES AND EFFECTS OF THE TRIBOLOGICAL SYSTEMS DAMAGE

Zbigniew Łosiewicz

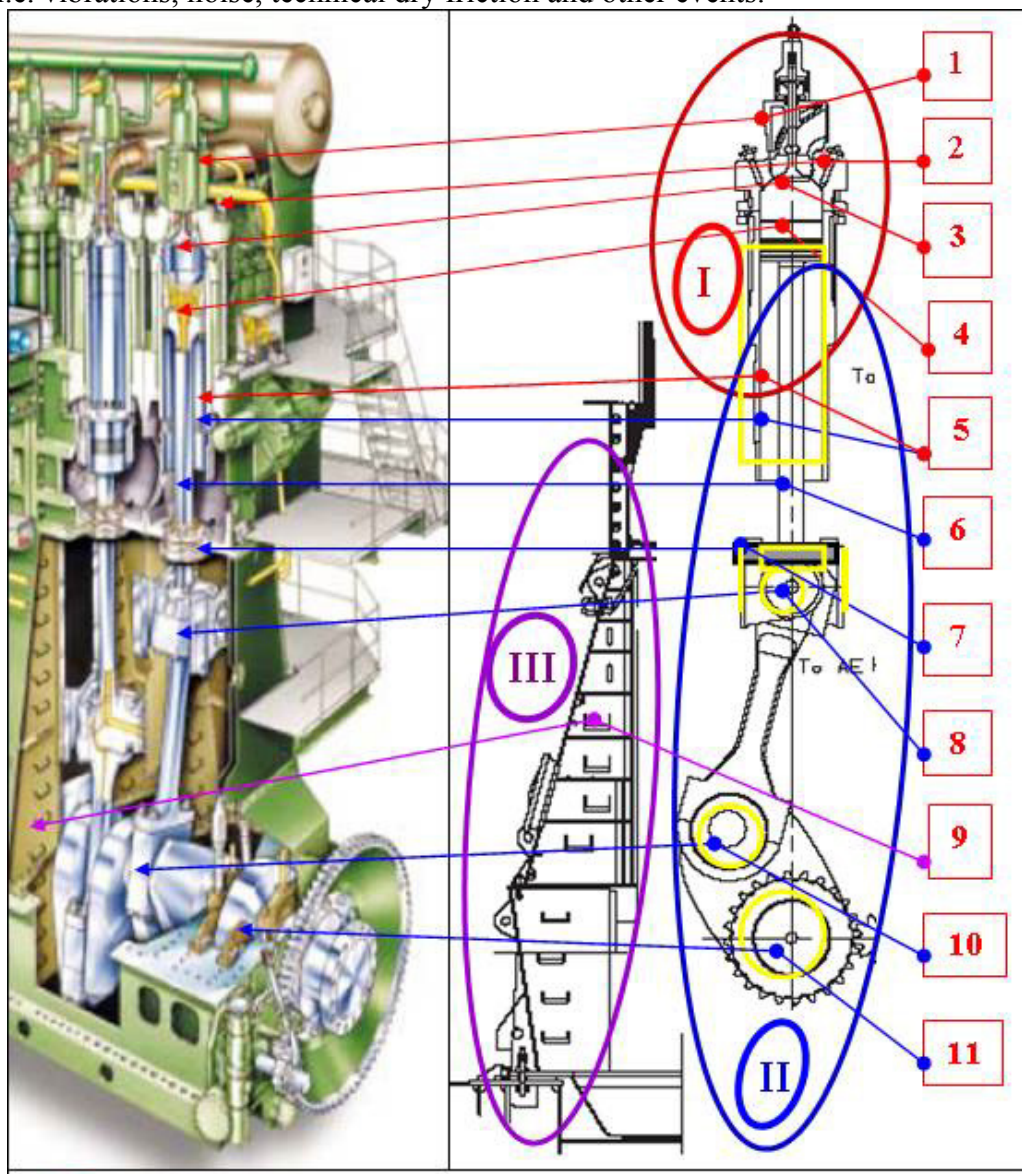
Fig. 1. Cross-section of the structural SG and its damaged zones by the dominating factors [14]:

Zone 1: 1- exhaust valve basket, 2 - fuel injection valve, 3 -exhaust valve head, 4 - piston, 5 - cylinder sleeve,

Zone 2: 5 -cylinder sleeve, 6 - piston rod, 7 - piston shank choke, 8 - crosshead bearing, 10 - crankshaft bearing, 11 - main bearing,

Zone 3: 9 - engine frame

Zone I (Fig.1) is a part of construction structure, in which the main factor of previously described damage of the SG is thermal energy generated in the process of combustion in the combustor.

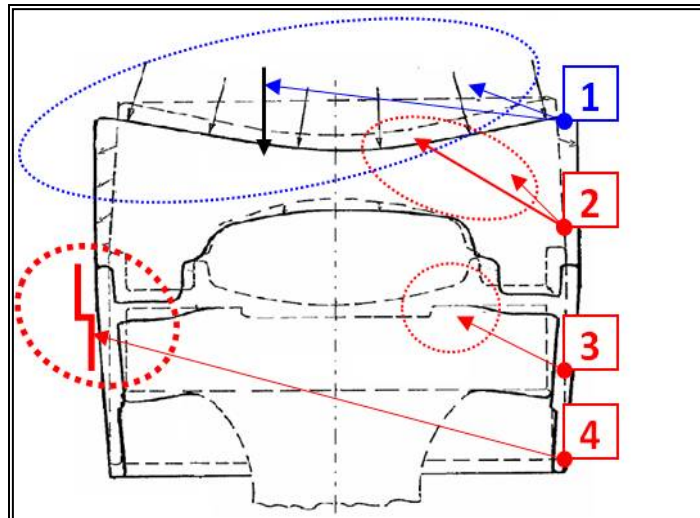
In the second picture (Fig. 2) one can notice a fracture of the piston casing's collar where the piston's head, casing and shank are combined

Fig. 2. The deformation of the piston's head and casing due to combustion gas force activity [17]:
 1 - gas forces, 2 - deformation of the piston caused by heat and gas forces, 3 - stress causing deformation, 4 - relatively high deformation in the vicinity of the telescopic tube and friction of the piston casing's collar

The friction occurred on the outside of the collar which joins the head with the piston casing. It took place after several thousand working hours (failing to comply with the limits anticipated between the overhauls TBO (Time Between Overhauls), due to material fatigue. The reason for that was the use of constructional solutions of the older generation of engines in the newer types, in which higher thermal load and higher stress occurred. The cause of the load/stress were superior pressure combustion gases.

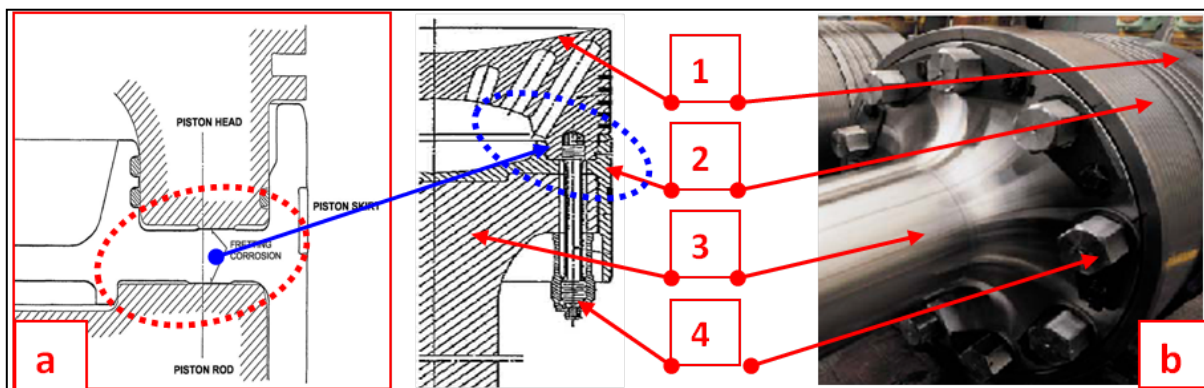
Fig. 3. a) piston casing's collar surface influenced by fretting corrosion, b) parts of the piston mutually co-operating with the cylinder sleeve: 1 - head, 2 - piston casing, 3 - piston shank, 4 - linking bolt of the head, casing and shank [18]

Fig. 3 describes the wear of the piston casing's collar due to frictional corrosion of the planes contacting the piston casing's collar with the head and the shank of the piston. The cause of such damage is the pressure occurring due to the combustion gases of greater pressure than anticipated in design. The gases cause deformation of the piston, friction of the piston collar and piston part displacement leading to frictional corrosion. The corrosion causes material loss of ca. 0,01 mm/1000h and lowering of the elastic pressure in the bolt which links the parts.

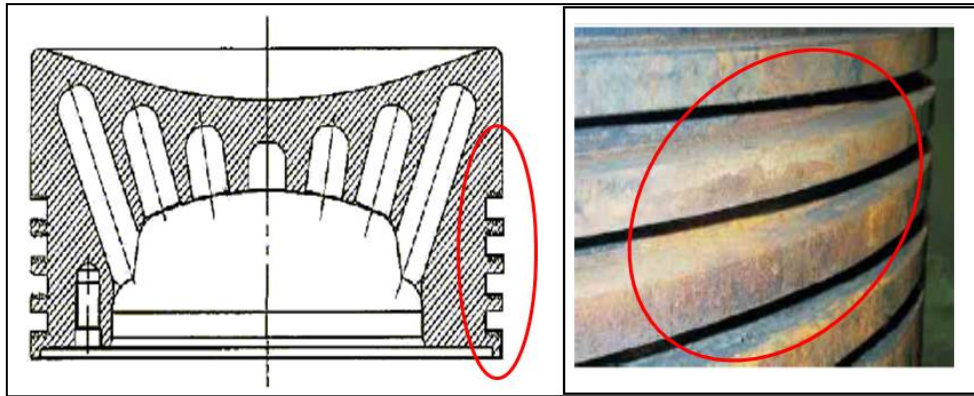
Fig. 4 shows the damage to the grooves of the piston rings inside the head of the piston. The reason of the damage is the loss of material caused by frictional corrosion leading to piston groove size alteration.

Fig. 4. Head of the piston with the piston grooves plated with chromium layer.

The cause of such damage are normal processes of the material loss due to the piston ring work in the grooves (happening in shifting sea weather conditions) and additional factors causing chemical-frictional corrosion. Improper use of the engine leads to thermal pressure increase, piston material overheating, carbon deposit occurrence and high-pressure corrosion caused by aggressive sulfur compounds created when residual fuel is combusted.

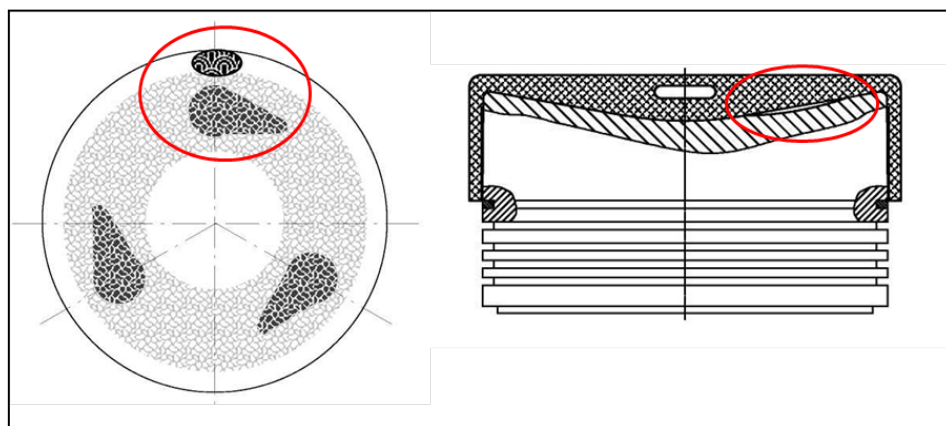
Fig. 5 and 6 show the damage to the surface of the piston head's bottom. Fig. 6 displays three types of the bottom's surface damage. In the picture are shown:

Fig. 5. The loss of material on the surface of the piston bottom [20]

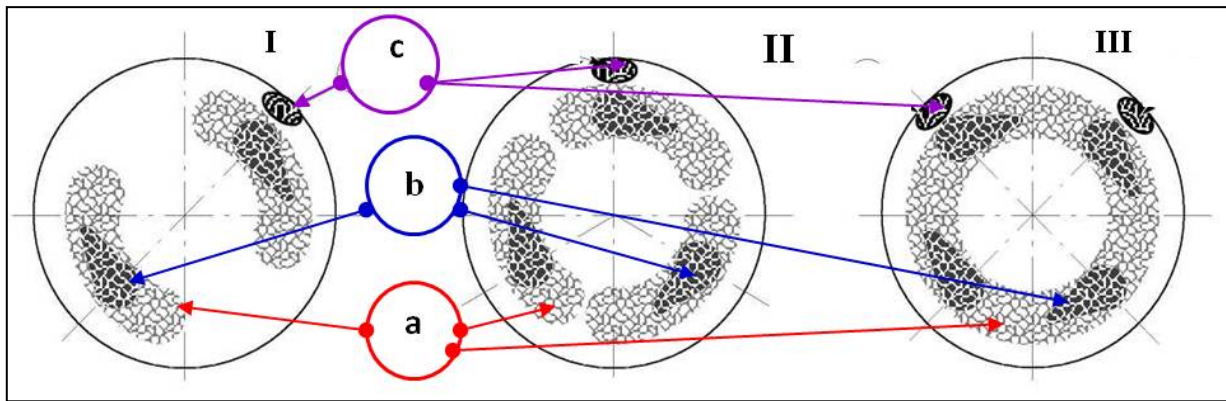
- corroded material layer on the wide area of the bottom (a),
- local loss of material caused by erosion (b),
- deep loss of material caused by burnup (c).

- corrosion of the piston bottom's surface (known as "sett block structure" or "elephant skin"), which is caused by high-temperature corrosion and by sulfur, vanadium and sodium compounds in the residual fuel (a) in the Fig. 6; the layer of the corrosion products if thin ($<0,2$ mm/1000working hours), uniform and coherent then has protective properties; when damaged, in the place of damage often occur (invisible for the human eye) corrosion pits.
- high-temperature corrosion and erosion, happening on the areas of the piston's bottom, which is subject to flame dynamics and streams of hot combustion gas, which leads to loss of the bottom's material (b) in the Fig. 6,
- improperly sprayed and leaking fuel (from the damaged injection valve), which percolates into the carbon deposit, burns on the surface of the piston's bottom creating deep pinholes (c) in the Fig. 6.

Fig. 6. Types of damage to the surface of the piston bottom for the types of engines with [21]:
 I - two injection valves, II - three injection valves, III - four injection valves, a - corrosion layer, b - local, erosive material loss, c - deep material loss caused by burnout

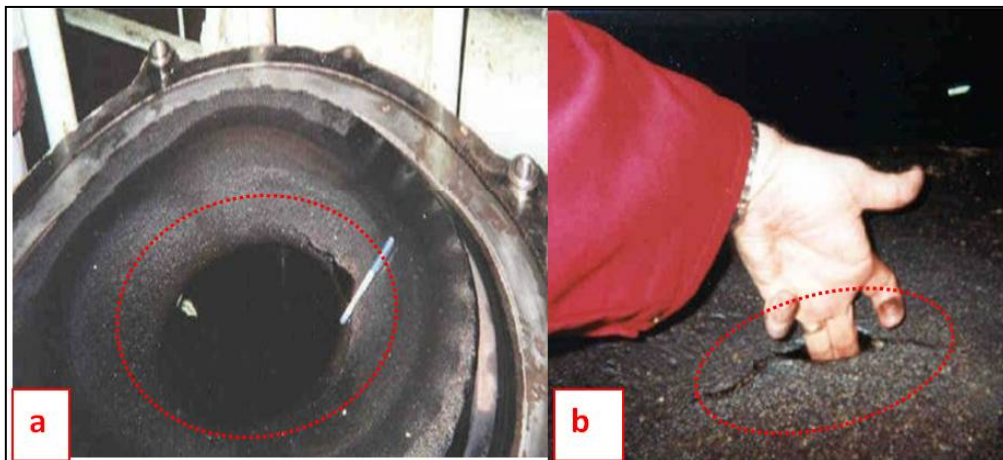
On the other hand, the Fig. 7 displays the examples of piston bottom damage, which are the result of occurrence of the causes described above.

Fig. 7. Examples of extreme piston bottom damage [25]:
 a) burnout hole caused by bad long-term fuel spraying and piston surface burning, b) damage caused by improper piston cooling

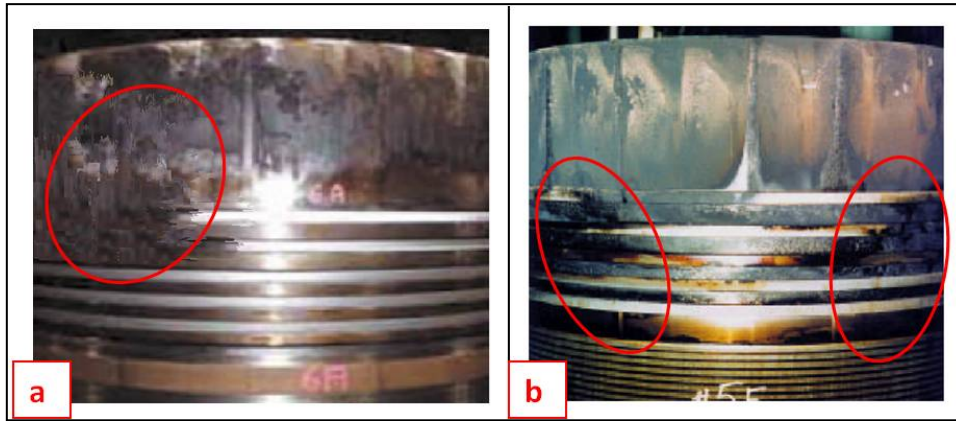
Fig. 8 shows damage to the piston rings installed in the head of the piston.

Fig. 8. Piston rings are abraded, they crack and break [25]

The damage shown in Fig. 8 points out the loss of piston rings. The reasons of such damage are construction errors coming from the use of construction solutions from the older types of engines in newer ones (which have different operating parameters). The damage occurs also due to DTR incompatible (technical-movement documentation) process of grinding-in [15, 16], using of non-original spare parts, improper piston-cooling media selection. Moreover, the damage is caused by improperly prepared cooling media and keeping improper parameters of work of the media [15, 16], invalidly prepared fuel [77], damage to the injection valve, wrong shape of the injection valve (count, size, direction of the sprayed fuel) [19].

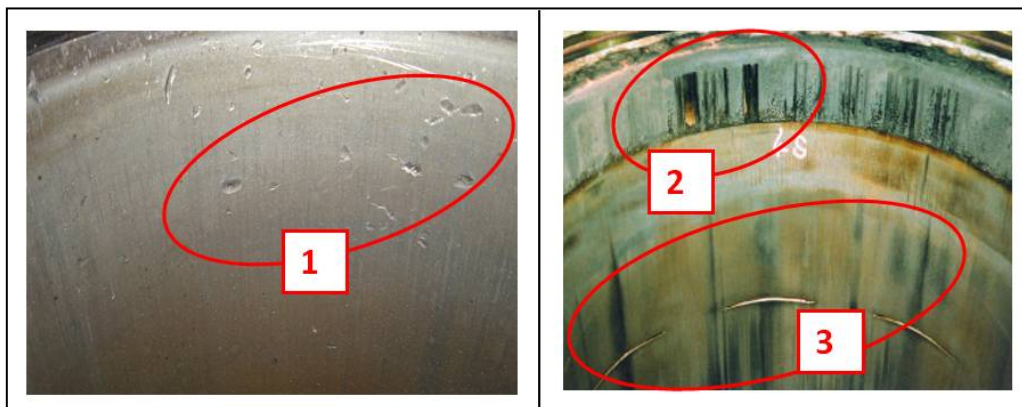
In the Fig. 9 one can observe a damage to the inner surface of the cylinder sleeve.

*Fig. 9. Damage to the surface of the inner cylinder sleeve [26]:
1 - mechanical damage by particulate solids, 2 - frictional corrosion, 3 - pinhole corrosion*

The damage displayed in the Fig. 9 is the shape change of the sleeve caused by electro-chemical, frictional, pinhole corrosion. Therefore the causes of the damage are:

- electro-chemical corrosion caused by sulfur acid created from high amount of sulfur in the residual fuel and high amount of water from the air pressure charging which liquefies on cool sleeve walls.
- frictional corrosion caused by particulate solids from the outside - from the process of combustion, friction and grinding of the piston parts, rings and sleeves.
- pinhole corrosion caused by improper lubrication of the sleeve surface (wrong or badly prepared oil, misplaced lubrication holes, or bad honing of the sleeve), when highly loaded - inadequately running injection apparatus.
- corrosion of the lower part of the sleeve caused by too-low pressure charging temperature, or too much water in it (bad work of the dehumidifier in the below-piston area).

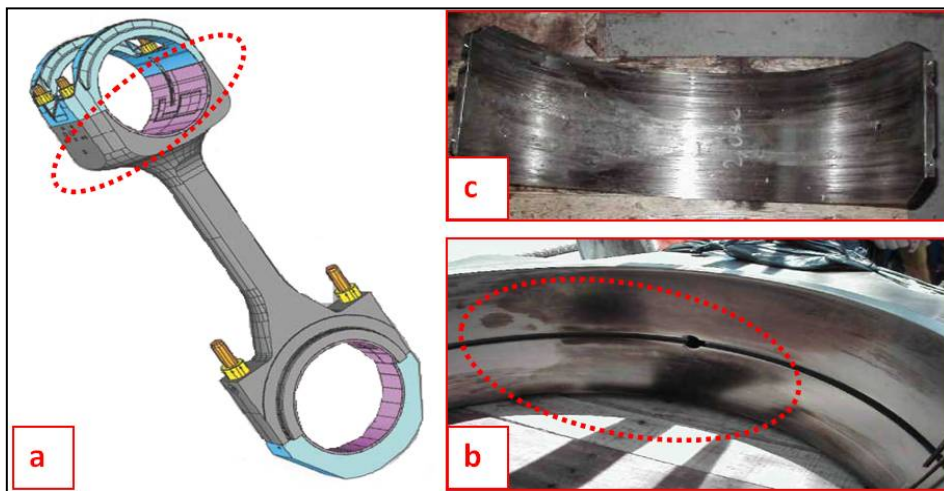
Fig. 10 shows damage to the connecting rod's head. The damage is caused by alteration of the head's structure on the contact surface with the bottom bearing liner. The bearing overheats from excessive wear of sliding surface.

Fig. 10. Connecting-rod [22, 24]: a) damage to the connecting rod's head where the lower bearing liner is adjoined, b) traces of overheating of the contact surface of crosshead's lower bearing liner, c) destroyed lower bearing liner

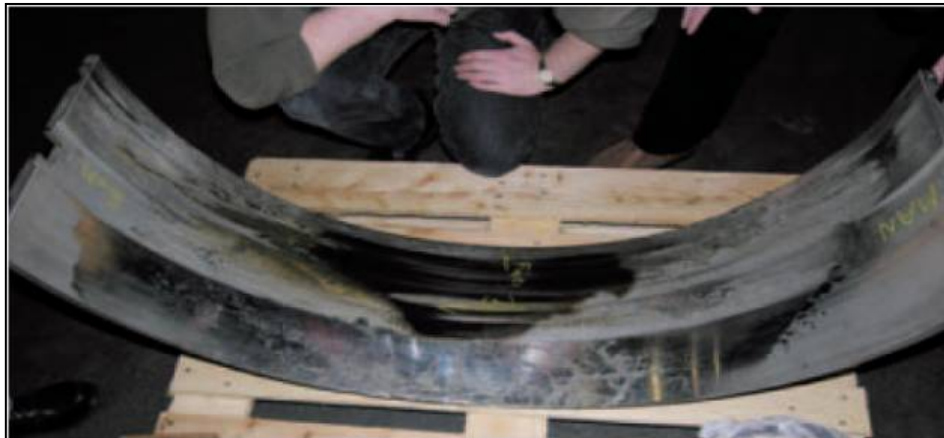
In the Fig. 11 one may observe the damage of the sliding coating of the bearing liner of the main engine bearing, which bears the marks of seizing. The cause of the damage is too long period between overhauls, along with improper smear oil processing, which leads to particulate solids layering. Also chemical constitution of the oil affects the coating damage ("used oil"), and external pressure due to bearing misuse. One may assume the marks of seizing are the result of oil film stoppage.

Fig. 11. Bearing liner with the marks of extensive wear [23]

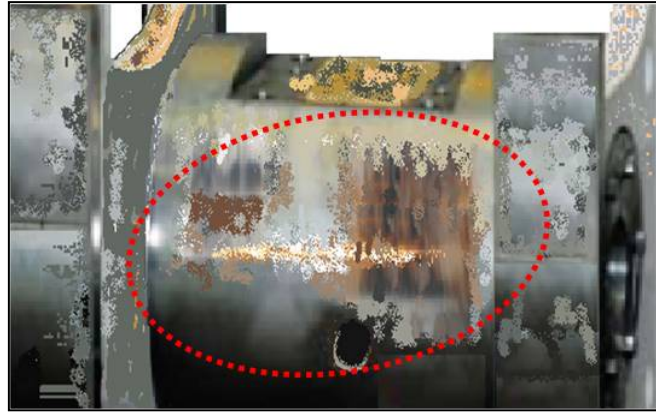
Fig.12 displays the damage to the crank-pin, which bears the marks of corrosive wear. The reason of the damage is inadequate installation of the bearing causing extensive wear, low smear oil pressure and high temperature leading to bearing liner overheating.

Fig. 12. Visible marks of corrosive wear caused by bearing overheating

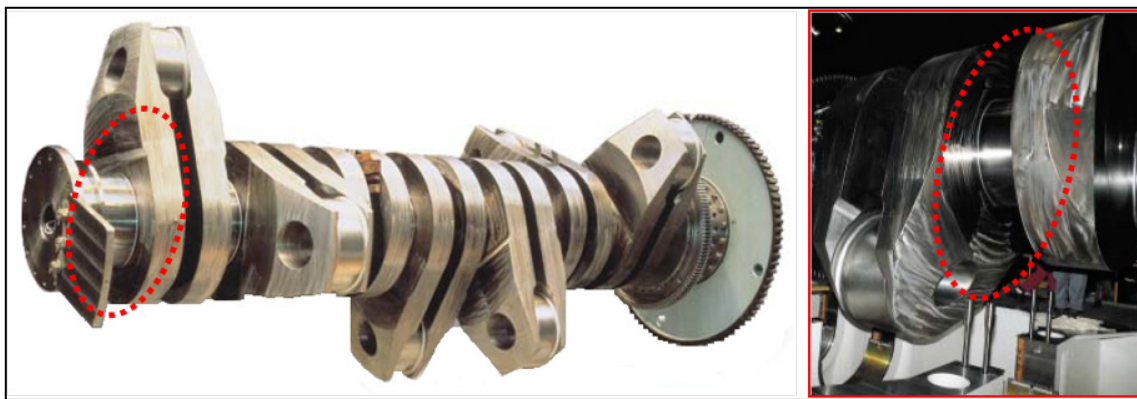
Fig. 13 and 14 show damage to the engine crankshaft, which is at the place of joining of its elements.

Fig. 13. Crankshaft with marked crank-pin [22]

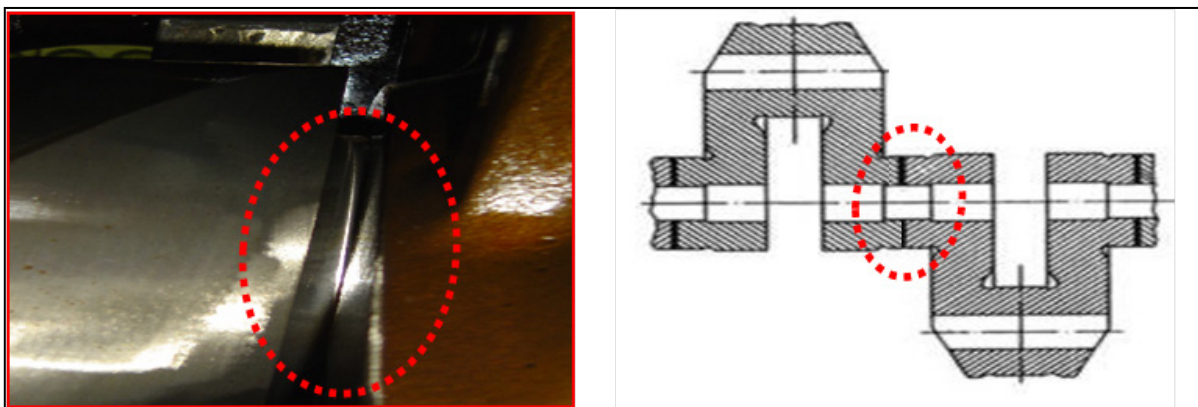
Fig. 14. Crack in the crankshaft at the joining of its elements [24]

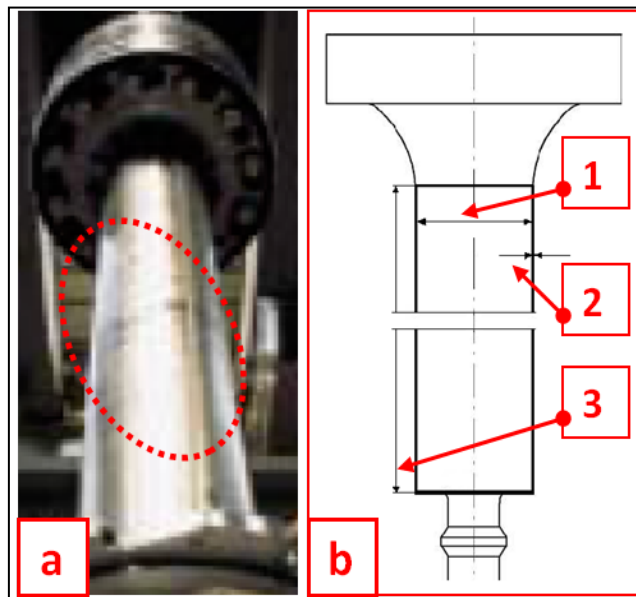
In the Fig. 15 one can notice the damage to the working surface with piston shank stuffing-box. The damage is the loss of material of the hardened face of the piston shank, local wear caused by

frictional corrosion and the occurrence of deep longitudinal scratches being the consequence of ridging and microslicing.

Fig. 15. The damage to the coating of the piston shank surface [12, 14, 22]; a) damaged surface, b) important dimensions: 1 - piston's diameter, 2 - thickness of the hardened coating, 3 - length of the hardened coating

- excessive frictional wear caused by inadequate lubrication,
- frictional corrosion caused by water occurrence in the pressure charging and creation of water-oil emulsion, aggressive chemicals occurrence as effect of combustion (they get to the below-piston space during cold starting or due to poor condition of the piston-cylinder sleeve system),
- deep longitudinal scratches caused by particulate solids coming from damaged piston, sleeve or piston shank's stuffing-box elements or the piston shank itself.

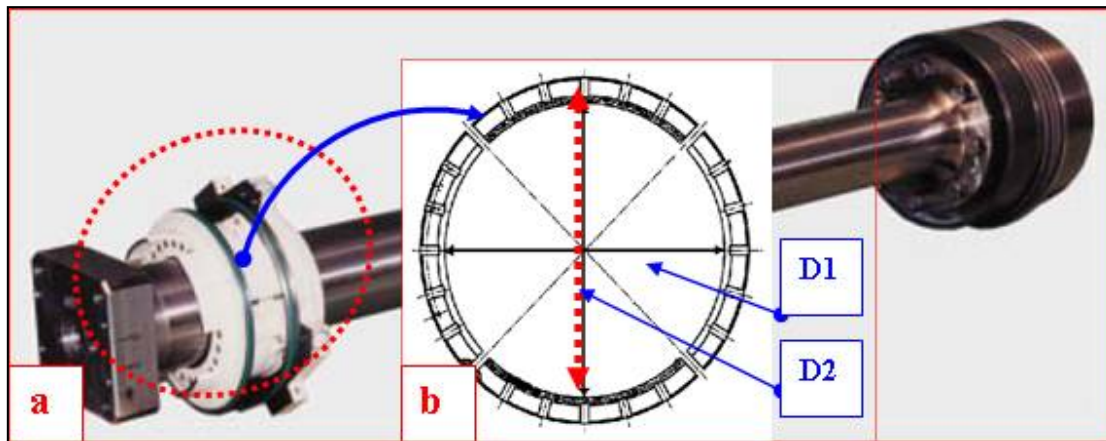
Picture 16 displays the damage to the piston shank's stuffing-box. The damage is the wear in the process of engine use, leading to section ovality occurrence and mechanical damage to the casing elements and segmental elements of the skimming-tightening rings.

- frictional wear, visualizing as uniform loss of material of the tightening rings caused by ring friction against the tightened surface of the piston's shank,
- DTR incompatible: "dry-running" of the piston's shank, crosshead bearing clearance, stuffing-box installation, contracting spring rupture, contamination of the tightening rings by the products of combustion leading to section ovality occurrence.
- installation errors (impurities of the elements, skew, ring assembly from different elements of the rings, "up-side-down" setup of the ring), corrosive damage, which may cause ring cracking [13],
- aggressive chemicals created during incomplete combustion in changing load, especially during maneuvers at the time which inadequate media parameters are kept or when the piston-cylinder system is damaged, which lead to corrosive damage of the casing and stuffing-box rings.

Fig. 16. Stuffing-box of the piston's shank [11, 13]: a) set on the shank [22], b) section ovality of the stuffing-box: D1 - allowable diameter, D2 - excessive wear diameter

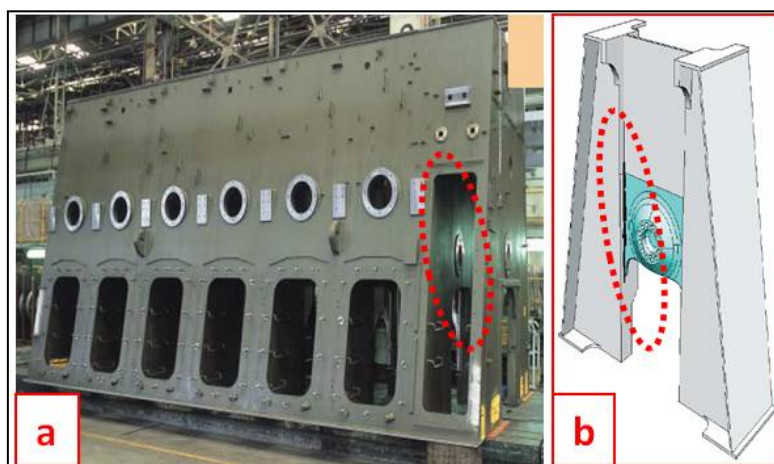
The damage and their causes in the zone will not be taken under consideration because they apply to the engine hull damage, such as cracks in the cross-corners of the welded joints of the engine's hull pillar, cracks of the welded joint of the main plate and ribbing plate, cracks of the ribbing plate between the technological holes, cracking of the resistance bearing column, etc. Some damage occurring in the zone influence the proper work of the main bearings. In example, the cracking of the column of the resistance bearing (being a part of the hull's pillar) (Fig. 17) may lead to main bearings' damage.

Fig. 17. Engine's hull pillar [23]: a) welded pillar multi-element construct , b) resistance bearing column

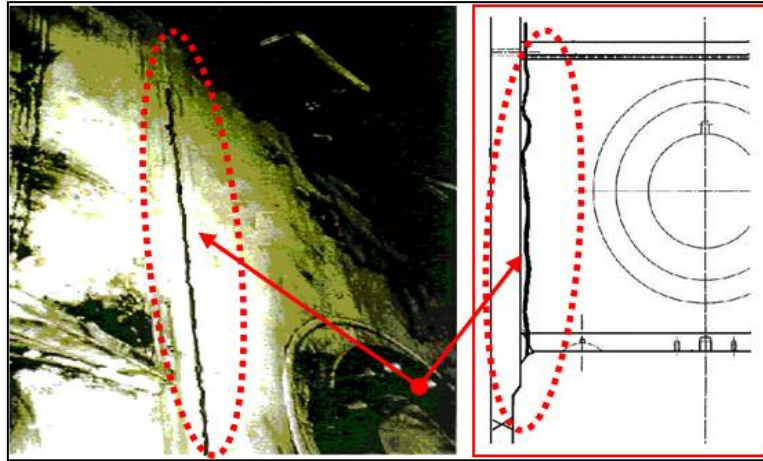
An example of resistance bearing crack along the fusion weld of the column and the main plate is described in the Fig. 18.

- constructional factors - joining of two heavy column elements with light ribbed element constructions,
- installation factors - welding errors such as improperly prepared edges of the welded elements, bad weld penetration, improper joint face of the fusion weld.
- running factors - changing pressure caused by periodical fuel combustion, increase in vibrations caused by improper running of the light lateral elements, vibration dampeners, using of the shock methods of tightening on the resistive bolts fastening the main bearing.

Fig. 18. Pillar of the engine's hull with a crack in the resistance bearing column along the fusion weld of the column and the main plate [10]
