Geotechnologies Applied to Anthropomorphic Structures: Use of GPR for Detection of Structural Problems, Causes and Effects - Case Study in Coimbra, Portugal

Abstract

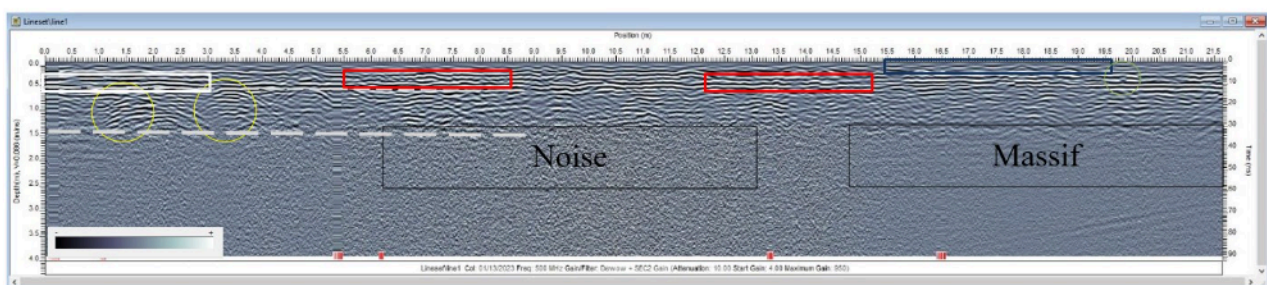
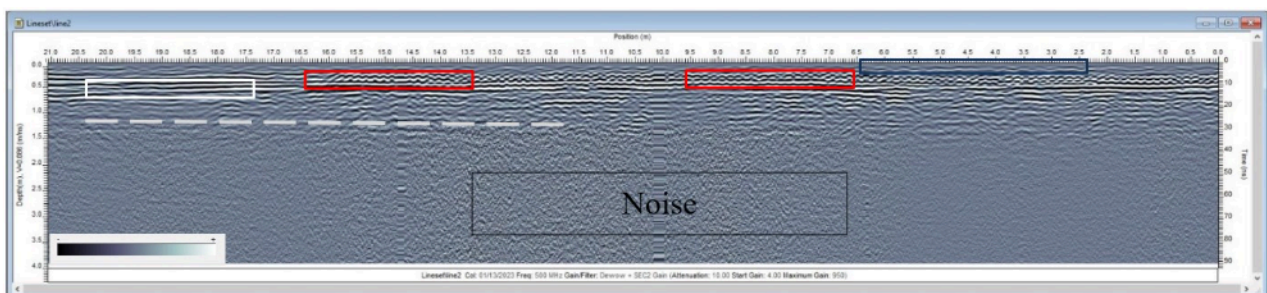
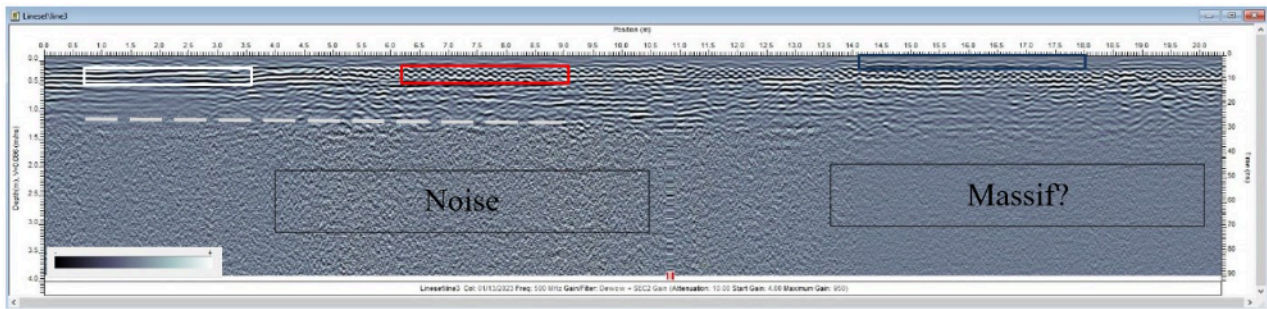
The results obtained from the acquisition performed on the East side (Lines 1, 2 and 3), show that on the surface, as expected, no significant changes were identified, and it is possible to see the floor slabs (blue polygon). At a depth of 0.50-0.55 m, marked by the red polygon, it is possible to identify the beam and the reinforcements, as well as the stratified area (white polygon). It is also possible to identify what appears to be a box and pipes (yellow and green circles). From 1.1-1.15 m depth, for the radargrams of lines 1, 2 and 3, the signal is different, partly due to the rocky substrate in which the structure is set (grey dashed line). There is also a lot of noise below this depth from signal attenuation due to the materials above (rock with high content of iron and clay and seepage water). All this structure is visible on the remaining processed radargrams (Figures 6, 7 and 8).

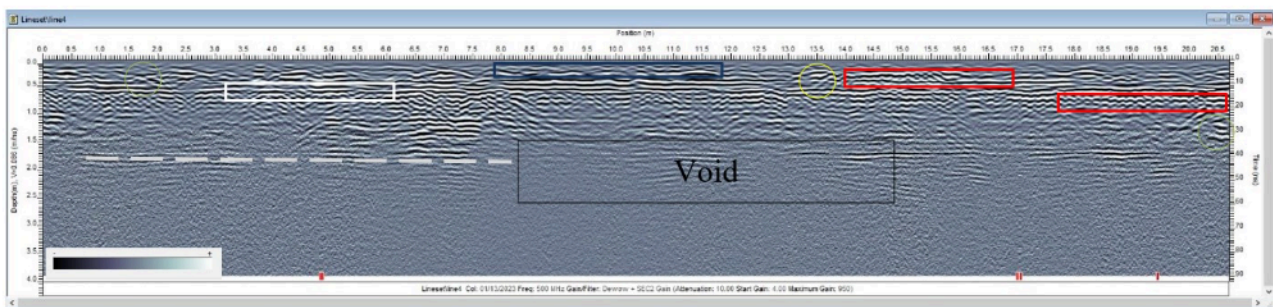
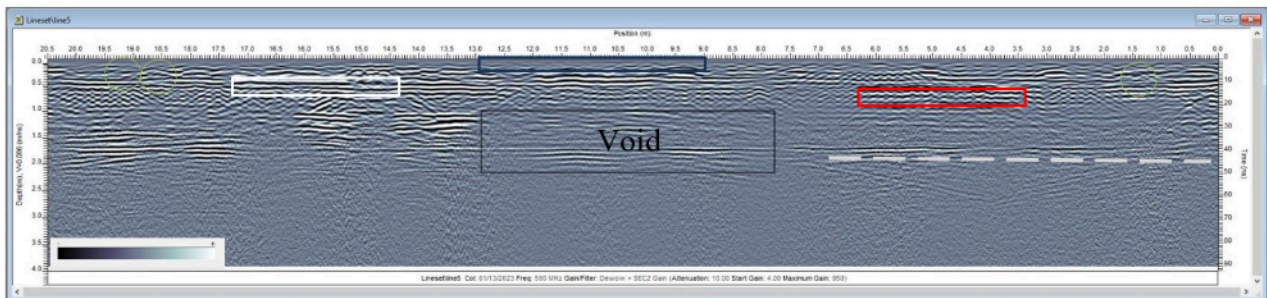
On the West side (Lines 4 and 5), it can also be seen that on the surface, no significant alterations are observed, and it is possible to see the floor slabs (blue polygon). At a depth of 0.50-0.55 m, marked by the red polygon, it is possible to identify the beam and the frames, as well as the stratified area (white polygon). It is also possible to identify what appears to be a box and pipes (yellow and green circles). From 1.5-1.7 m depth, for the radargrams of lines 4 and 5, the signal is different and is partially attenuated by the materials above (iron and seepage water) and by the existing void resulting from the built structure (Figure 11) (grey dashed line). All these structures are visible on the remaining processed radargrams (Figures 9 and 10).

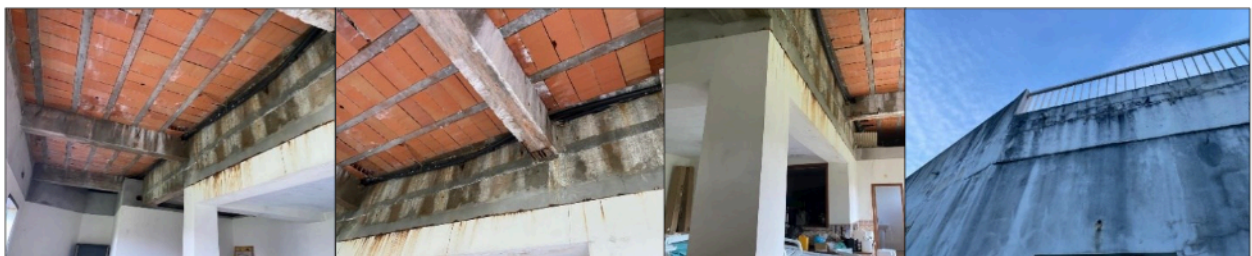
Fig. 11. Interior and exterior of the structure correspondent lines 4 and 5.

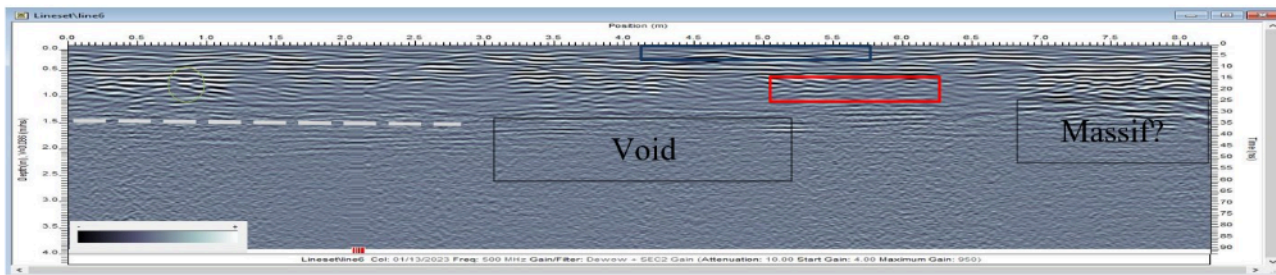
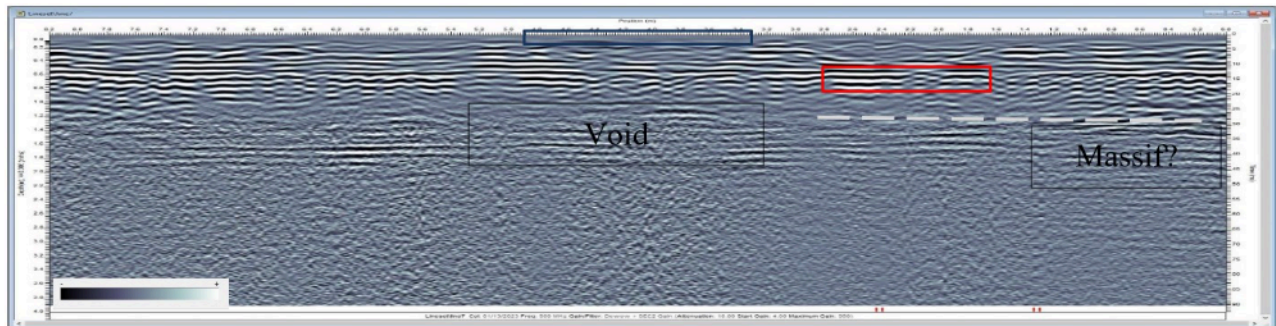
On the South side (Lines 6 and 7), it is also possible to see no significant changes on the surface, with the floor slabs being visible (blue polygon). At a depth of 0.60-0.70 m, marked by the red polygon, it is possible to identify the beam and the frames. It is also possible to identify what appears to be piped (green circle). From 1.5-1.7 m depth, for the radargrams of lines 6 and 7, the signal is different and is partially attenuated by the materials above (iron, rock with high iron and clay contents and infiltration water) and by the existing void resulting from the built structure (grey dashed line). All these structures are visible on the remaining processed radargrams (Figures 12 and 13).

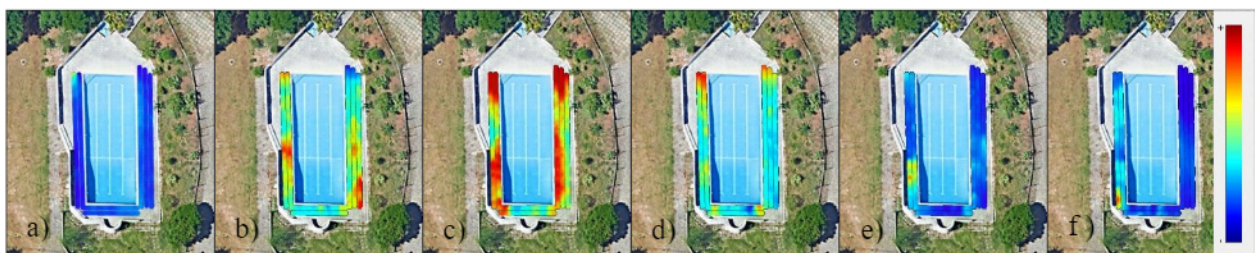
At the surface, as it had been referred from the visualisation of the radargrams, there are no significant changes mirrored in the uniformity of the reflectance values. In this case, the surface was dry and structurally sound.

At 0.35-0.40 m depth, corresponding to the slab, there are some significant changes with high reflectance values on the East side, possibly corresponding to water infiltration in the rock mass and on the west side to water infiltration in the contact between the pool and the slab, at the point where there are higher reflectance values. At a depth of 0.50-0.55 m, the alteration in the structure is notorious. By water infiltration and the presence of iron from the beams of the structure. As can be seen in figure 11, the frames are bare and with high rates of deterioration. From 0.65-0.70 to 1.65-1.70 m depth, the variations in reflectance values tend towards uniformity and lower values. This fact is because underneath the deteriorated structure there is an open space which corresponds to the interior storage space of equipment and machinery related to the swimming pool maintenance (Figure 11). In the last slice, it is possible to identify a change in the southwest corner, which will correspond to an occurrence in the masonry wall built in the structure, as can be seen in the last photograph of Figure 11.

Fig. 14. a) Surface Slice. b) Slice to a depth of 0.35-0.40 meters. c) Slice to a depth of 0.50-0.55 meters. d) Slice to a depth of 0.65-0.70 meters. e) Slice to a depth of 1.10-1.15 meters. f) Slice to a depth of 1.65-1.70 meters.
